Source: Leece-Neville Heavy Duty Systems Division - Arcade, NY USA  
Date: August 28, 2018  
Bulletin No: TSB-1173  
Models: Counterfeit Alternators in Marketplace  
Subject: Counterfeit Prestolite Alternators

### Counterfeit Prestolite / Leece-Neville Alternators

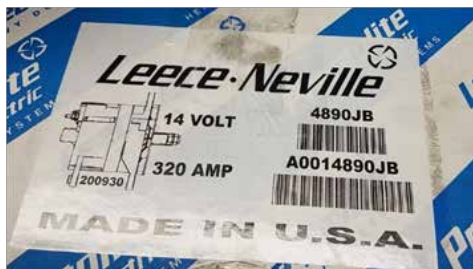
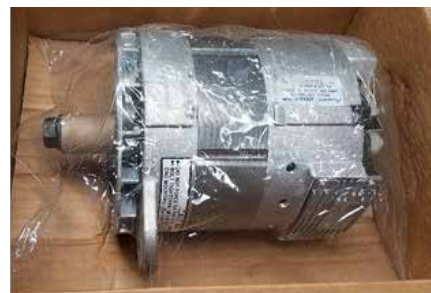
1. Did you purchase it from an authorized Prestolite / Leece-Neville distributor.
2. Was the price too good to be true?
3. The box label is larger than our authentic 4x 6-1/4 label (counterfeit label shown below).
4. The plastic shrink over the alternator in the box is thin and doesn't hold the unit securely (counterfeit unit shown at right below).

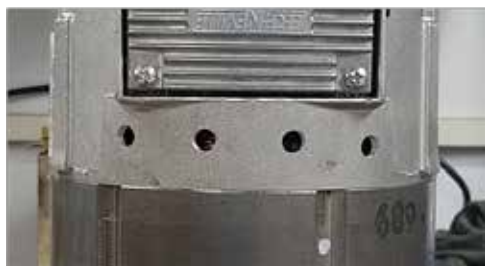
5. The rear housing on this counterfeit A0014890JB was modified by someone to add the cooling holes, but were put into the housing poorly and unevenly spaced (counterfeit unit shown below).

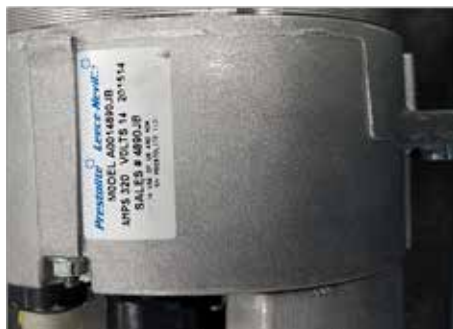
6. The product label was the wrong size and orientation (counterfeit shown below).
