## **SERVICE BULLETIN**

**CONVENTIONAL AIR CLEANER HOUSING BOOT  
DEFORMED**

**GROUP: 0-GENERAL  
BULLETIN NO: SB-18-027  
DATE: 9-28-2018  
REF: HMM-180917-B1**

**SUBJECT VEHICLES:** 11MY-18MY Conventional Trucks equipped with a J08 engine

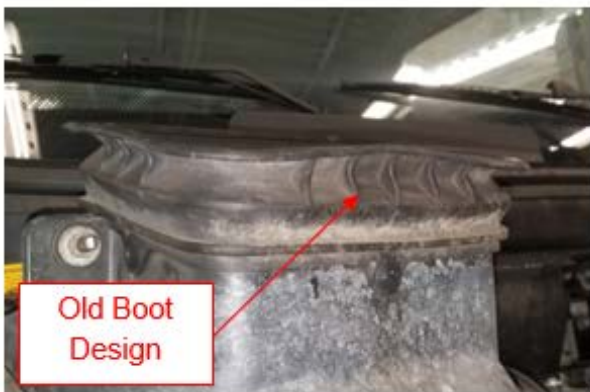
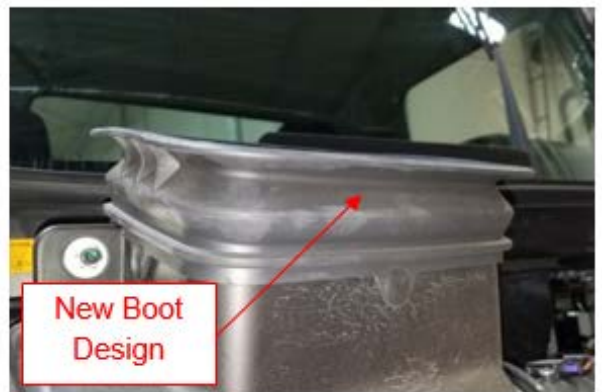
The subject vehicle may experience an appearance concern of the air cleaner housing boot. This deformation does not affect function. The air cleaner housing boot has been changed, removing the ribs on the front side to prevent deformation. This boot can be replaced separately from the air cleaner housing if replacement is desired.

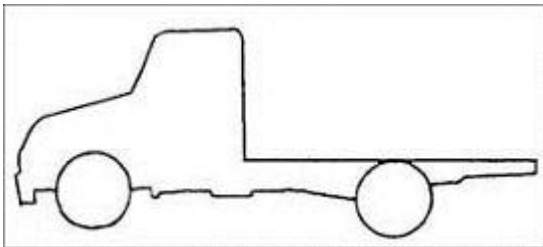
1. Park the vehicle on a flat, level and solid surface.

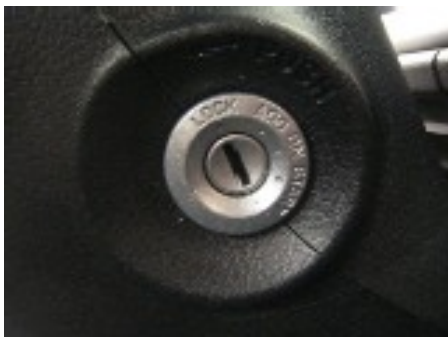
2. Confirm the engine is stopped, the ignition switch is in the off (LOCK) position, and the key is removed.

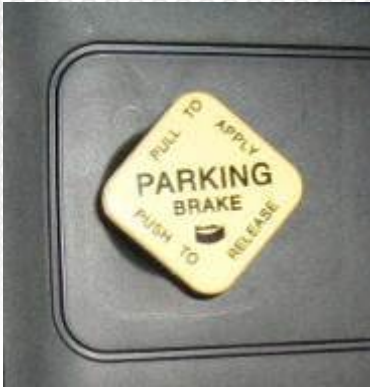
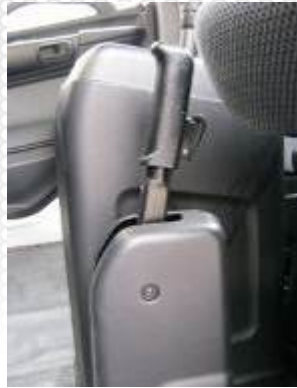
### 3. Apply the parking brake

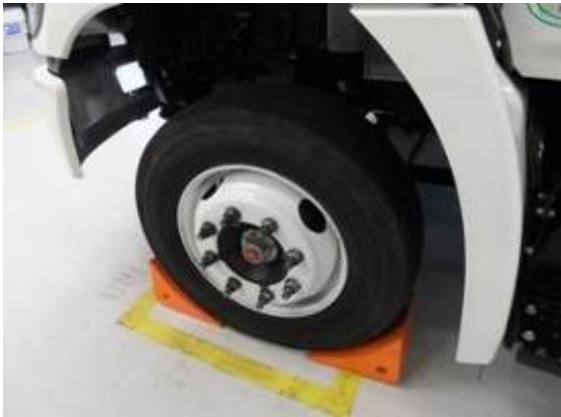
### 4. Chock all of the wheels.

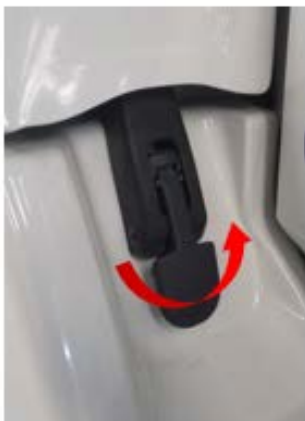
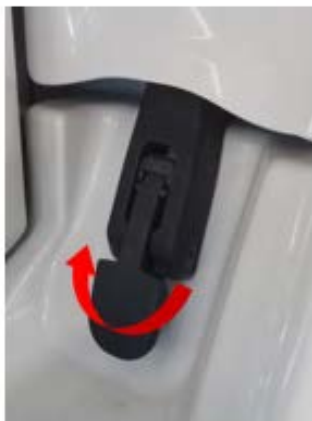
### 1. Release the hood latches on both sides of the vehicle.

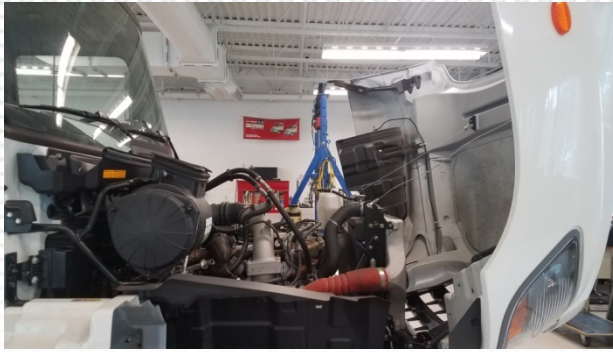
2. Raise the hood fully.

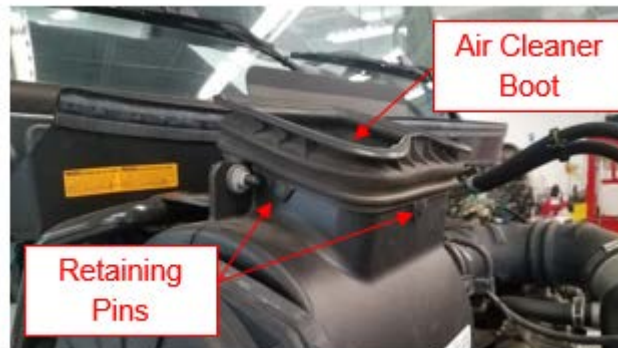
3. Using a suitable trim tool, carefully remove the four (4) retaining pins securing the air cleaner boot. Note that the photo shows two of the four pins, the remaining two pins are on the opposite side of the housing. Retain these pins for reassembly, then remove and discard the old air cleaner housing boot.

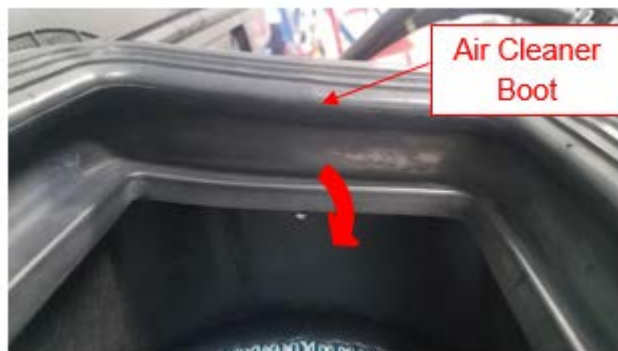
4. Place the new boot (17714-EV030) on the air cleaner housing. Make certain the inner lip hooks over the edge of the air cleaner housing on all four sides.

**NOTICE:** There are notches on the side of the air cleaner boot to indicate proper orientation

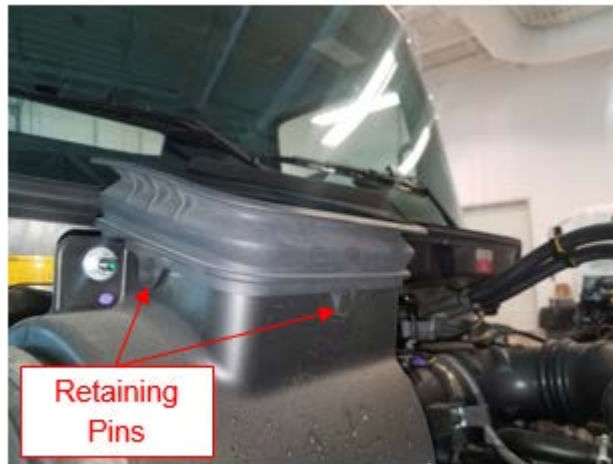
5. Press the retaining pins removed in step 3 back into the air cleaner housing to secure the new air cleaner housing boot. Note that the photo shows two of the four pins, the remaining two pins are on the opposite side of the housing.

**NOTICE:** If these retaining pins are damaged, replace using part number 17783-EV010.

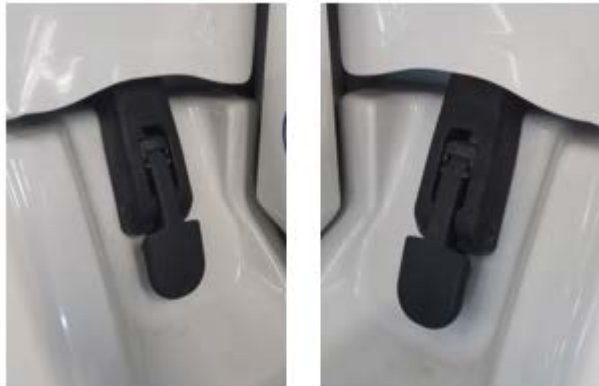
6. Lower the hood and engage the hood latches on both sides of the vehicle.
