SI B11 03 08  
Engine

July 2018  
Technical Service

## CRANKCASE VENTILATION SYSTEM DIAGNOSIS AND MEASUREMENT

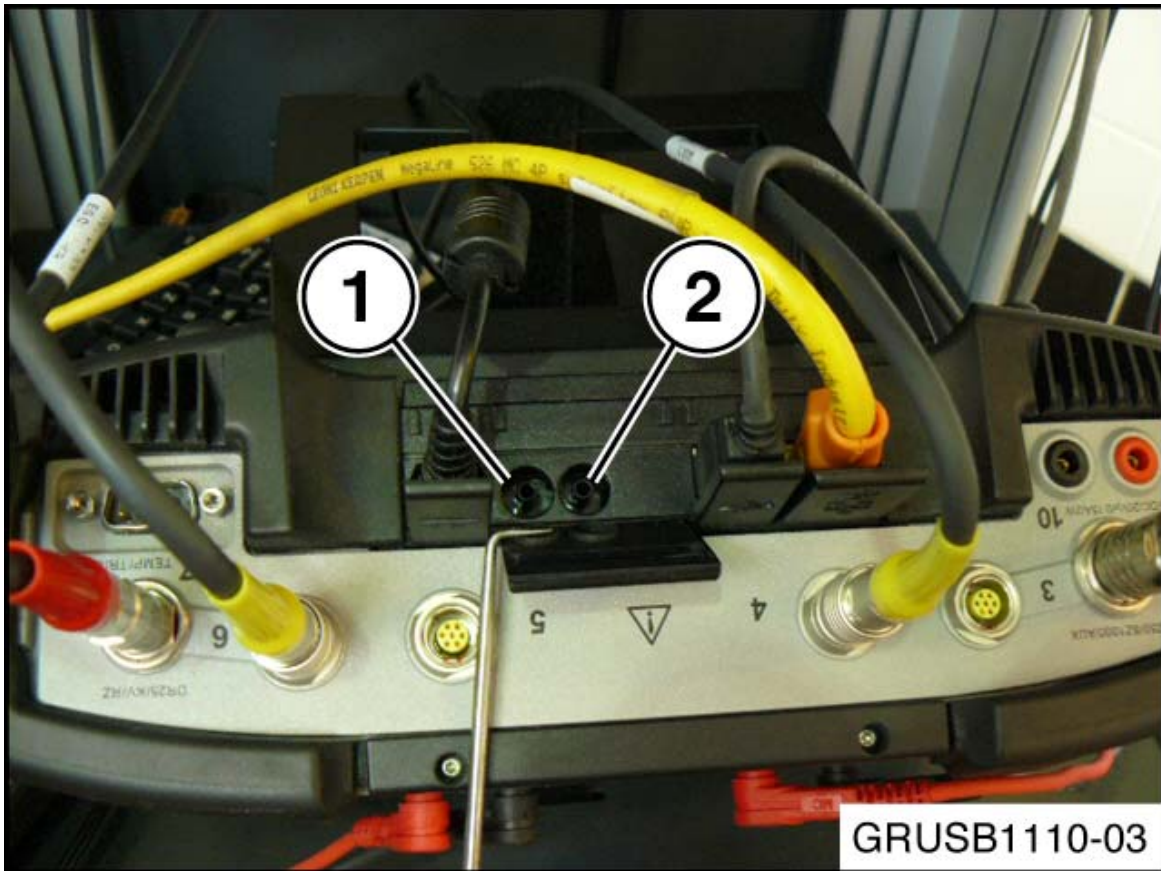
1. Select "Activities".
2. Select "Measuring Devices".
3. Select "Measuring Device".
4. Select "OK".
5. Select the appropriate IMIB when the Connection Manager screen is shown.
6. Select "Set Up Connection".
7. When the multimeter screen is shown, select "Low Pressure 1".
8. Connect the pressure measurement hose, P/N A5E0134072, to the left port on the IMIB (1). Two measurement hoses were shipped with the IMIB to every center. See the illustration below. Refer to SI B04 35 09 for more information regarding the equipment shipped to all centers with the IMIB.

Port 1 = (1)

Port 2 = (2)

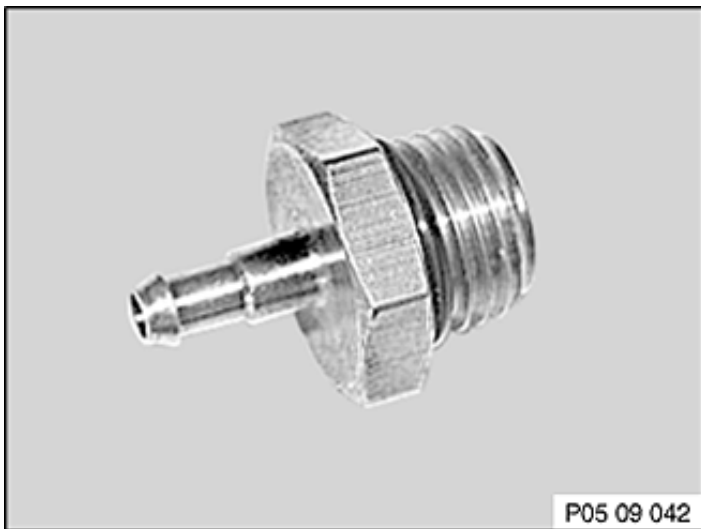
Diagnostic Tool Adapter P/N 81 29 2 158 850.

The adapter will be used to adapt the 2G quick disconnect equipment during low-pressure measurements (up to 3 bar; see the user's guide), and is attached to the IMIB using the low-pressure rubber hose (Siemens P/N A5E01034072), supplied with the IMIB. For additional information, refer to Service Information B04 15 10.

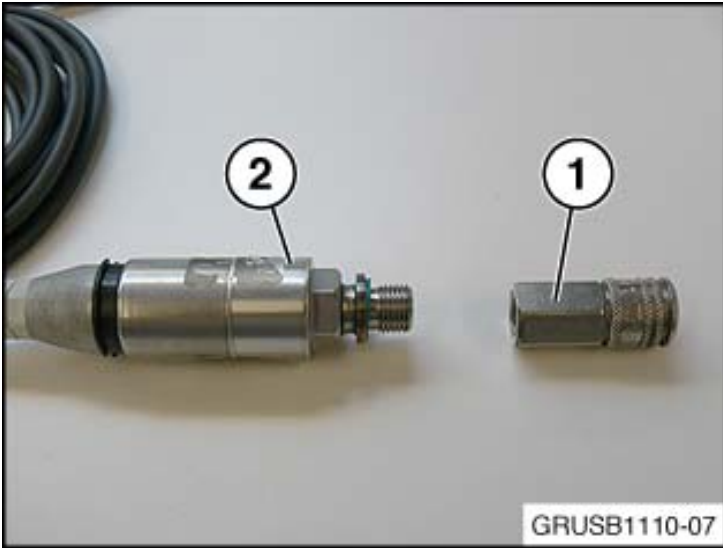
Option 1:

Remove the quick disconnect coupler (1) from the 2G equipment 25 bar pressure transducer (2).

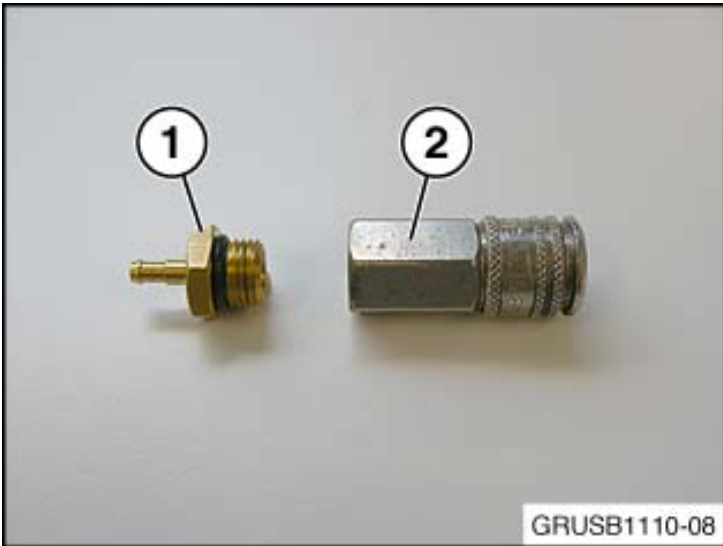
Install the Diagnostic Tool Adapter, P/N 81 29 2 158 850 (1), on to the quick disconnect coupler (2).

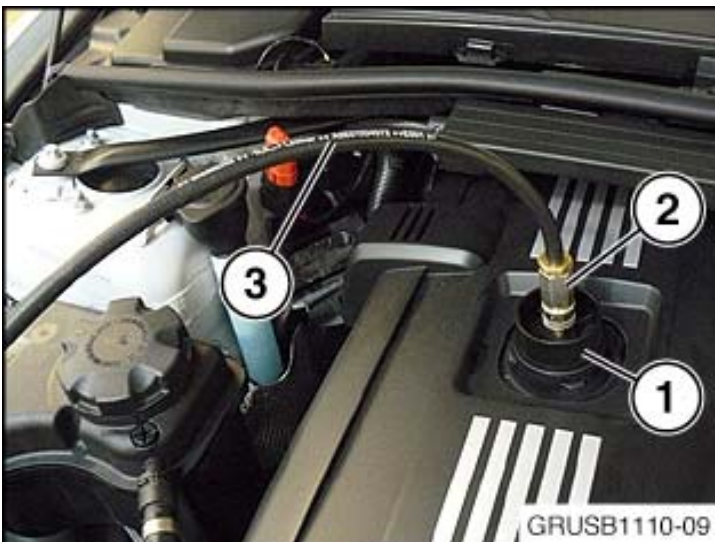
Remove the engine oil cap and install the special pressure tester adapter, P/N 83 30 0 496 326 (1). Connect the quick disconnect coupler (2) onto the pressure tester adaptor. Connect the IMIB pressure measurement hose, P/N A5E0134072 (3).

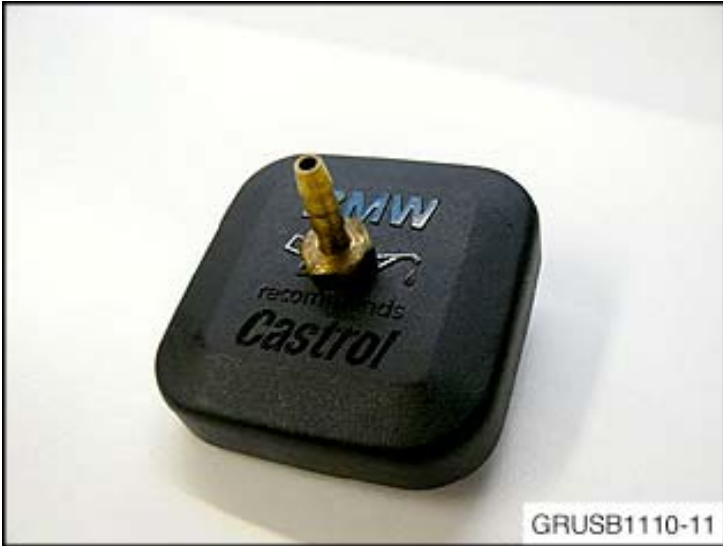
Remove the oil cap adaptor from the existing Slack Tube Manometer.

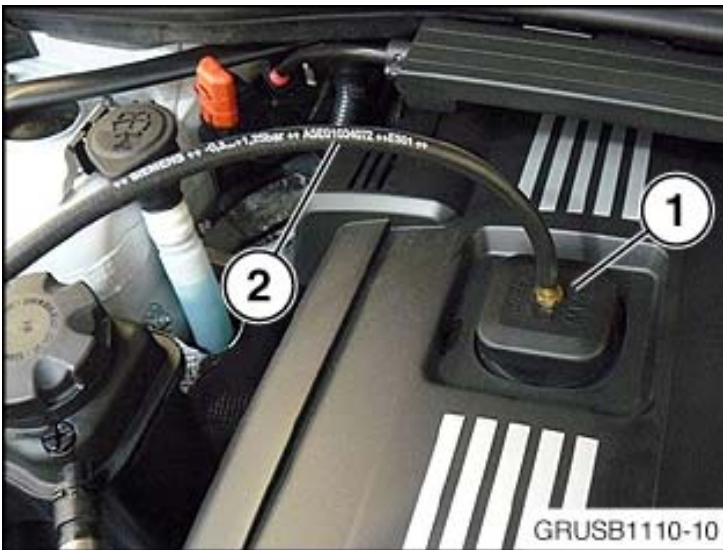
Remove the engine oil cap and install the oil cap adaptor (1). Connect the IMIB pressure measurement hose, P/N A5E0134072 (2).
