Technical Service Bulletin: TSB150033	Released Date: 17-Sep-2018
New Fuel Pump Short Block Service Kits

This document announces the release of a fuel pump short block.

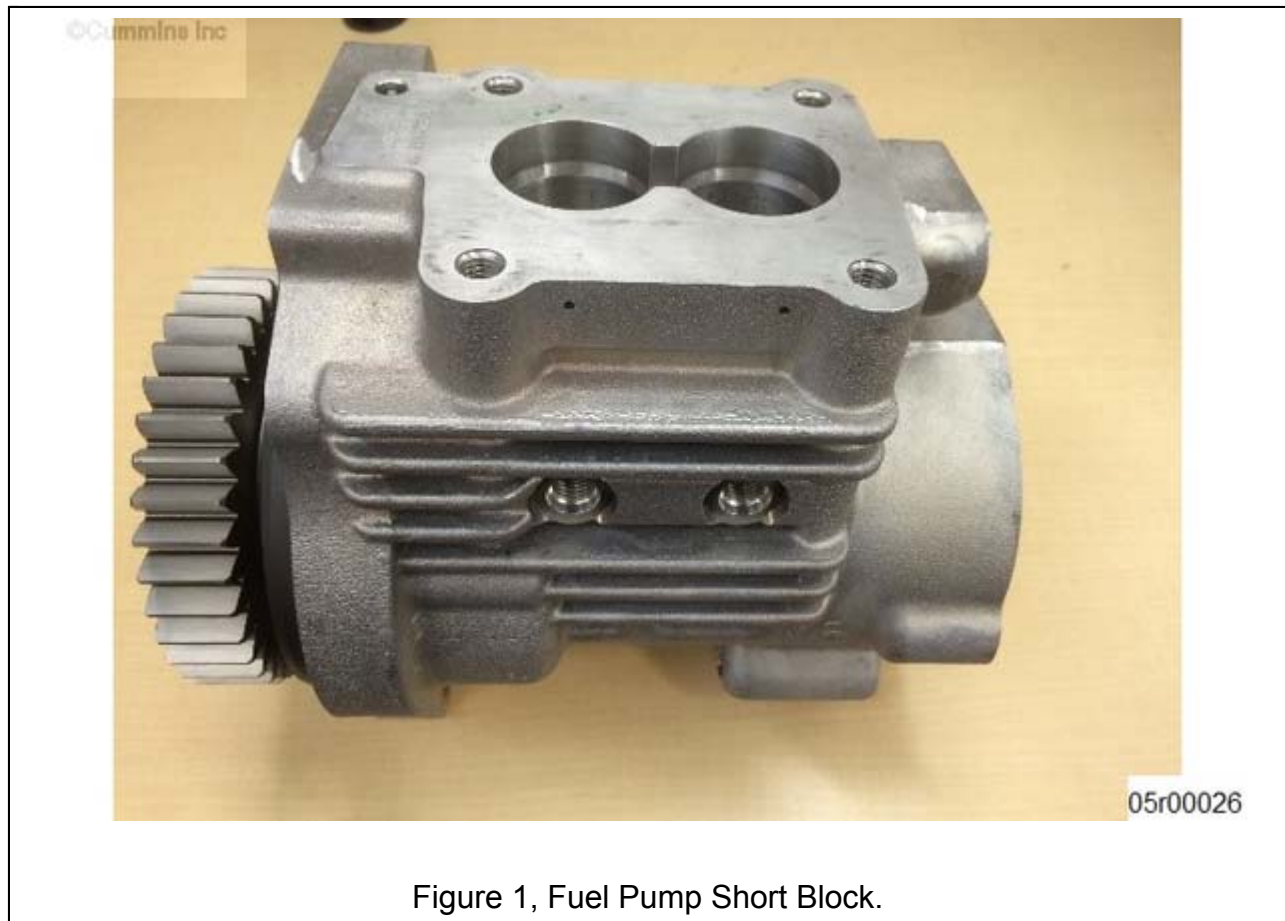
Fuel pump short block service kits have been released. The short block fuel pump allows for the reuse of the existing fuel pump head and fuel pump gear pump to make a complete fuel pump.

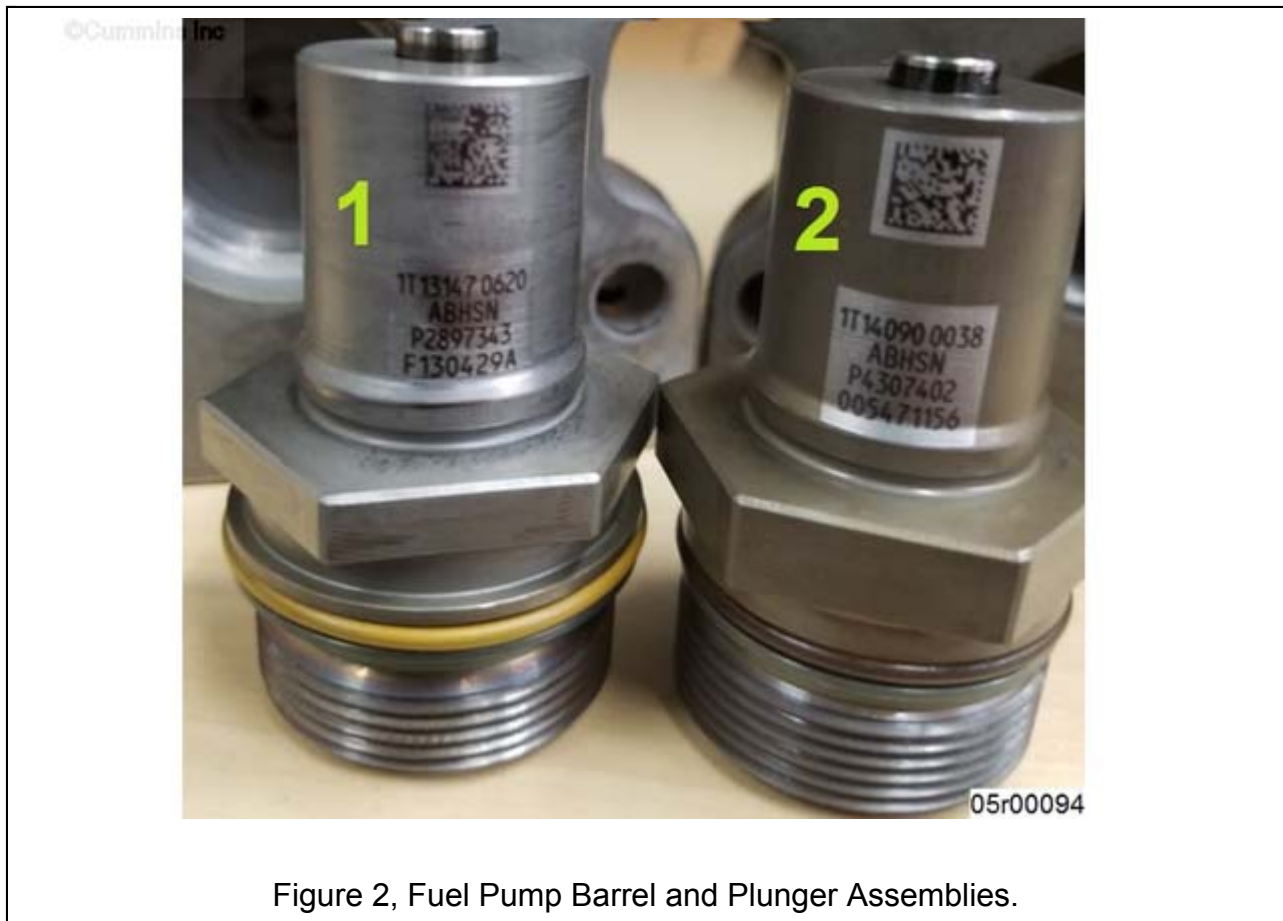
Figure 2, Fuel Pump Barrel and Plunger Assemblies.

Barrel and plunger assemblies are not interchangeable between the ISX/QSX15 CM2250 and the ISX/QSX15/X15 CM2350 fuel pump head. Installation of incorrect barrel and plunger assembly will result in excess fuel in lubricating oil.

See Figure 2 below for visual barrel and plunger assembly differences.

1. ISX/QSX15/X15 CM2350
2. ISX/QSX15 CM2250
