# Dealer Service Bulletin

**NO.:** 7SB003-18-01V

**AFFECTED:** Intent

**SUBJECT:** Insufficient cooling from dash air conditioning

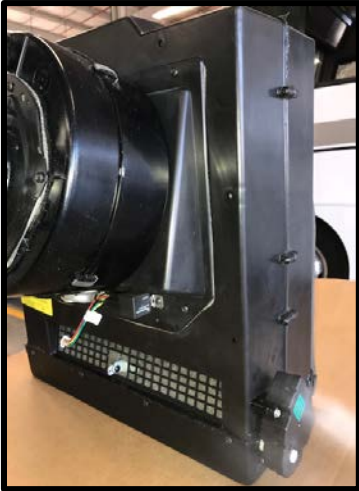
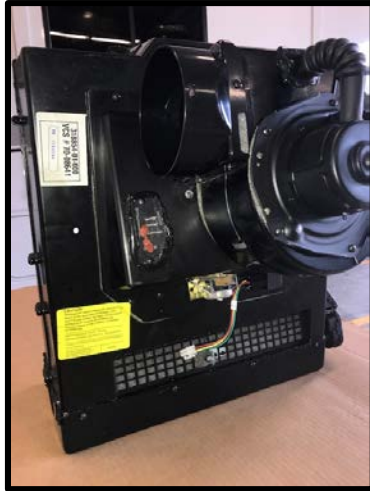
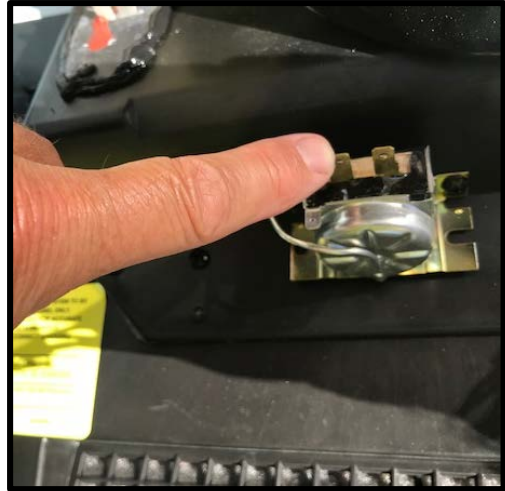
Frontal / Interior View – i.e. the fan faces toward co-pilot seat

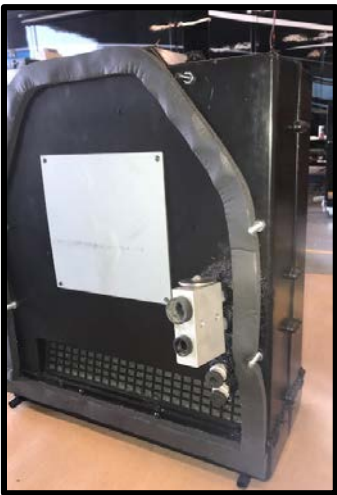
Back / Faces Bulkhead – i.e. seals to the interior side of fire-wall (shown here up-side down). A total of '5' mounting studs pass through bulkhead and 7/16ths cap-nuts retain assembly. Note: The evaporator coil / heater core on the new assembly is copper vs. aluminum. This improves heat-transfer efficiency and is also a visual clue that this evaporator assembly is the correct installation.

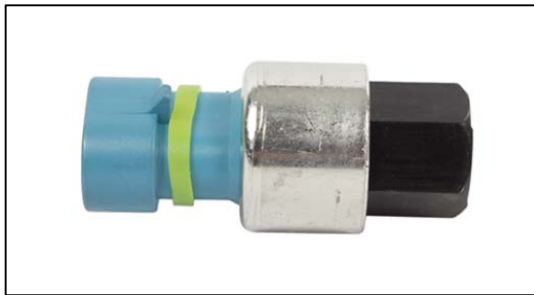
**Note:** Please inspect the Ford supplied binary pressure switch located on the low-side A/C hose and confirm the 'band' on this switch is a 'yellow' band. The low-side cut-out pressure on this switch is between 8 – 12 PSI. Should the pressure switch have a 'white' band on it, a yellow-band switch must be sourced and installed. This switch needs to be sourced through the local Ford dealer. (Ford's part number is HU94-19E561-AA)
