## Service Campaign 68-14

**AFFECTED:** 2018 & 2019 Revels

**SUBJECT:** Revel Heating System

**Overview:** Revel Heating System - Flush, Rinse & Refill Procedure

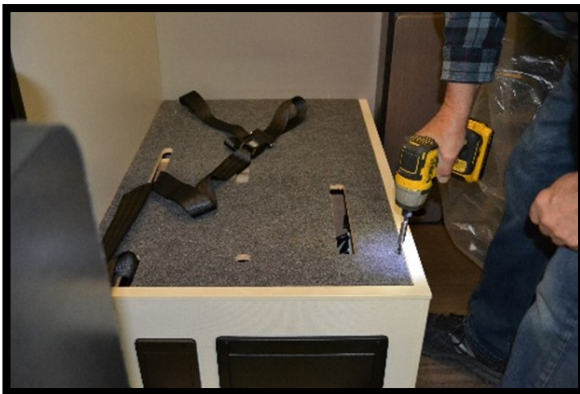
1. Remove dinette seat back, seat cushion and filler cushion from dinette. Set aside.
2. Remove screws on dinette seat base access panel and lift up.

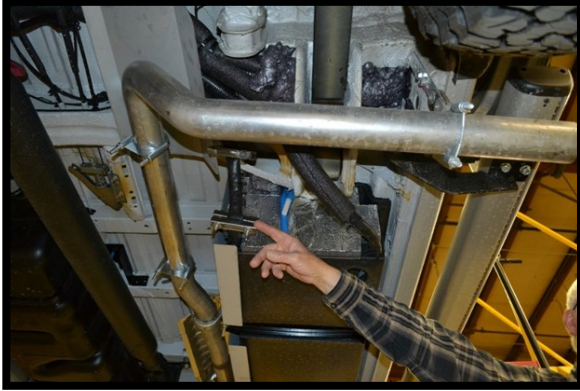
4. Put motorhome on lift and raise.
5. Locate the hydronic heat lines on the rear of the water tank (just in front of the right rear tire), specifically the line entering the insulated water tank closest to the driveshaft. Pinch off the (2) sections of rubber heater hose exiting the tank with clamps. This section of lines is considered the fill and drain point for the system.

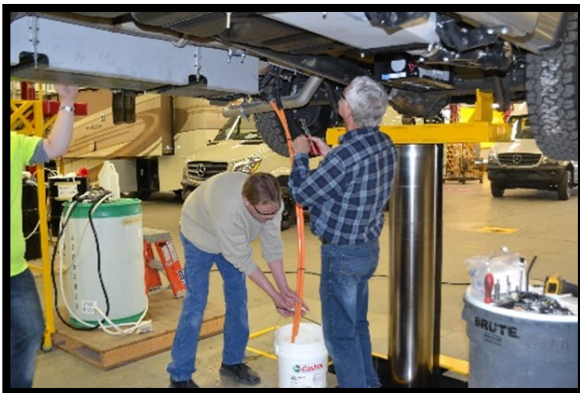
7. Attach long drain lines and place hoses inside a bucket.

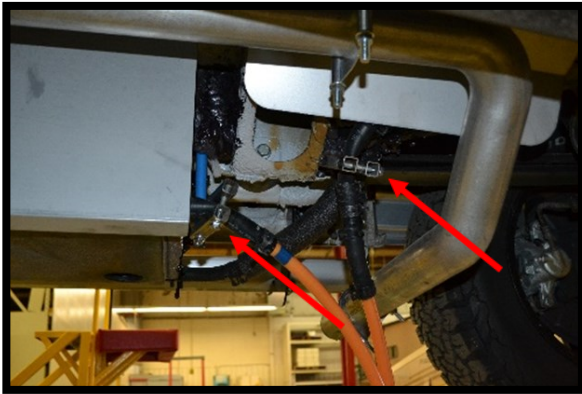
8. Loosen clamps to allow antifreeze to drain from the system.

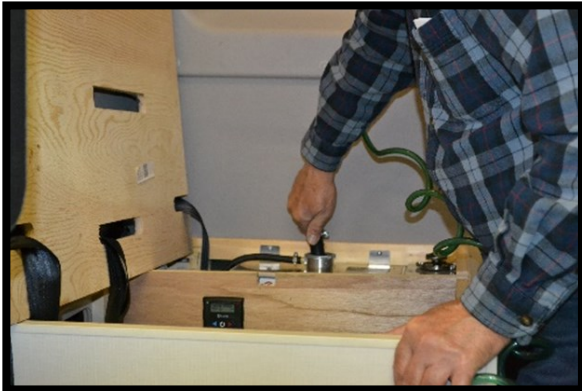
9. Attach an air hose into the Comfort Hot Coolant Tank and blow air through the system for approximately 5 minutes or until antifreeze is fully drained from the system.

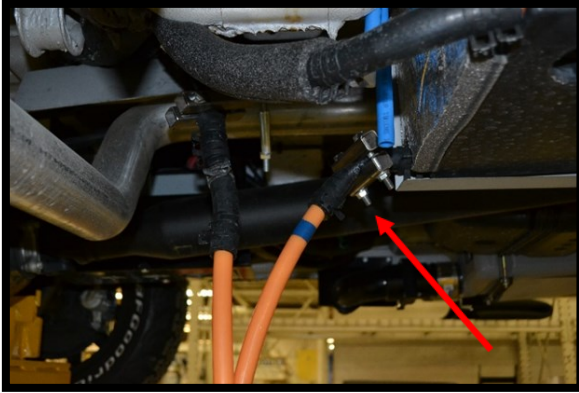
11. Unhook the drain line from the hose exiting the water tank to prepare the system for a purified water “Back-Flush”.

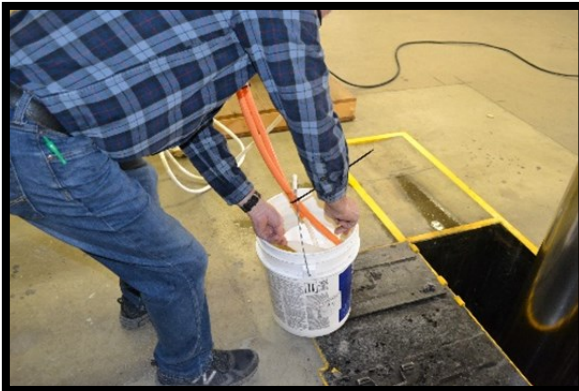
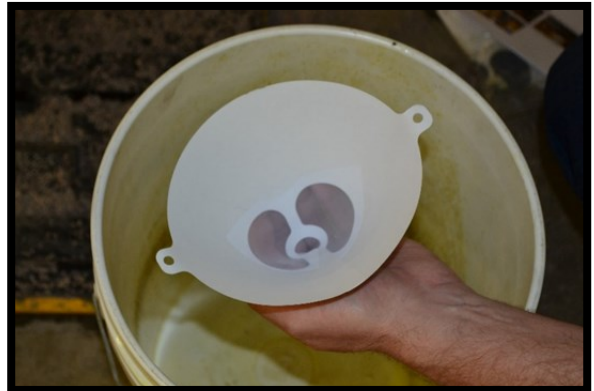
12. Get an empty bucket and place a strainer filter under the drain line to catch any debris that may be in the system. Excessive debris may require an additional flush. Contact Tech Service with any questions or concerns.

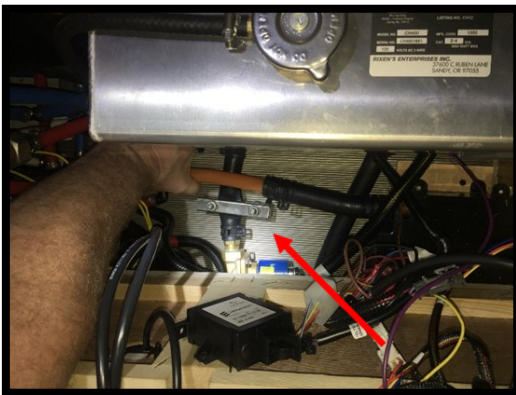
13. Pinch off hydronic heat line in front of solenoid valve to ensure the backflush water is routed through all system components.

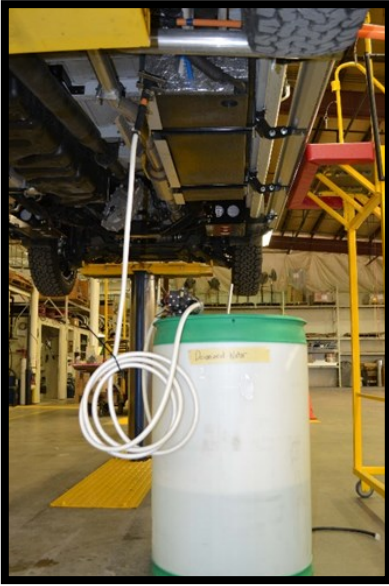
14. Pump 5 gallons of Deionized (DI) water through the system. **Note: If standard 'tap' water is used, damage to the system may occur.**

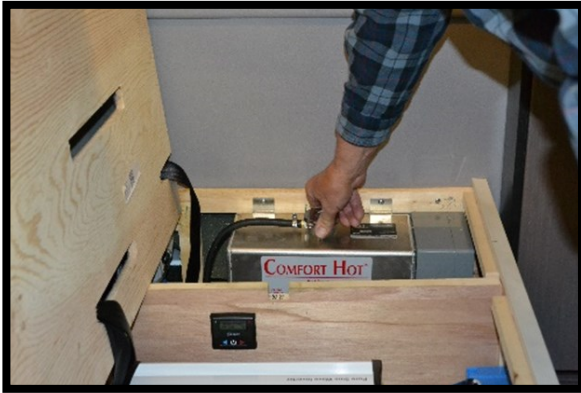
18. Remove Comfort Hot Coolant Tank cap and fill tank with DI water.

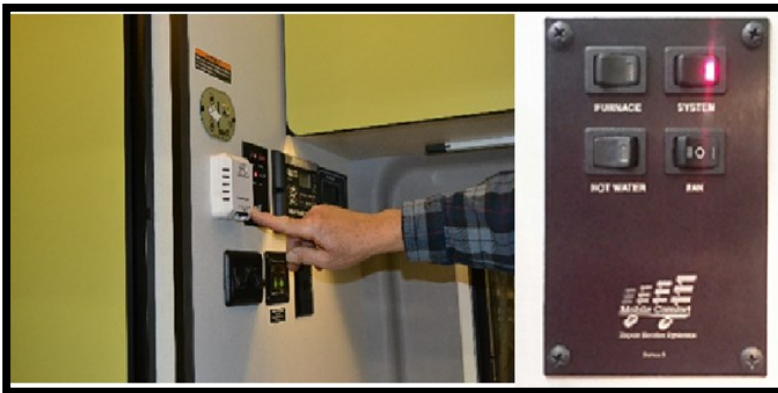
19. Turn up the thermostat, start the heating system and run it for 15 minutes to circulate water through the system.

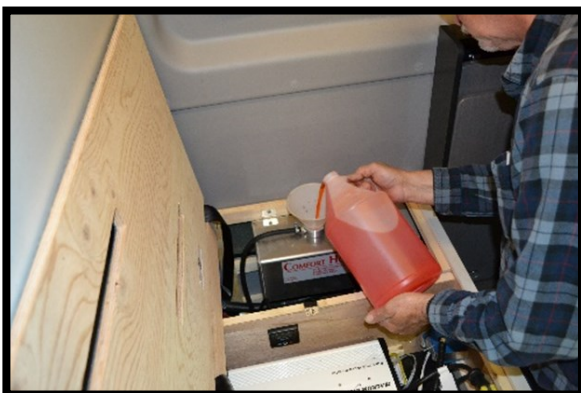
22. Remove Comfort Hot Coolant Tank cap and add 1 gallon of Dex-Cool antifreeze to the Comfort Hot Coolant Tank. Fill the remainder of the tank with DI water, within 1" of top of tank.

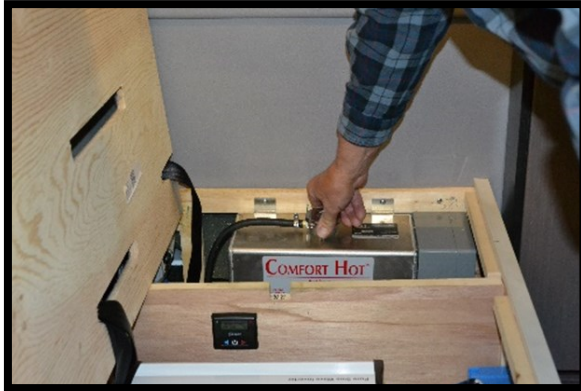
23. Attach Comfort Hot Coolant Tank cap.

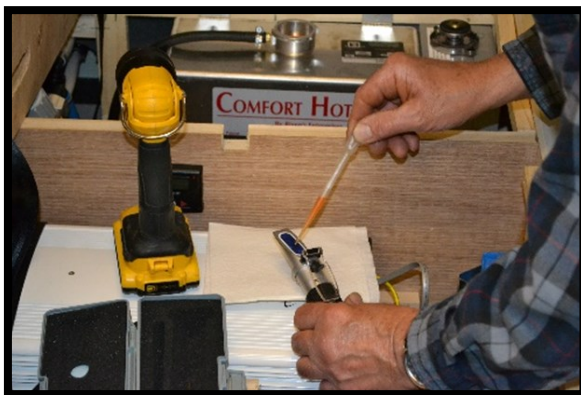
25. Test the Comfort Hot Coolant Tank Antifreeze level with refractometer. The level should read 60 (water)/ 40 (antifreeze). If the level is high, add more water to the system and retest.

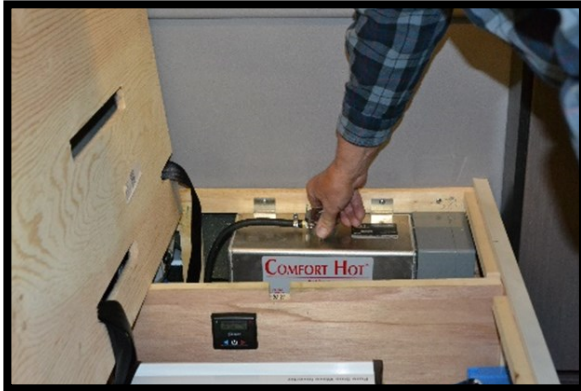
23. Attach Comfort Hot Coolant Tank cap.
