WJ59 - Ensuring Correct Documentation of the Implementation of AG01 Emissions Recall (Workshop Campaign)

Vehicle Type: **Cayenne Diesel (92A)**

Subject: **Documentation of the implementation of AG01 Emissions Recall in the IN-FORM tool**

Information: **The implementation of campaign "AG01 Emissions Recall" was not documented fully according to specifications in the IN-FORM tool on the affected vehicles.**

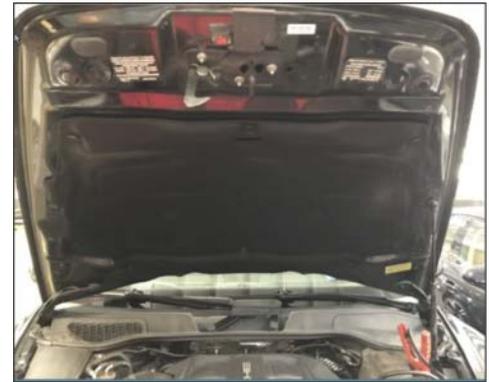
Front lid – initial audit

- 2 Take a photo of the inner front hood. The photo should be taken at a wider distance, with high resolution, and should show the front hood from the inside completely ⇒ *Front lid – initial audit*. This is required in order to document the labels applied after carrying out the AGO1 Emissions Recall. Save this photo with the following file name:

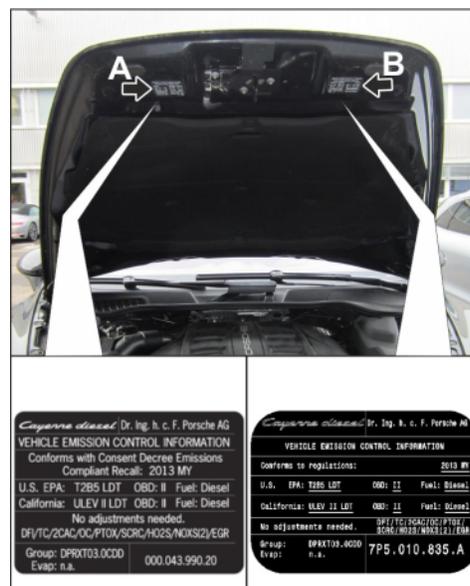
Sample model year 2013 Cayenne Diesel VECI labels

1.1 Check whether there are **two** Vehicle Emission Control Information labels affixed on the inside of the lid:

A **new supplemental** label ⇒ *Sample model year 2013 Cayenne Diesel VECI labels -A-*, which was affixed when the AG01 Emissions Recall was performed, **and** an **original** label ⇒ *Sample model year 2013 Cayenne Diesel VECI labels -B-*, which was affixed during the production process.

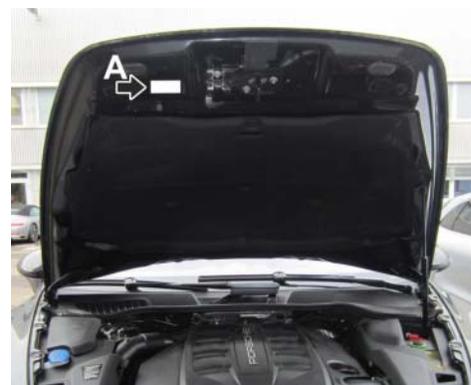
Supplemental model year 2013-2014 Cayenne Diesel VECI label placement

1.2 Check whether the new supplemental Vehicle Emission Control label is positioned **on the inside of the front lid at the top right in direction of travel**.

Observe the different positions for applying the label on model year 2013-2014 and model year 2015-2016 vehicles (see pictures below).

- Supplemental model year 2013–2014 Cayenne Diesel VECI label placement ⇒ *Supplemental model year 2013-2014 Cayenne Diesel VECI label placement -A-*

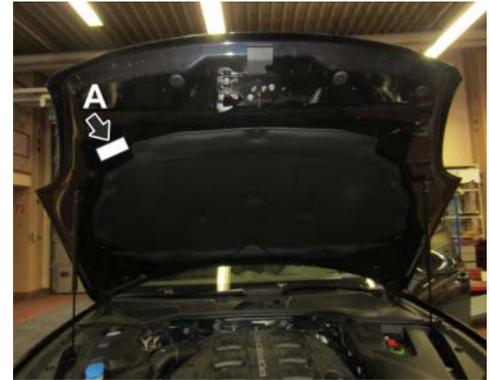
*Supplemental model year 2015-2016
Cayenne Diesel VECI label placement*

- Supplemental model year 2015–2016 Cayenne Diesel VECI label placement ⇒ *Supplemental model year 2015-2016 Cayenne Diesel VECI label placement -A-*

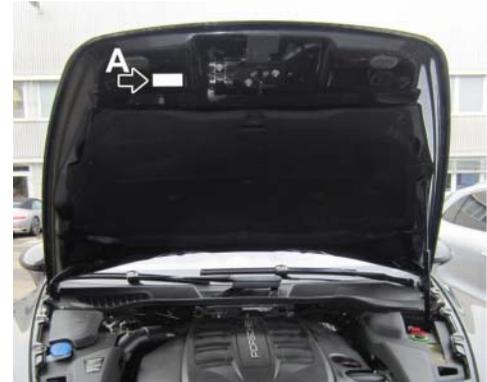
Model year 2013-2014 Cayenne Diesel VECI label placement

- 2.3 Stick new supplemental Vehicle Emission Control Information label at the top of the front lid at the right-hand side in direction of travel.

When doing so, always check that the **model year shown** on the new label and the **placement of the label** are correct in accordance with specifications for model year 2013-2014 vehicles ⇒ *Model year 2013-2014 Cayenne Diesel VECI label placement -A-* or model year 2015-2016 vehicles ⇒ *Model year 2015-2016 Cayenne Diesel VECI label placement -A-*.

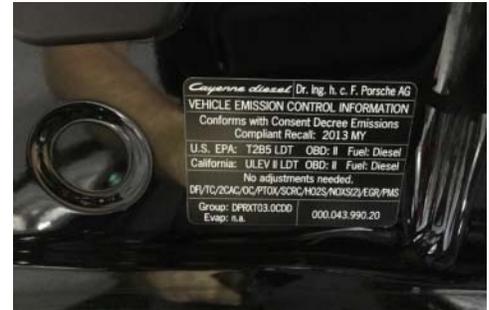
Sample model year 2013 Vehicle Emission Control Information label photo

- 3.1 Take a photo of the new supplemental Vehicle Emission Control Information label. The photo should be taken at a close distance, with high resolution, and should be clear enough to read the information on the label as shown in the sample photo for model year 2013 Vehicle Emission Control Information label ⇒ *Sample model year 2013 Vehicle Emission Control Information label photo* below. Save this photo with the following file name: **[VIN]_02_VECI_new.jpg**

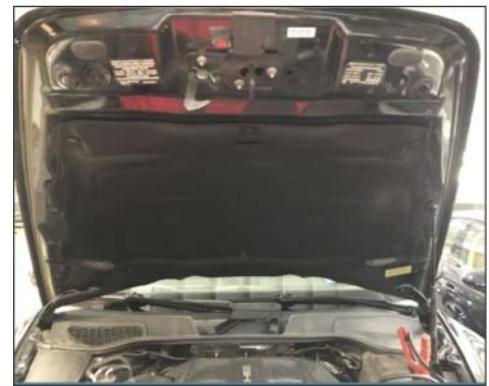
Sample model year 2013 front hood overview

- 3.2 Take a photo of the inner front hood. The photo should be taken at a wider distance, with high resolution, and should show the front hood from the inside completely as shown in the sample photo for a model year 2013 vehicle ⇒ *Sample model year 2013 front hood overview* with both Vehicle Emission Control Information labels visible. Save this photo with the following file name: **[VIN]_03_VECI_overview.jpg**

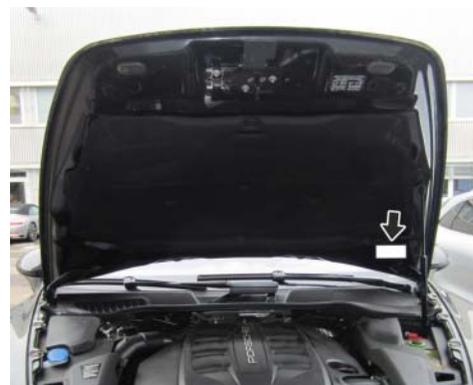
Cayenne Diesel Proof of Completion label placement

1.1 Check that the Proof of Completion label is positioned **on the inside of the front lid at the bottom left in direction of travel** ⇒ *Cayenne Diesel Proof of Completion label placement -arrow-*.

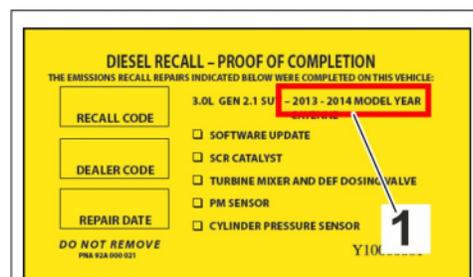
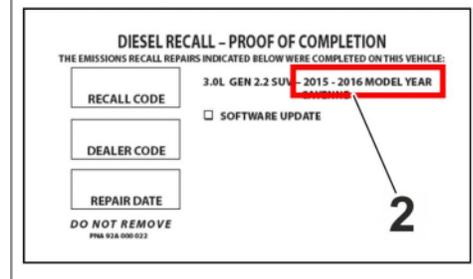
Proof of Completion label - model year period

1.2 Check whether the **model year period** specified on the Proof of Completion label ⇒ *Proof of Completion label - model year period -1-* or ⇒ *Proof of Completion label - model year period -2-* corresponds to the **model year period of the particular vehicle**.

Label will be yellow in colour for model year 2013-2014 and white for model year 2015-2016.

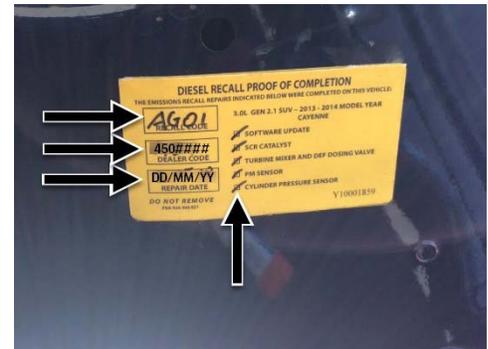
This includes the campaign number **"AG01"**, the dealer code, the repair date of the AG01 Emissions Recall as well as the check boxes for the required measures for the AG01 Emissions Recall.

- Sample model year 2013-2014 Proof of Completion label ⇒ *Sample model year 2013-2014 Proof of Completion label -arrows-*

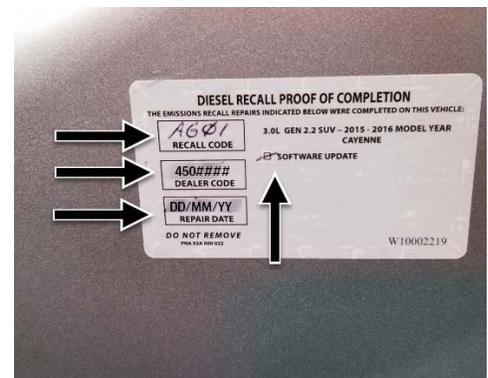
- Sample model year 2015-2016 Proof of Completion label ⇒ *Sample model year 2015-2016 Proof of Completion label -arrows-*

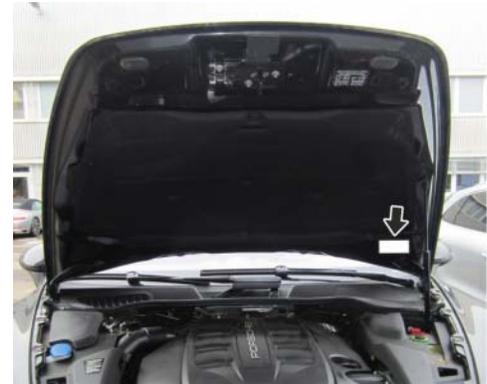
Cayenne Diesel Proof of Completion label placement

- 2.4 Affix new Proof of Completion label in the lower area on the front lid at the left-hand side in direction of travel.

When doing so, make sure that the **model year period shown** on the new label corresponds to the model year period of the particular vehicle and that the label is **positioned correctly** ⇒ *Cayenne Diesel Proof of Completion label placement -arrow-*.

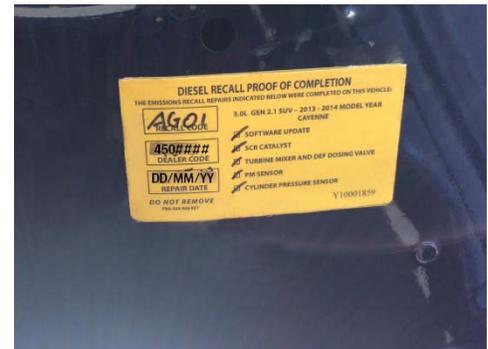
Sample model year 2013-2014 Proof of Completion label photo

- 3.1 Take a photo of the Proof of Completion label. The photo should be taken at a close distance, with high resolution, and should be clear enough to read the information on the label as shown in the sample photo for the model year 2013–2014 Proof of Completion label ⇒ *Sample model year 2013-2014 Proof of Completion label photo* below.

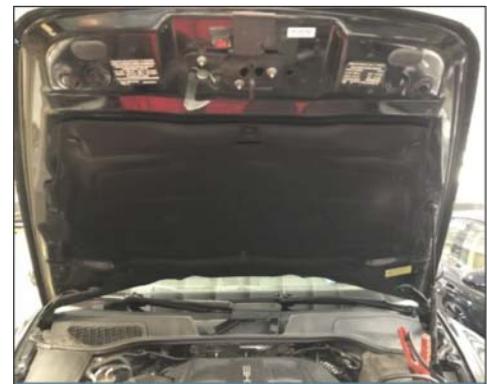
Sample model year 2013 front hood overview

- 3.2 Take a photo of the inner front hood. The photo should be taken at a wider distance, with high resolution, and should show the front hood from the inside completely as shown in the sample photo for a model year 2013 vehicle ⇒ *Sample model year 2013 front hood overview* with the Proof of Completion label visible.

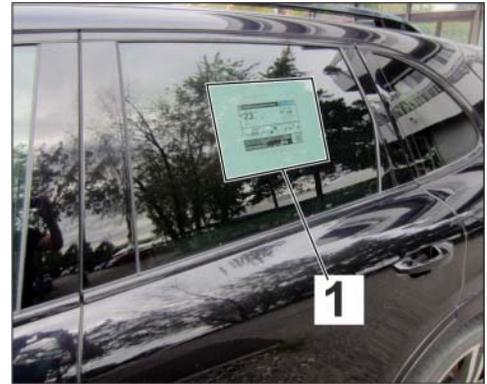
1.1 Check that the EPA Fuel Economy label ⇒ *EPA Fuel Economy label -1-* is affixed to the **inside of the rear left door window** and can be read from outside.

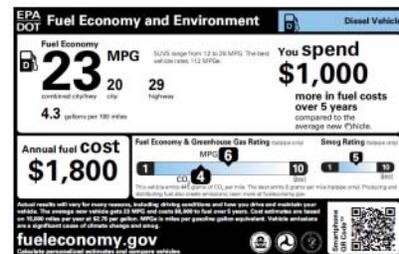
Sample model year 2013 EPA Fuel Economy label

2.1 Print new EPA Fuel Economy label and enter the vehicle identification number (VIN) of the particular vehicle as well as your dealer number in the corresponding boxes ⇒ **-1-**. Check that the **model year** ⇒ **-2-** on the label is correct and corresponds to the vehicle.

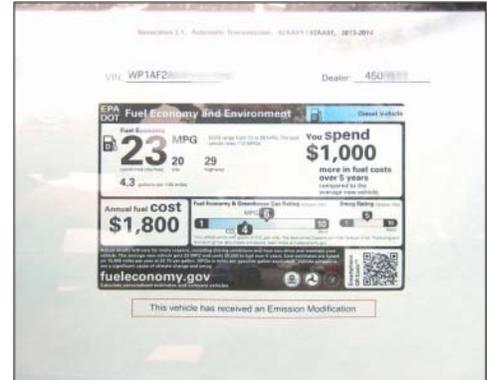
Sample model year 2013 EPA Fuel Economy label photo

- 3.1 Take a photo of the EPA Fuel Economy label. The photo should be taken at a close distance, with high resolution, and should be clear enough to read the information on the label as shown in the sample photo for model year 2013 EPA Fuel Economy label ⇒ *Sample model year 2013 EPA Fuel Economy label photo* below.
Save this photo with the following file name:
[VIN]_06_EPALabel.jpg

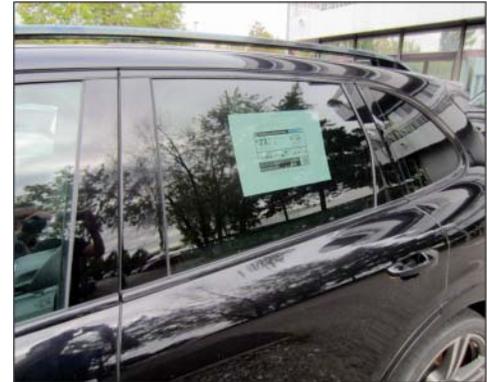
Sample model year 2013 EPA Fuel Economy label overview

- 3.2 Take a photo of the vehicle's left side. The photo should be taken at a wider distance, with high resolution, and should show the rear left door window completely as shown in the sample photo for a model year 2013 vehicle ⇒ *Sample model year 2013 EPA Fuel Economy label overview* with the position of the EPA Fuel Economy label visible.
Save this photo with the following file name:
[VIN]_07_EPALabel_overview.jpg.

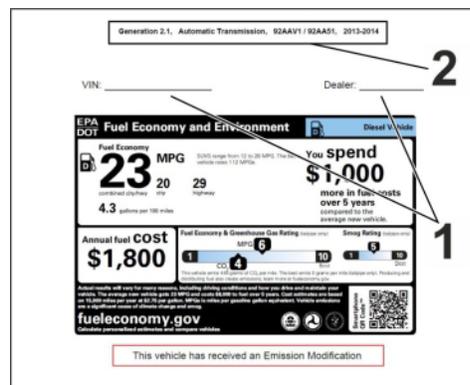
Sample model year 2013 EPA Fuel Economy label

- 1 Print new EPA Fuel Economy label and enter the vehicle identification number (VIN) of the particular vehicle as well as your dealer number in the corresponding boxes ⇒ *Sample model year 2013 EPA Fuel Economy label -1-*. Check that the **model year** ⇒ *Sample model year 2013 EPA Fuel Economy label -2-* on the label is correct and corresponds to the vehicle.

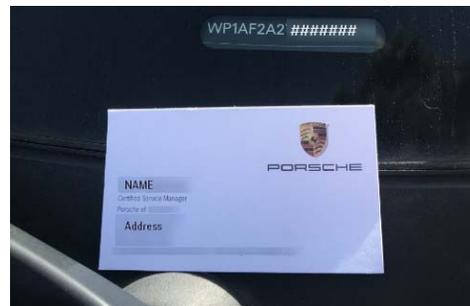
Service Manager's business card next to the VIN

- Work Procedure: 1 Place the Service Manager's business card next to the vehicle identification number (VIN) in the lower left area of the windshield and take a photo in such a way that both the **business card** and the **vehicle identification number (VIN)** are fully **legible** ⇒ *Service Manager's business card next to the VIN.*
