# Technical Service Bulletin

## 35 Leaks from transmission

35 18 33 2028085/6 July 30, 2018. Supersedes Technical Service Bulletin Group 35 number 15-18 dated September 18, 2015 for reasons listed below.

Model(s)	Year	VIN Range	Vehicle-Specific Equipment
S4, S5, S5 Cabriolet, RS5, S6, and S7	2010 - 2016	All	0B5 S-Tronic transmission

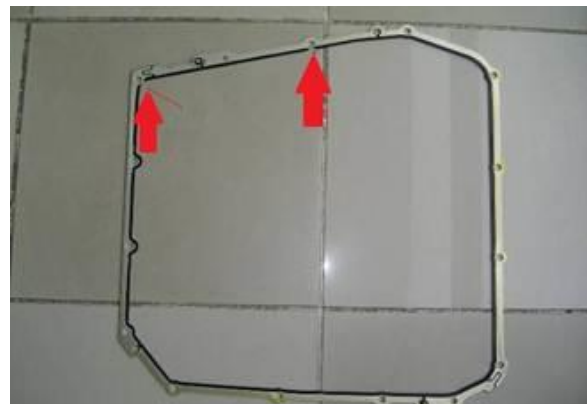
**Figure 1.** Leak on the oil pan seal (red arrows).

- Leaking from the oil pan seal (Figure 1).

- If the oil pan is undamaged, replace only the oil pan seal.
- If the oil pan is damaged (Figure 5), check the mechatronics for loose bolts (Figure 6). Replace any loose bolts and torque according to the repair manual instructions. Replace both the oil pan and seal.
- If pan is cracked (Figure 2, above) and no loose bolts on the mechatronics unit are found, replace oil pan and seal.
- If there is a leak between gearbox housing and intermediate housing (Figure 3, above), reseal the case by following instructions in Elsa to complete the repair at Repair Manual, *Transmission >> S Tronic Transmission Internal Components >>35 Gears, Shafts >> Removal and Installation >> Sensor Module with Transmission Input Speed Sensor -G612-, -G632-, -G676- and Circuit Board 3.*

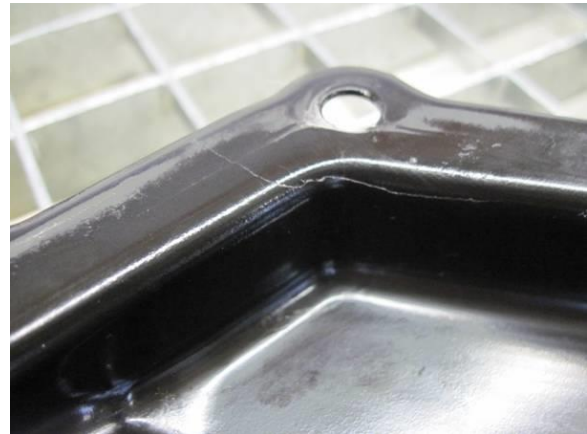
**Figure 2.** Crack in the oil pan.

- Crack in the oil pan (Figure 2).

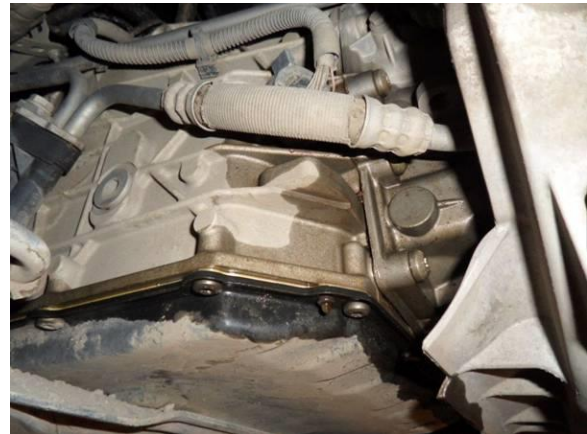
**Figure 3.** Leak between gearbox housing and intermediate housing.

- Leak between gearbox housing and intermediate housing (Figure 3).

**Tip:** The source of the leak may be confused with o-ring of drain plug.

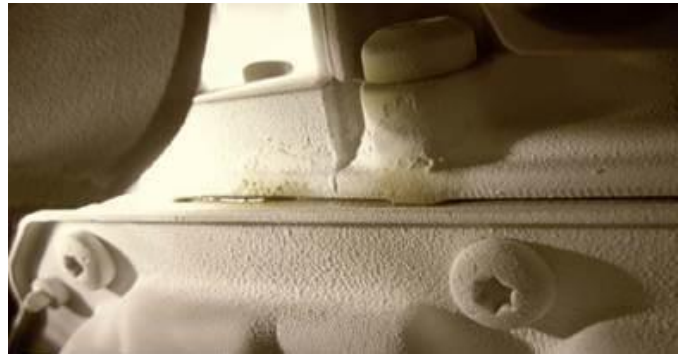
*Figure 4. Leak located with talcum spray.*

1. Locate the leak by first thoroughly cleaning and drying the stained area. Then, apply talcum spray (or similar) to the area that was stained with oil (Figure 4).

2. Warm up the vehicle with a test drive then re-check for leaks.

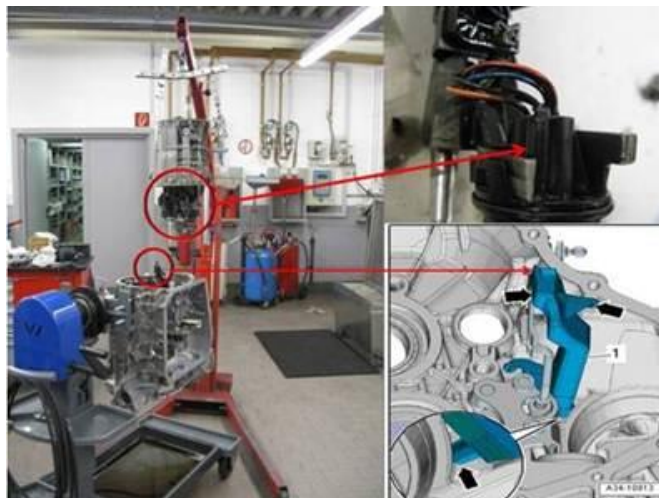
**Figure 7.** Caution points: drip tray Sensor module connector.

**Tip:** Use caution when lifting or lowering intermediate housing to avoid damage to components (Figure 7).
