# Technical Service Bulletin

## 87 A/C compressor replacement

87 18 88 2035582/3 July 30, 2018. Supersedes Technical Service Bulletin Group 87 number 14-58 dated October 17, 2014 for reasons listed below.

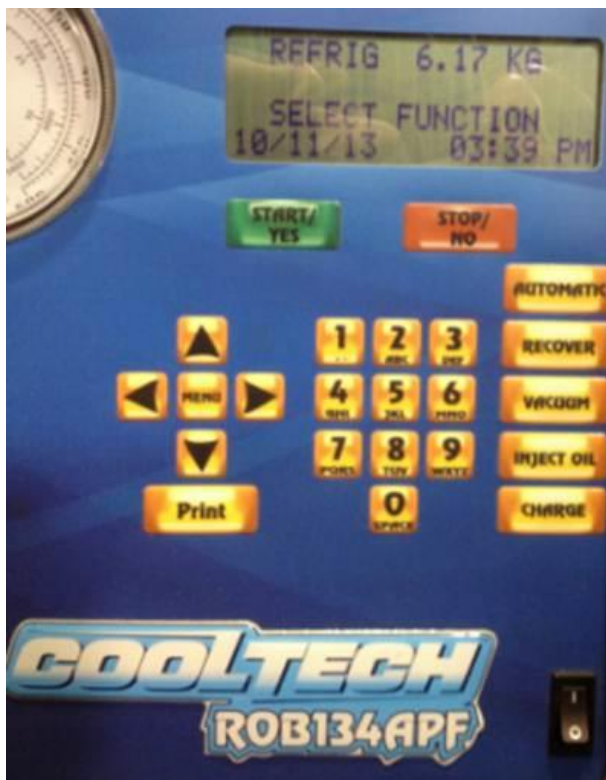
*Figure 1. Date and time screen.*

1. Ensure that the A/C service unit shows the correct date and time (Figure 1). If the date and time are incorrect, use the menu to program the correct date and time before proceeding.

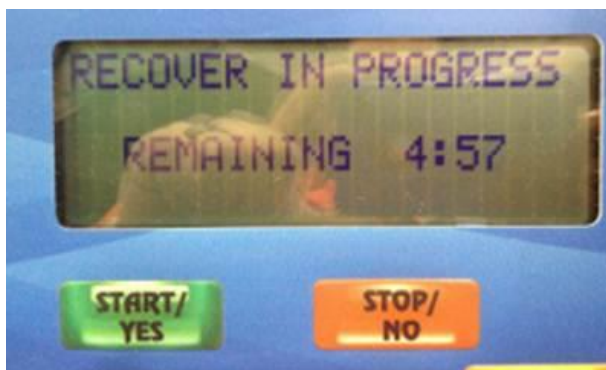
*Figure 2. System recover in progress.*

2. Connect the A/C service unit to the vehicle.
3. Perform a recovery of the system (Figure 2).

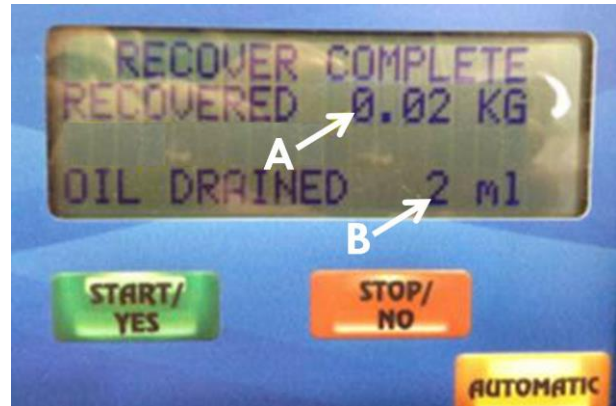
**Figure 3.** Amount of refrigerant recovered (A), and amount of oil drained (B).

- Record values for **RECOVERED** and **OIL DRAINED** (Figure 3) on the repair order.

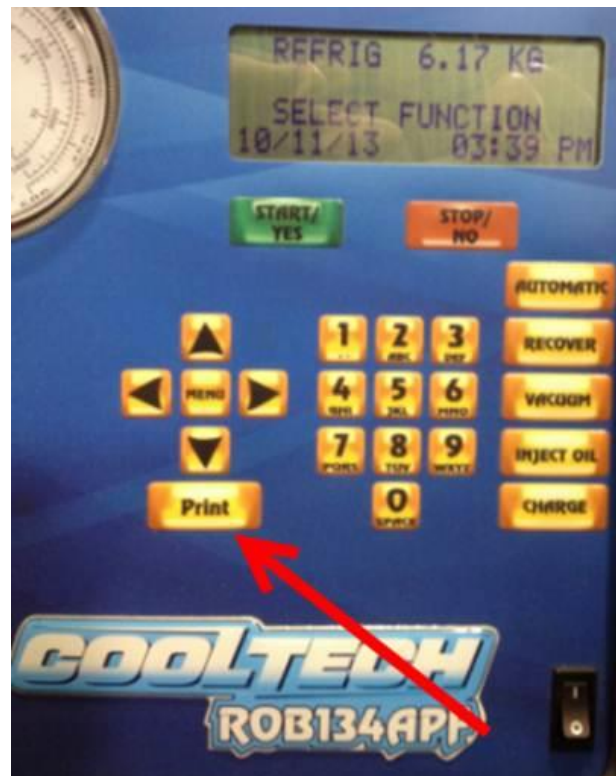
**Figure 4.** Location of the Print button.

- Immediately after recovery, select the **Print** button (Figure 4).

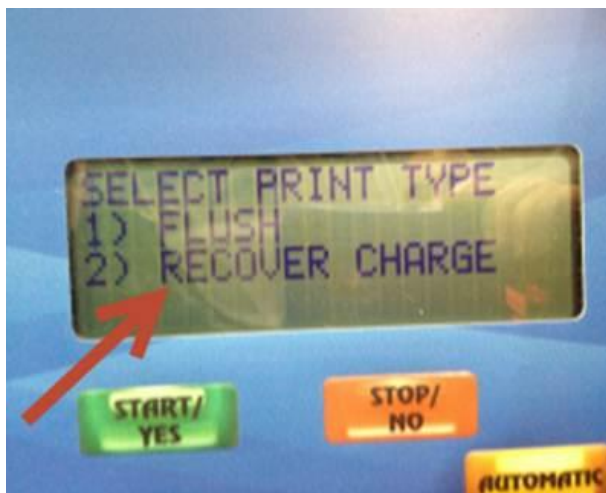
*Figure 5. Selecting a print type.*

6. When the SELECT PRINT TYPE screen opens, use the keypad to select **2) RECOVER CHARGE** (Figure 5).

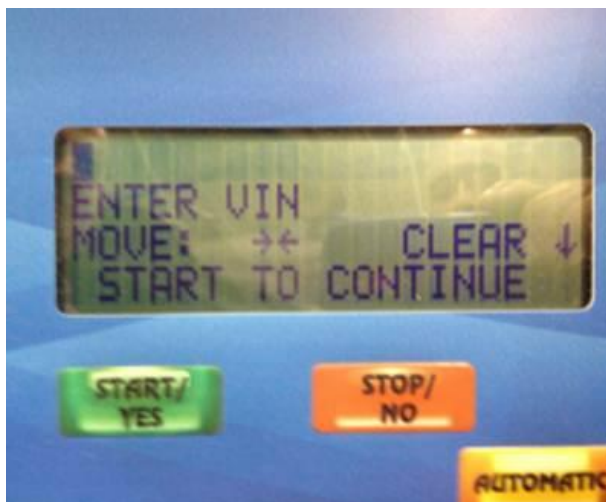
*Figure 6. Enter VIN screen.*

7. On the next screen, use the keypad enter the last 8 digits of the VIN then press the **START/YES** key (Figure 6).

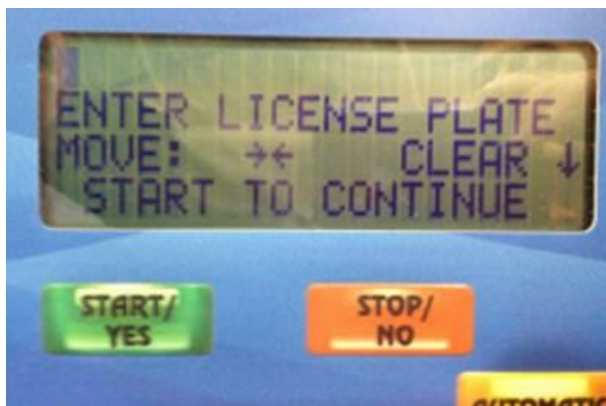
*Figure 7. Enter license plate screen.*

8. The next screen will request the license plate (Figure 7). Entering the license plate is not necessary. Press the **START/YES** key to continue.

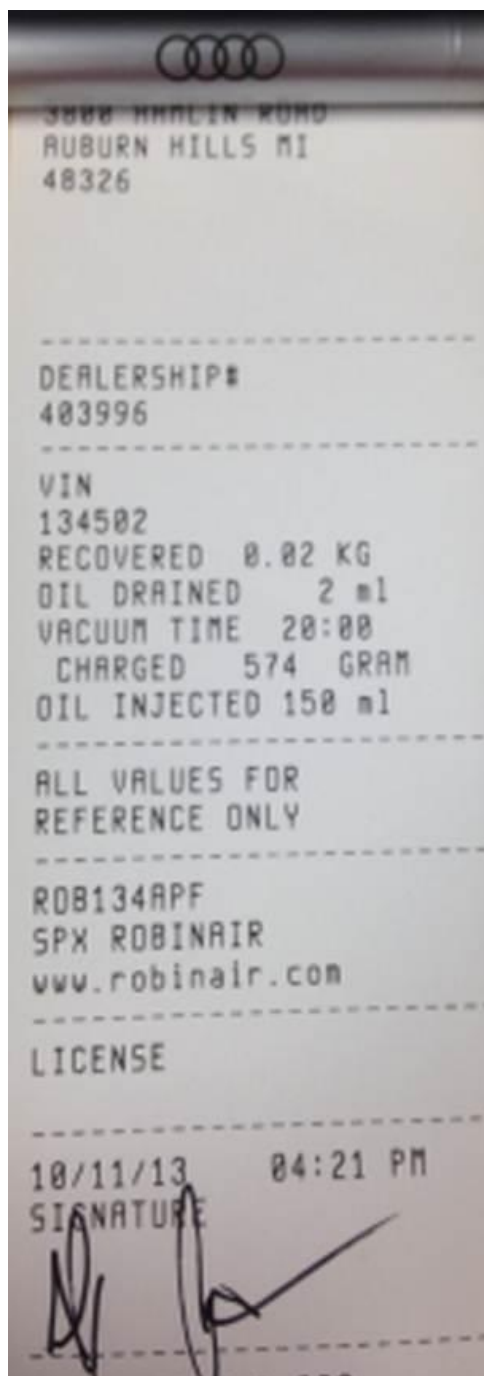
**Figure 8.** Printed report.

9. The A/C service unit will create a printed report (Figure 8). Send the printed report with the defective A/C compressor. Package the defective compressor in empty packaging from the replacement compressor.
