# SERVICE BULLETIN

Technical Service Bulletin: 225-0829

Forest River is alerting you to an issue involving certain 2018 – 2019 – Galleria - GAB24FLM, GAB24QM and GAB24TM Class B motorhome recreational vehicles. Please carefully review the attached document pertaining to your vehicle.

# GALLERIA – MUD FLAP STIFFENER INSTALLATION INSTRUCTIONS

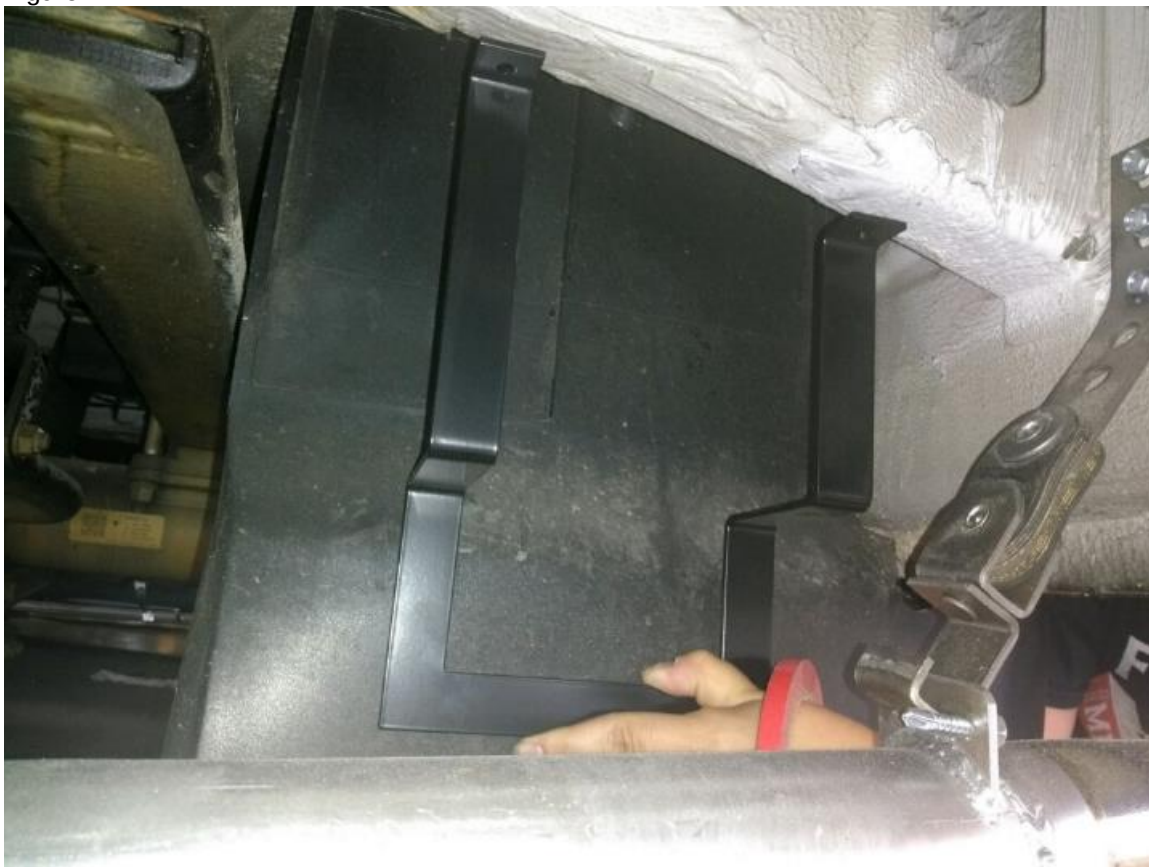
Figure 1

The passenger side rear mud flap may contact the vehicle exhaust during highway travel speeds, leaving a mark on the vehicle exhaust tip.

Step 2: Remove and discard the rear passenger side mud flap;

Step 3: Install replacement passenger side mud flap;

Step 4: Install the mud flap stiffener directly behind the newly installed passenger side mug flap using the provided lags;
