# Instrument Panel (Dashboard) and Door Panels Sticky/Cracked

**Service Category** Vehicle Interior

**Section** Interior Panels/Trim

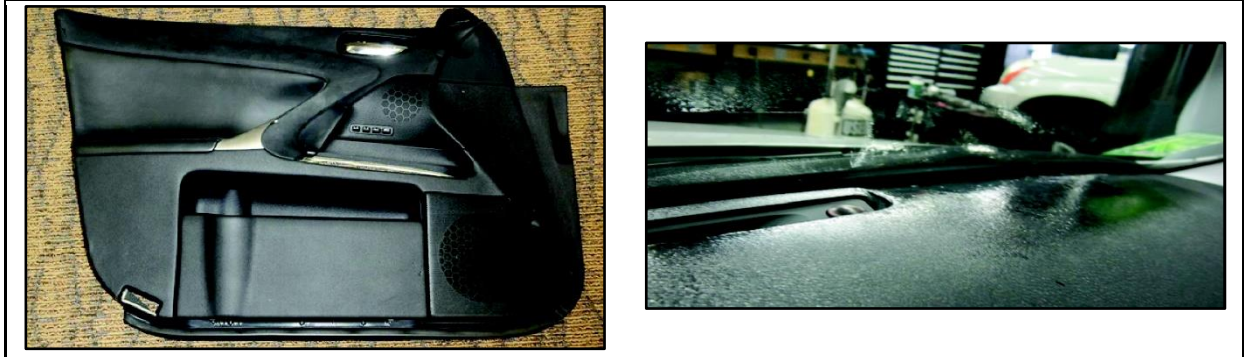
- When a vehicle with a sticky interior panel(s) is parked out of heat and humidity for more than a few hours, the panel surface may become chalky. Once the vehicle is exposed to heat again, the sticky condition may return.
- Interior panels can become sticky over time for a variety of reasons and circumstances. Most vehicles subject to repair under this Service Bulletin have more than likely been operated for extended periods in areas of high temperatures and high humidity.
- In some cases, the interior panels may appear shiny due to aftermarket interior dressing.

**Figure 1. Example of Sticky Condition**

Follow the Repair Procedure in this bulletin to address this condition.

Does the dashboard and/or door panel(s) exhibit a sticky and/or cracked appearance?  
(See Figures 1 – 3 for examples of these conditions.)

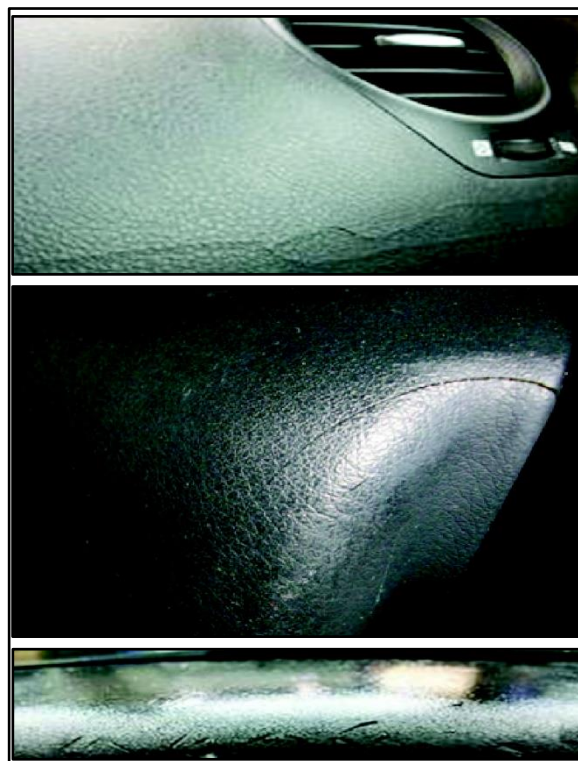
**Figure 3. Example of Cracked Condition**
