Instrument Panel (Dashboard) Sticky/Cracked

Service Category Vehicle Interior

Section Interior Panels/Trim

Some 2003 – 2018 applicable Lexus models may exhibit a condition where the instrument panel pad (dashboard) becomes cracked and/or sticky. Follow the Repair Procedure in this bulletin to address this condition.

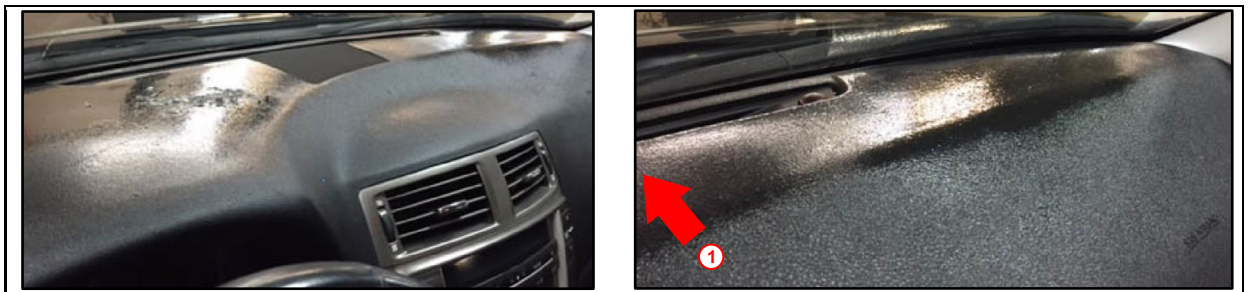
Figure 1. Example of Sticky Condition

1	Front of Vehicle
----------	-------------------------

2. Replace the instrument panel safety pad sub-assembly.
 - A. Remove the instrument panel safety pad sub-assembly.

- B. Install the NEW instrument panel safety pad sub-assembly.

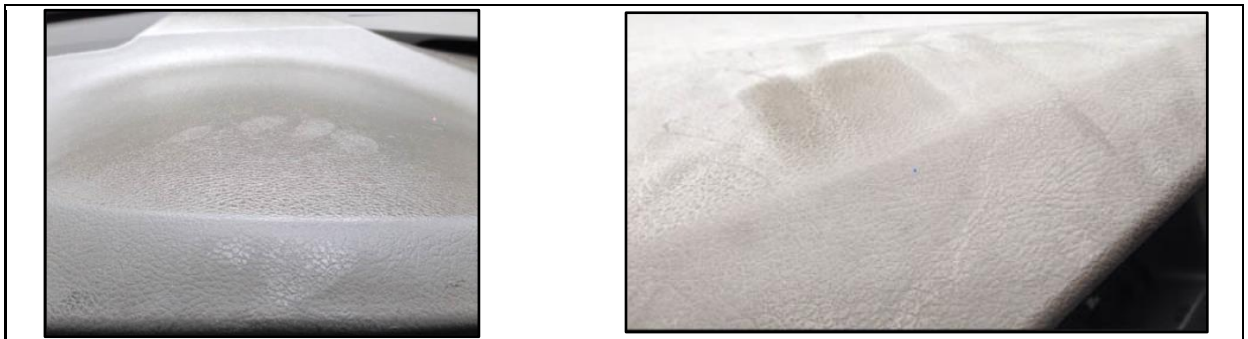
Figure 2. Example of Chalky Condition (Becomes Sticky)

When a vehicle with a sticky dashboard is parked out of heat and humidity for more than a few hours, the dashboard surface may become chalky. Once the vehicle is exposed to heat again, the sticky condition may return.

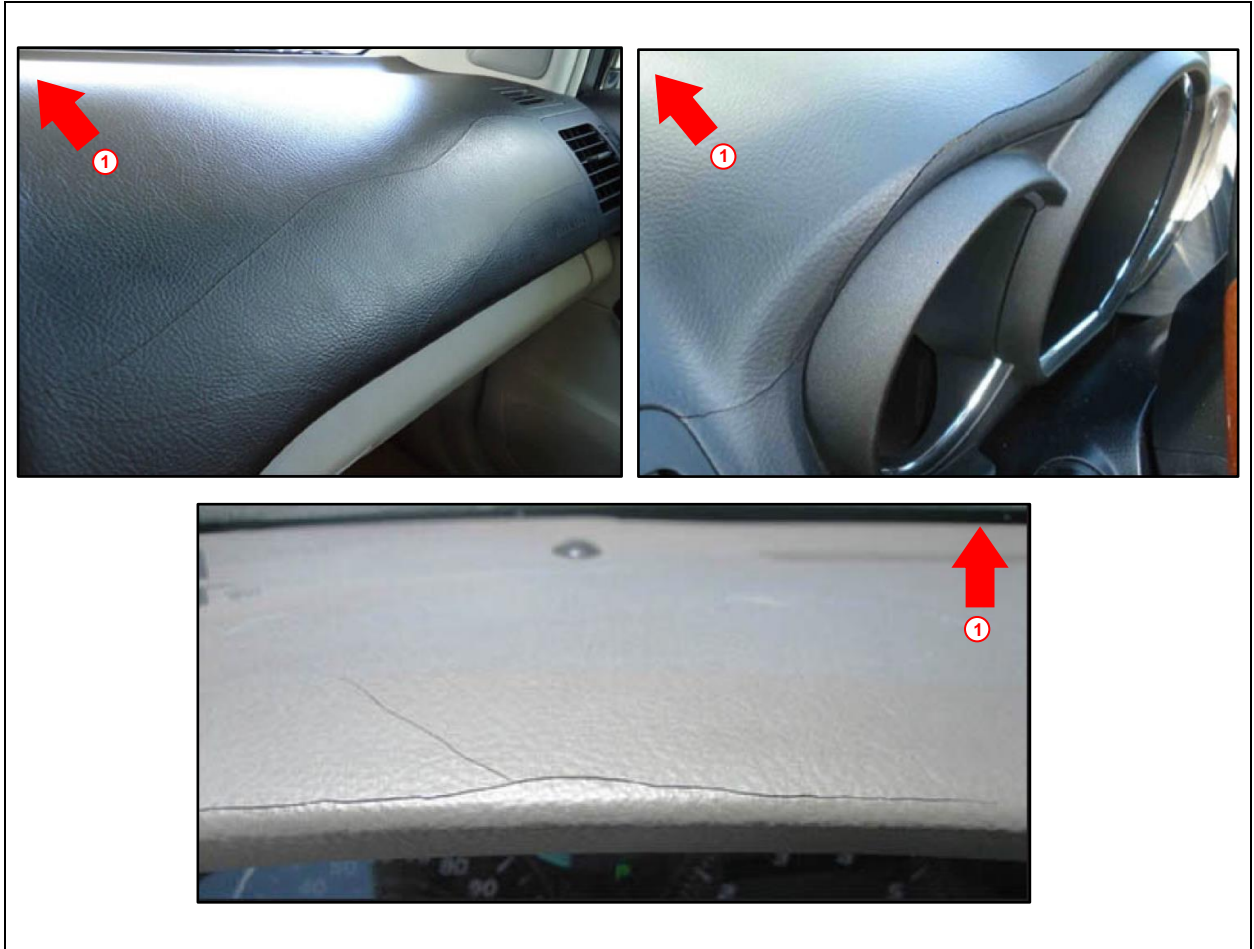
Figure 3. Example of Cracked Condition

1	Front of Vehicle
---	------------------
