Subject		Market
Squeak Noise from Front of Vehicle While Driven on Uneven Surfaces - NO.1 Body Mount		USA
Service Category	Section	
Suspension	Front Suspension	
Applicability		
MY 2018 Tacoma MY Tacoma

Squeak Noise from Front of Vehicle While Driven on Uneven Surfaces - NO.1 Body Mount

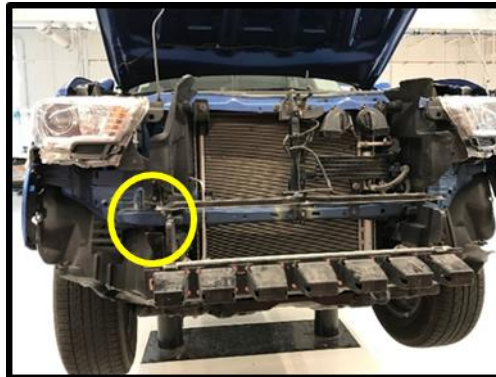
Some 2018 model year vehicles may exhibit a squeak or rattle noise from the Front Right Body Mount Bushing (No. 1) when driving over uneven roads or bumps. Make sure to confirm that noise is coming from Front Right Body Mount Bushing (No. 1) before proceeding.

Location of Front Right Body Mount Bushing (No. 1)

1. **Do Not** disassemble the Front Right Body Mount Bushing (No. 1), please call TAS.
2. Document the Front Right Body Mount Bushing (No. 1) condition by photo for TAS to confirm the phenomenon. (see below for example)

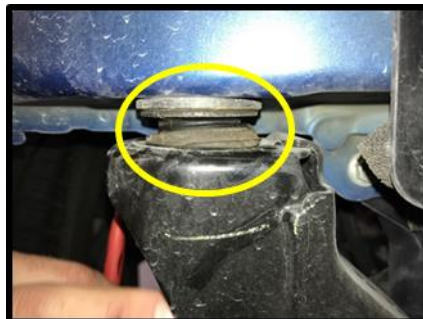
Example of Front Right Body Mount Bushing (No. 1) condition photo
