# SS: 1033464 - WST 5700XE Sun Visor - LED Skirt Marker Valance Lights water ingress.

## WST 5700XE Sun Visor - LED Skirt Marker Valance Lights water ingress

WST 5700XE

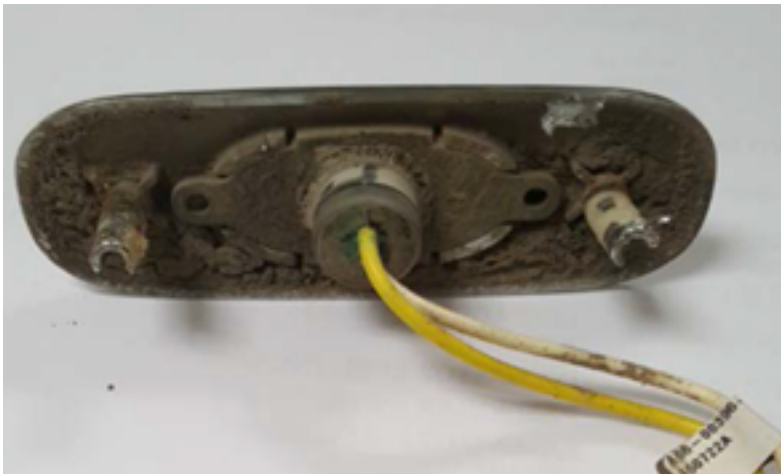
Old Design - Failed Part:

Current LED Marker Valance Lights installation exposes Lights to water splash and chemical contamination that causes plastic material cracks and water/moisture intrusion resulting in Lights early failures.

Supplier developed new Marker Valance Light Assemblies with new plastic material more resistant to corrosion and added a seal gasket to provide also a better connector water/moisture sealing.
