LTB00797NAS2

# TECHNICAL BULLETIN

Rear Bumper Cover-to-Body Gap

MODEL:	MODEL YEAR:	VIN:
Range Rover Sport (LW)	2014 Onwards	000002 Onwards

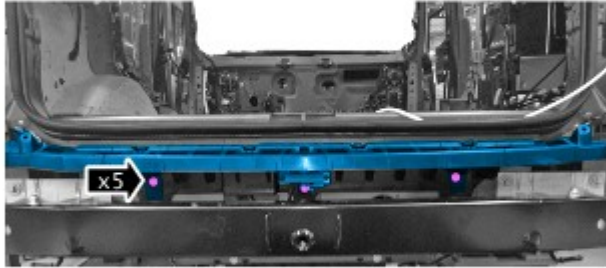
E178389

Remove the rear bumper cover center support bracket.

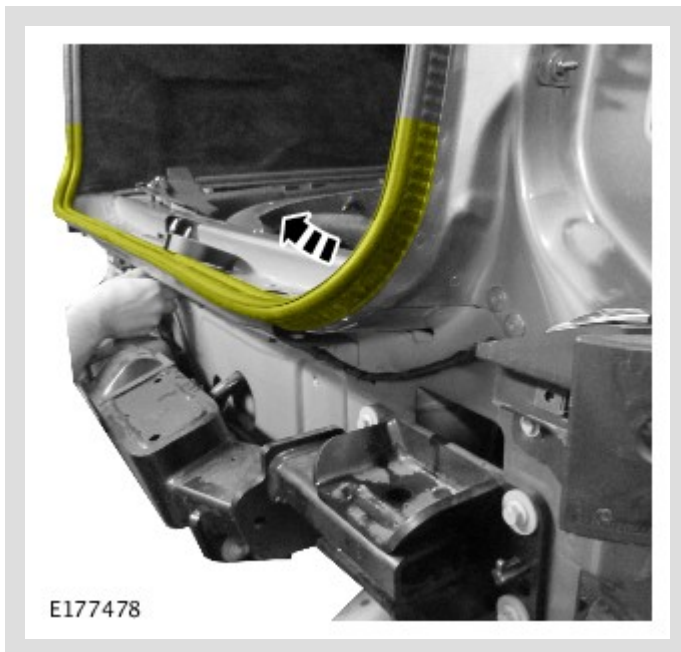
5

Remove the tailgate weatherstrip.

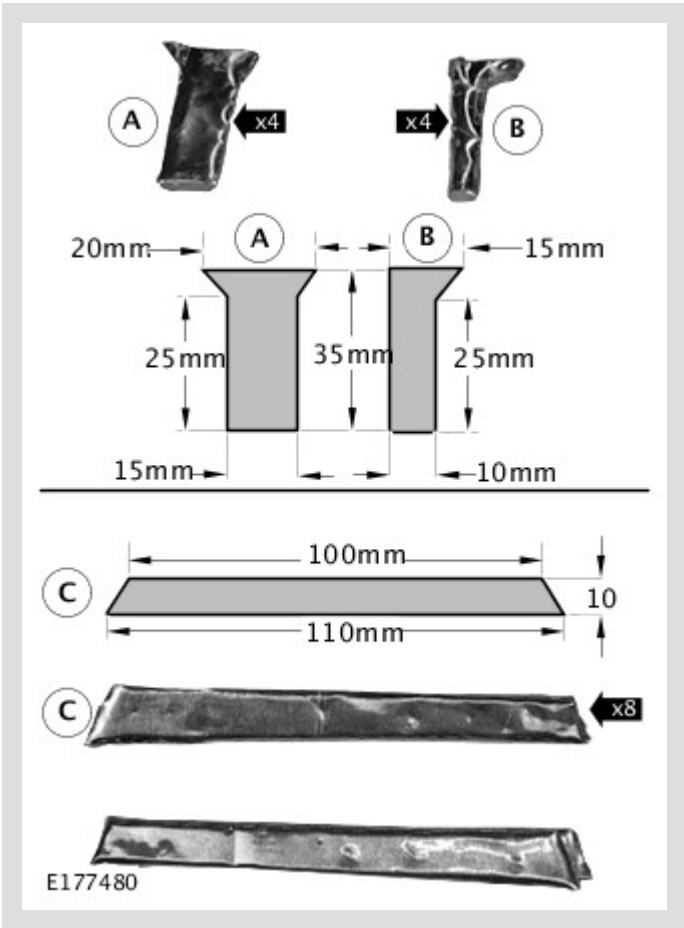
9

Use a suitable tool to cut the seal pad to the sizes shown.

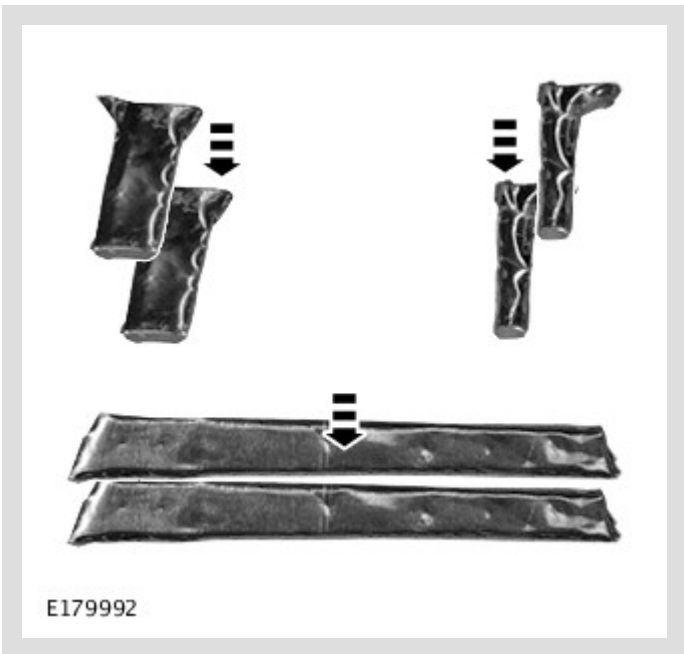
10

Stick two equal pieces together to make each piece twice the thickness.

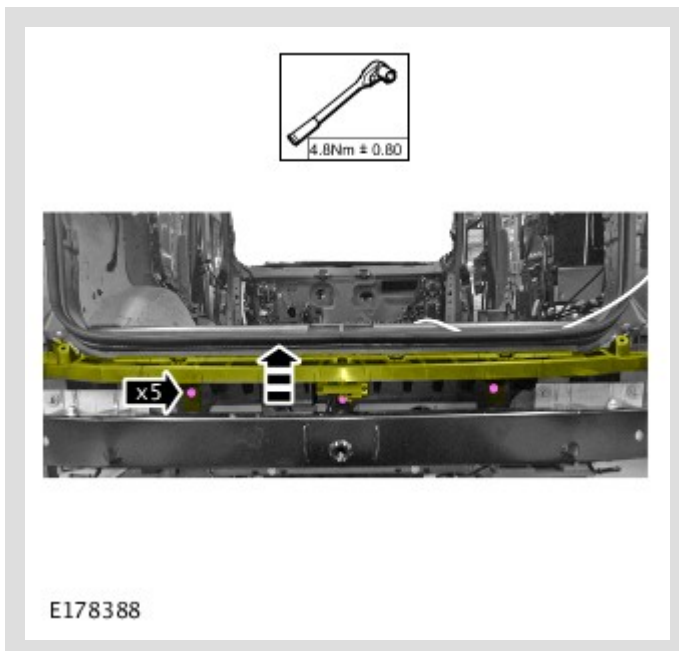
21

Install the rear bumper cover center support bracket holding at its uppermost position.

- Torque: 4.8 Nm
