Preliminary Information

PIT5637 Diagnostic Tip - Camera Unavailable Message

Brand:	Model:	Model Years:	VIN:		Engine:	Transmissions:
			from	to		
Chevrolet	Silverado 2500/3500	2018 - 2019	All	All	All	All
GMC	Sierra 2500/3500	2018 - 2019	All	All	All	All

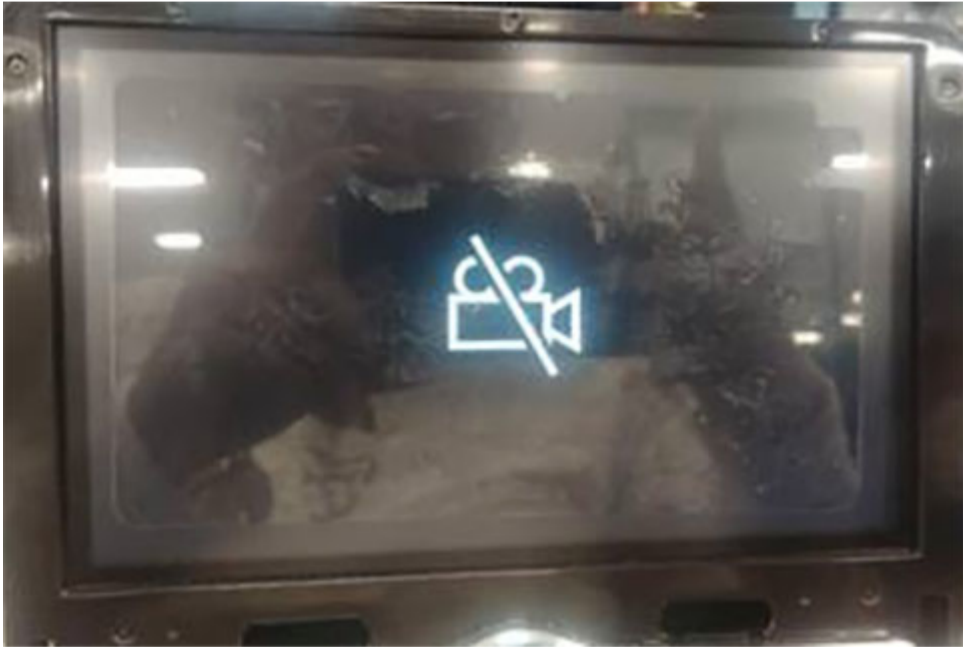
Involved Region or Country	North America
Additional Options (RPO)	ZW9 - Box Delete and IOB - Radio
Condition	A customer may comment that the radio display shows a picture of a camera / video icon with a slash going through it, when shifted to reverse and the vehicle is not equipped with RPO UVC Rear Vision Camera.
Cause	Per FMVSS 111, the radio cannot be reconfigured to eliminate an image when placed in reverse like previous model years. (Box Delete vehicles only)

This image is to inform the driver that a rear camera is not available on the vehicle. No repair is needed as this is normal operation. Rear Vision Camera kits can be purchased at authorized GM dealerships under RPO RWR.
