Technical Service Bulletin Notification TSB #18-017
Unit Serial Number:

Manual Override Access for Front Jacks

TSB # 18-017
 Job Code: 9804414
 Flat Rate: .3 Hour

Publication Date: October 2018
 Make: Highland Ridge
 Model: Ultra Lite FW
 Light FW
 Model Year: 2018-2019

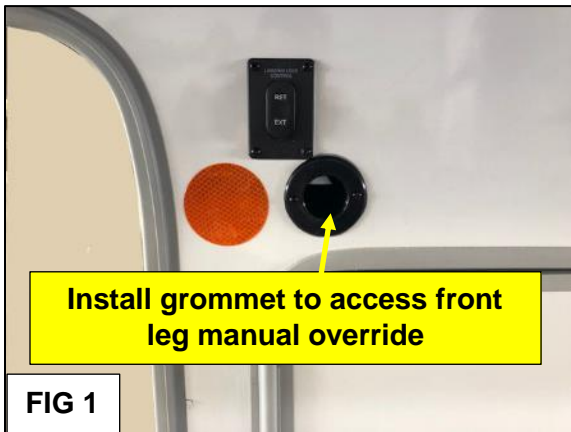
FIG 1: Grommet to be installed just above the forward compartment on the Off Door Side.

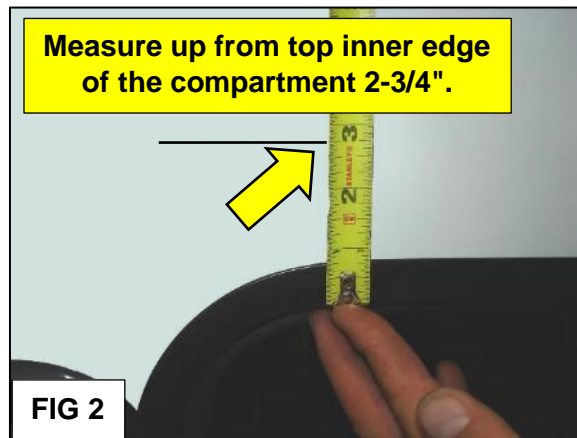
FIG 2: Open the forward most compartment on the Off Door Side.
 Measure up 2-3/4 inches from the **inside** of the door edge trim.
 Mark with an erasable marker, pen or pencil.

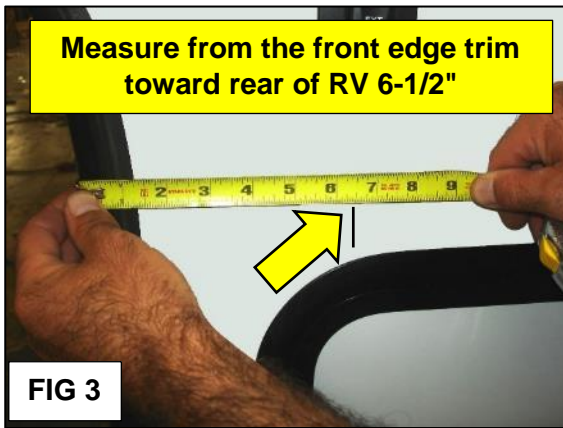
FIG 3

Measure from the front edge trim toward rear of RV 6-1/2"

FIG 3: Measure back to the rear of the fifth wheel, from the front edge trim, 6-1/2 inches. Make another mark with the erasable marker, pen or pencil. This locates the center of the access hole for the manual override.
FIG 4: Before drilling; make sure there will be enough clearance so the grommet does not come into contact with the switch or the compartment edging and that it sits flush to the outer wall.

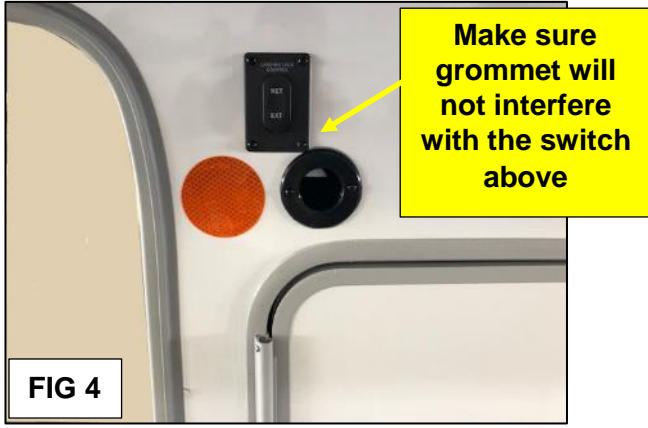
FIG 4

Make sure grommet will not interfere with the switch above

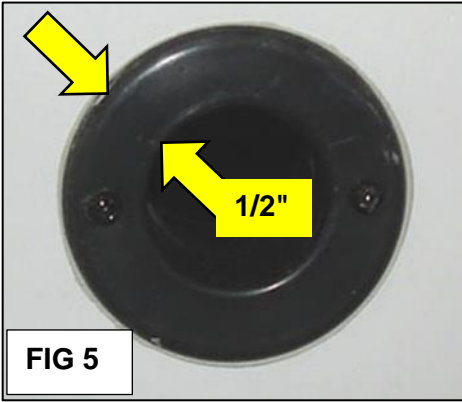
FIG 5

FIG 5: The lip of the grommet is 1/2 inch wide. The grommet can be located up to 1/4 inch off of the center mark of the hole and the crank handle will still fit on the manual override shaft behind the outer wall. (Fig 6)
FIG 6: Manual override shaft inside the front of the RV. (The pin can be seen by looking inside the forward baggage compartment and up slightly.)

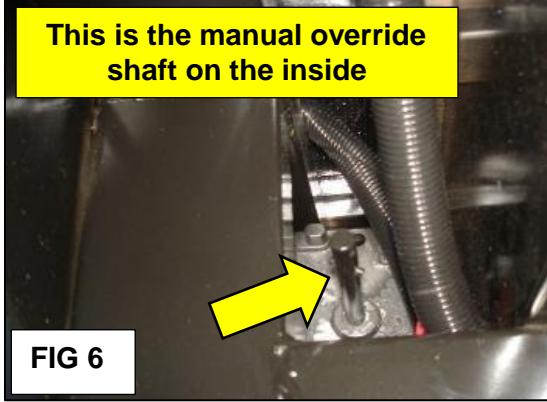
FIG 6

This is the manual override shaft on the inside

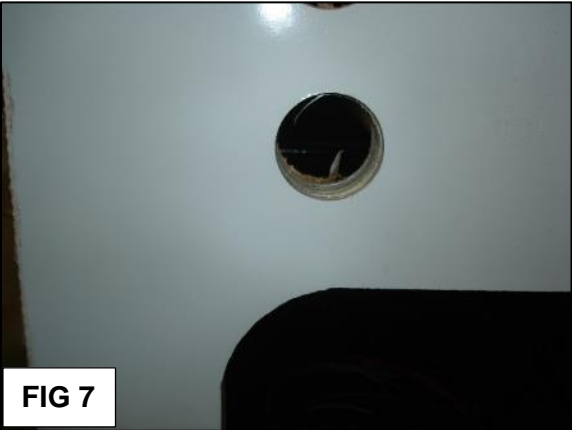
FIG 7

FIG 7: Drill the 2 inch diameter hole when the location has been finalized.
FIG 8: While drilling, you will enter through a thick layer of wood followed by a thin layer of aluminum.

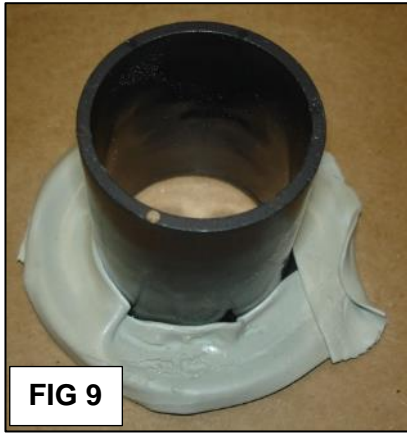
FIG 9: Install butyl tape around the lip of the grommet. (Fig 9)

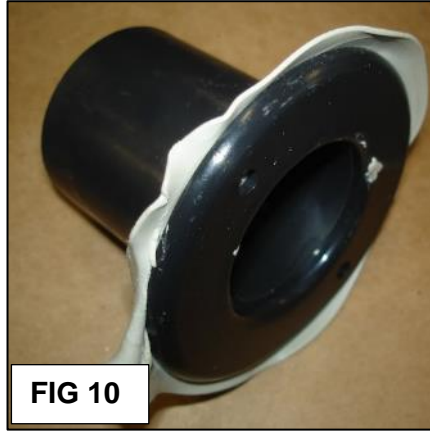
FIG 10: Butyl tape should extend beyond the lip of the grommet. (Fig 10)

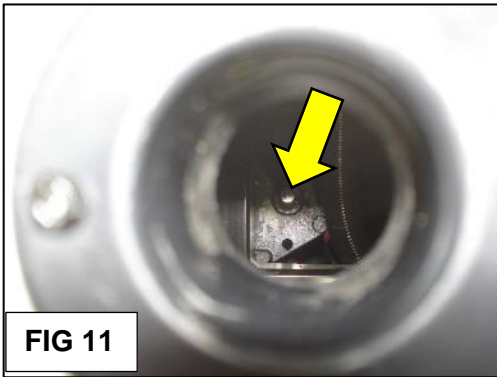
FIG 11: With the grommet positioned in the hole, you can see the manual override shaft inside (arrow).

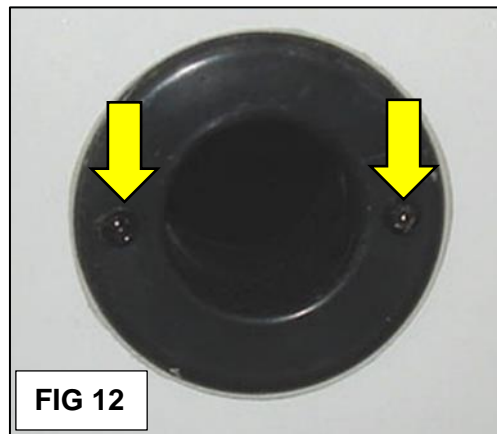
FIG 12: Secure the grommet to the outer wall using the two screws from the kit.
Trim the excess butyl tape from around the grommet.
