**Technical Service Bulletin Notification TSB #18-018**  
**Unit Serial Number:**

Jayco has determined that certain Model Year 2019 Entegra, Aspire and Anthem Class A motorhomes require installation of the heat shield in the engine compartment.

**Heat Shield in engine compartment omitted**

**TSB:** 18-018

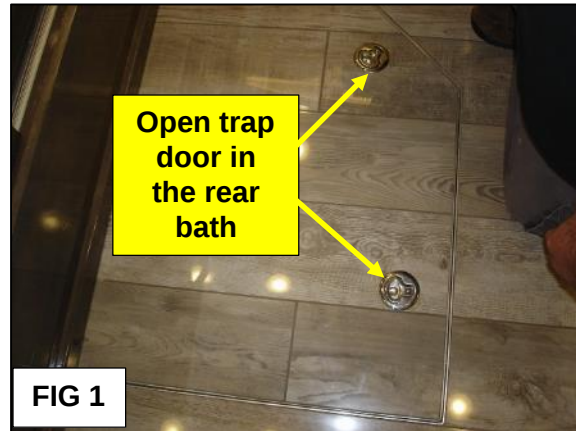
### FIG 1: FOR MODELS WITH A REAR BATHROOM:

There is a trap door in the floor of the bathroom.  
Lift the rings, turn them 90° to unlock the lid.  
Lift the door to access the engine compartment.

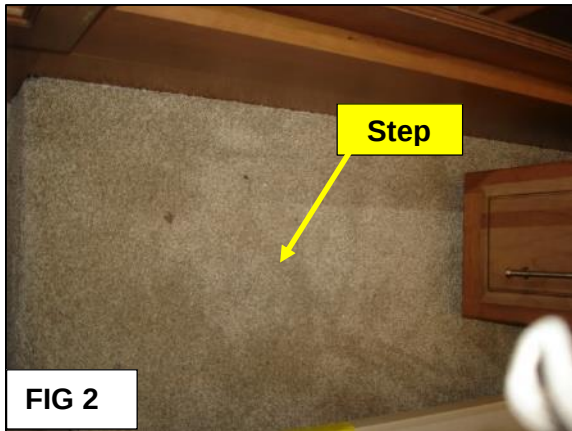
**FIG 2:** There is a carpeted step beside the bed next to the wardrobe in the bedroom.

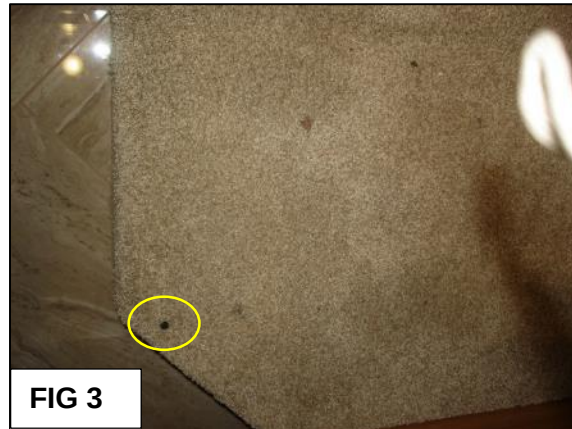
**FIG 3:** There will be 4 lag bolts that must be removed in order to access the engine.  
One of those lag screws is shown here circled.

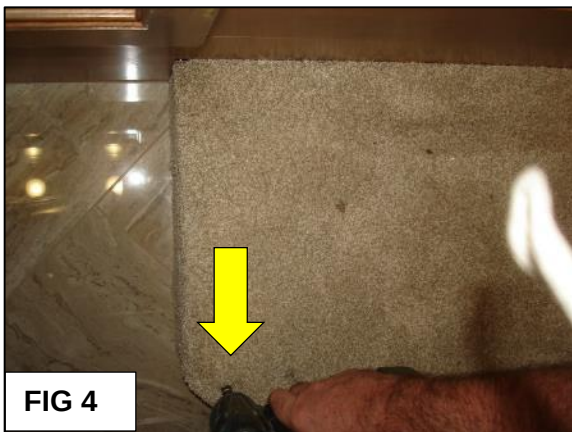
**FIG 4:** Use the screw gun with the 5/16" nutsetter bit and remove the 4 lag screws.

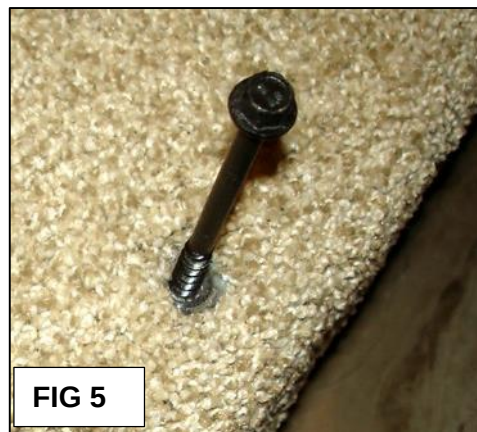
**FIG 5:** Shows one of the lags unscrewed. The lags are 4 inches long.

Once the lags are removed, the step can be raised. It is attached to hinges which will allow you to lift up the step and tilt it back toward the wardrobe.

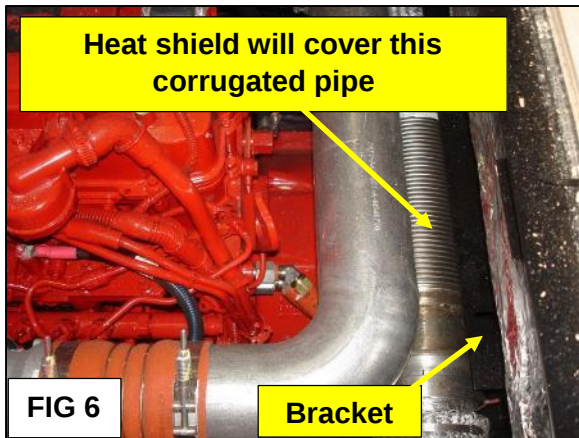
**FIG 6:** Immediately in front of the access hole, you should see the corrugated pipe. This pipe will be covered by the heat shield. This shield will need to be placed underneath the bracket shown here.

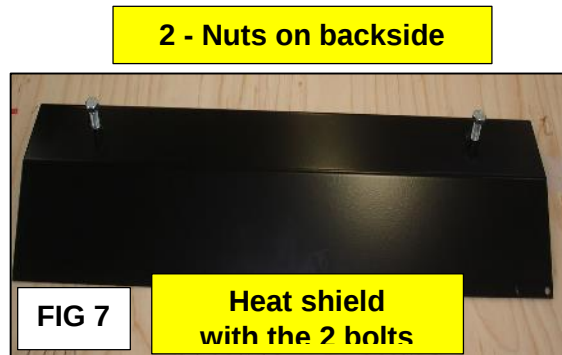
**FIG 7:** Remove the two bolts from the shield. Nuts are welded on the back side of the shield to make bolt installation easier.

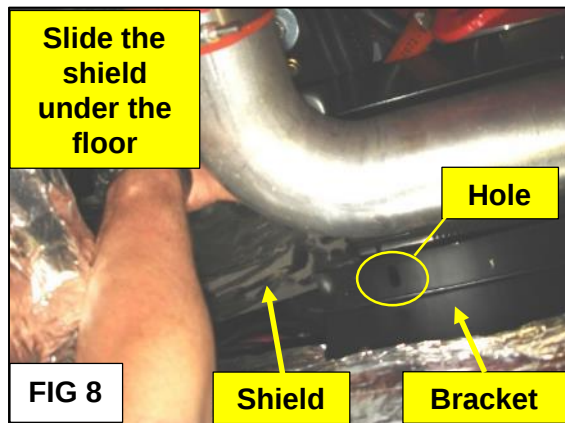
**FIG 8:** To get the shield in place over the corrugated pipe, you must first slide the shield under the floor at the end of the large elbow pipe. (slide shield to the left)

Welded nuts should be face down, holes face up, and holes in shield should face toward bracket.

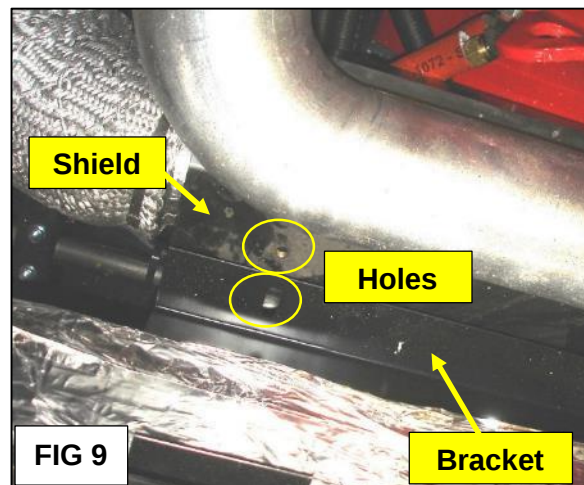
**FIG 9:** Slide the shield to the right, under the large elbow pipe, and underneath the bracket but on top of the corrugated pipe.

Line up the holes in the shield with the oblong holes in the bracket.

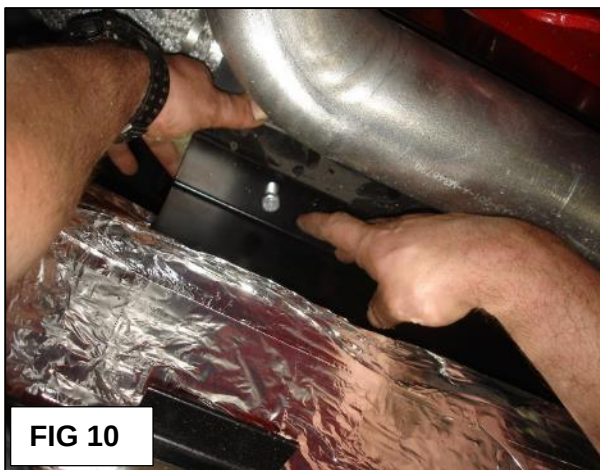
**FIG 10**

**FIG 10:** Thread a bolt (by hand) in the hole next to the large elbow.  
The bolt goes through the bracket first, then into the shield.  
Leave the other bolt out temporarily.

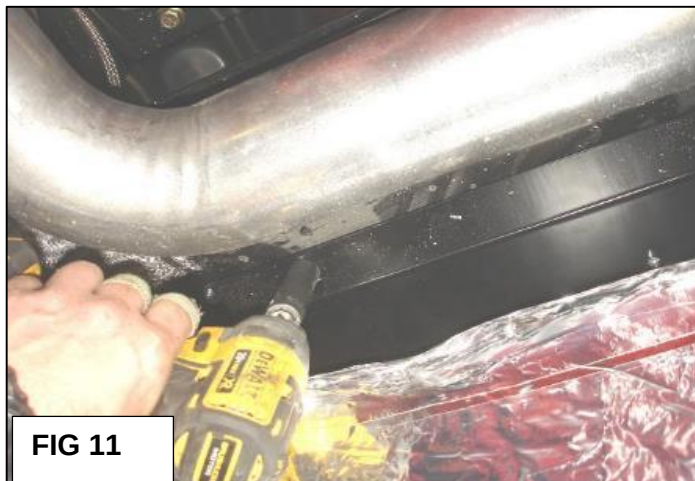
**FIG 11**

**FIG 11:** Attach the 9/16 socket and socket adapter to the screw gun and tighten the bolt but not completely.  
By tightening this bolt, it brings the other end of the shield up closer to the bracket.  
This will make it a lot easier to start the second bolt.

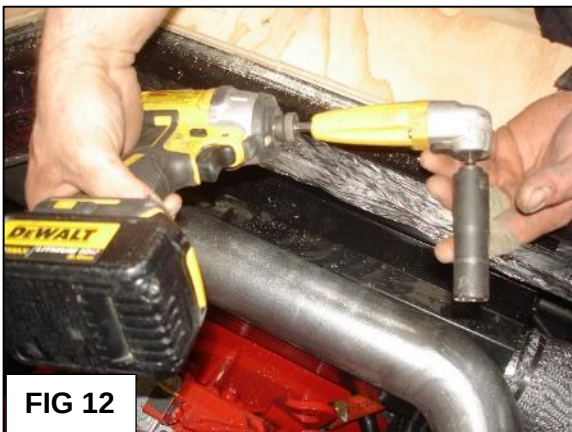
**FIG 12**

**FIG 12:** Start the second bolt by hand.  
Configure the right angle drill driver, and the 9/16 socket and socket adapter on the screw gun as shown in this photo.

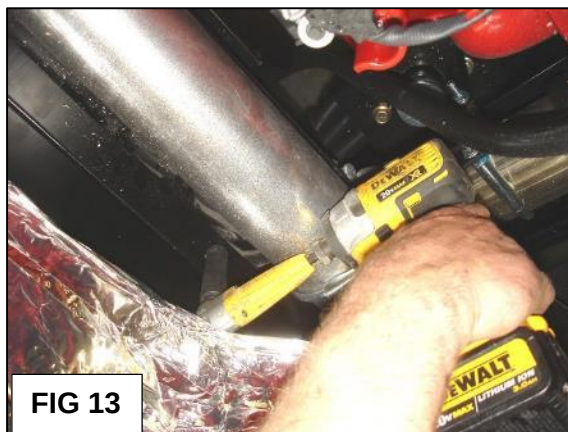
**FIG 13**

**FIG 13:** Tighten the second bolt using the right angle driver & socket assembly as shown.  
Both bolts can now be tightened completely.

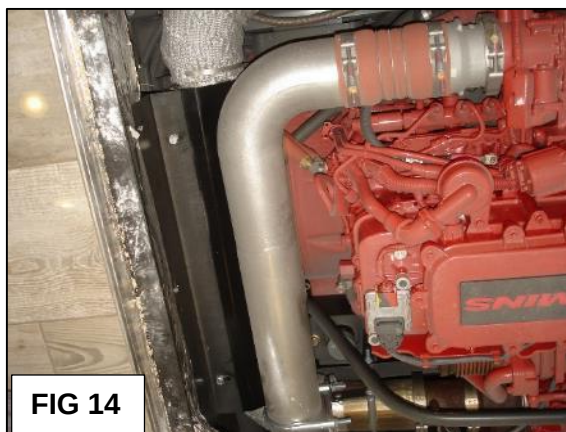
**FIG 14**

**FIG 14:** Shield is secured in place.  
Bolts have been tightened.

For Rear Bathroom models:  
Close and lock the trap door.

For Bedroom units:  
Close the step, reinstall the lag  
screws in the step.
