GROUP <b>CHA</b>	MODEL <b>2012-2013MY Optima (QF)</b>
	NUMBER <b>092</b>	DATE <b>October 2018</b>
<b>TECHNICAL SERVICE BULLETIN</b>		
<b>SUBJECT: BRAKE PEDAL STOPPER PAD REPLACEMENT</b>

This bulletin provides the procedure to replace the brake pedal stopper pad on some 2012-2013MY Optima (QF) vehicles, produced from August 12, 2011 through September 27, 2013. The brake pedal stopper pad may deteriorate over time, allowing the stop lamp switch plunger to remain extended when the brake pedal is released. A deteriorated pad can result in the continuous illumination of the stop lamps.

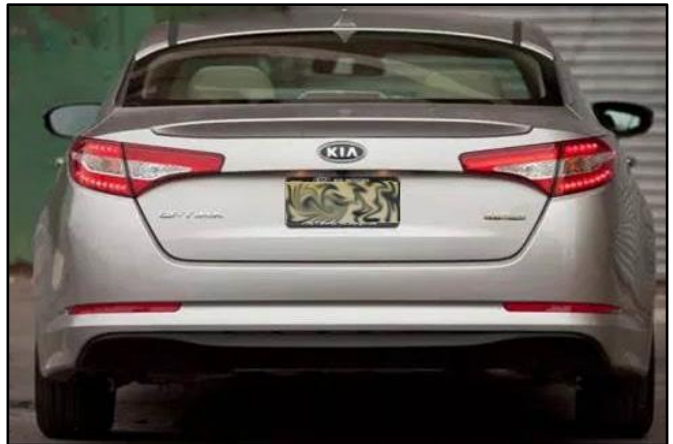
7. Confirm proper function of the rear brake lamps when applying the brake pedal. Ensure the rear brake lamps turn off after releasing the brake pedal.

ESC MIL may be illuminated during this procedure with DTC C1513 Brake Switch Error.
