**Mack Models**

**Volvo Models**

| <b>Title</b> | Grounding Bus Bar (Grounding Star, Four Point Ground Stud) On Frame Rail;<br>Inspection To Be Performed For Power And Ground, Data Link DTCs - <b>US10 And<br/>Newer Emissions, Model Year 2011 And Newer</b> |

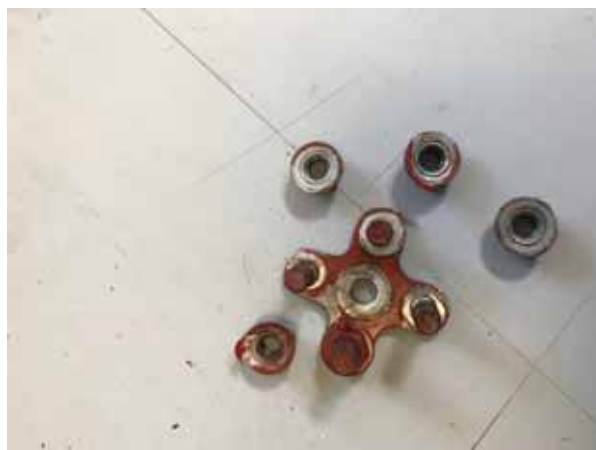
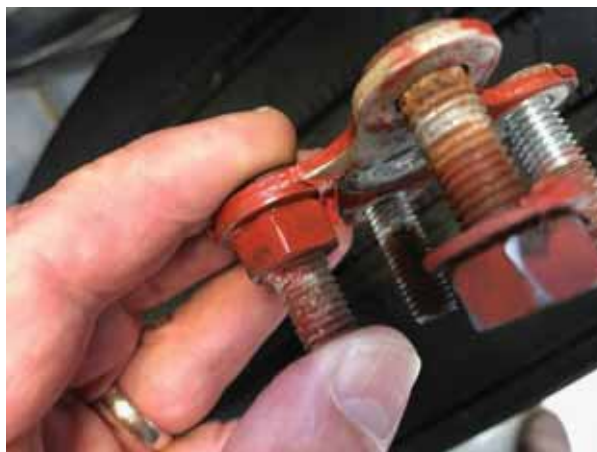
| <b>Cause</b> | During chassis assembly, the grounding star is painted prior to cable installation.<br>Overspray on the contact surfaces may cause a poor ground connection resulting in<br>power supply and/or data link codes to be generated. |

| <b>Solution</b> | The ground star is located on the driver's side frame rail near the battery box and fuel<br>tank. If the ground becomes loose or gets protective coating, paint, dirt, or corrosion in<br>between the terminals, the ground star needs to be removed, cleaned, and the<br>protective coating needs to be reapplied. |

Any concern with power and ground should include a complete inspection of this part  
for tightness, cleanliness, and condition.
