## Volvo Models

| Title | Volvo Chassis - <b>VHD</b> Splash Shield Rubbing Lower Cowl - <b>US17+OBD2016 Emissions, Model Year 2018 (Common Rail Fuel System ONLY)</b> |

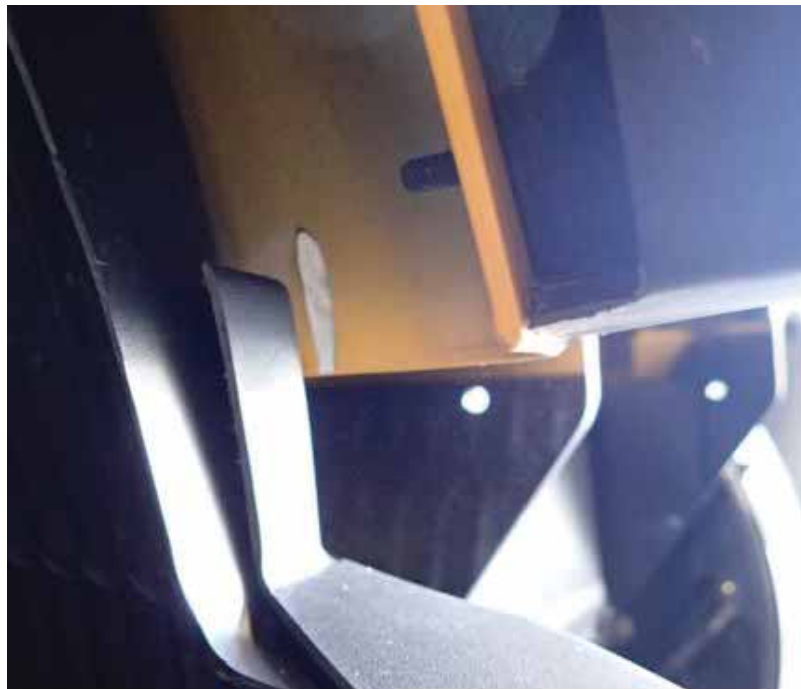
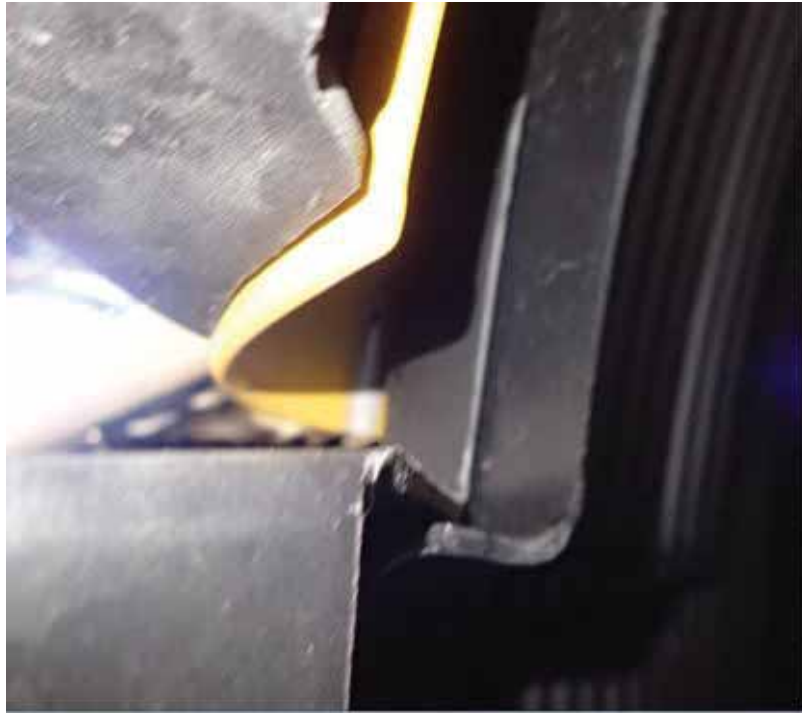
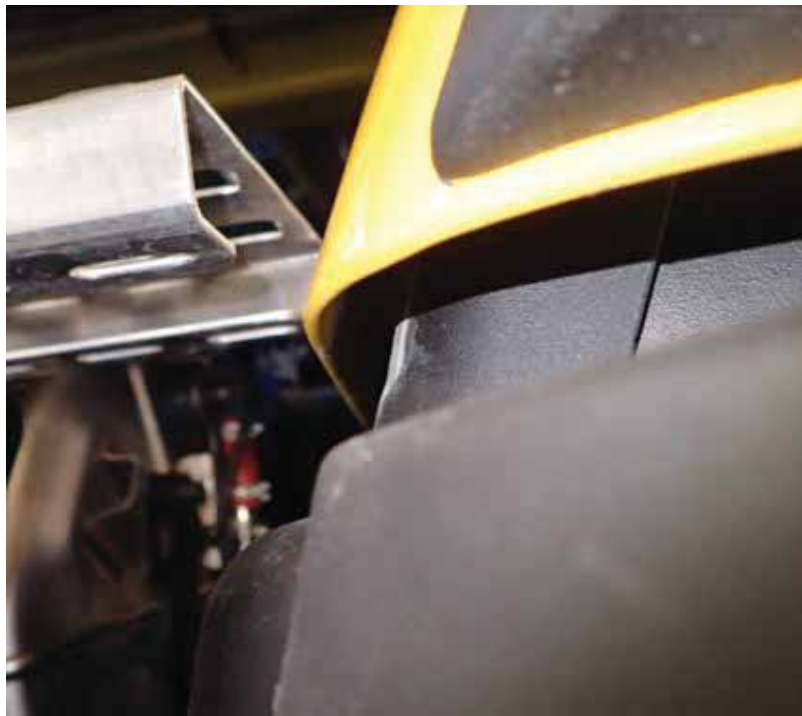
| Cause | In VHD models it is possible for the splash shield to rub the lower section of the cowl. After time the splash shield can rub through the cowl. No parts replacement is necessary the existing parts can be adjusted to obtain additional air gap. |

| Solution | If the splash shields are rubbing the lower part of the cowl as seen below. |

**To gain the correct air gap ( 22mm ) the splash shield will have to be loosened and retightened in the correct sequence. See images bellow.**

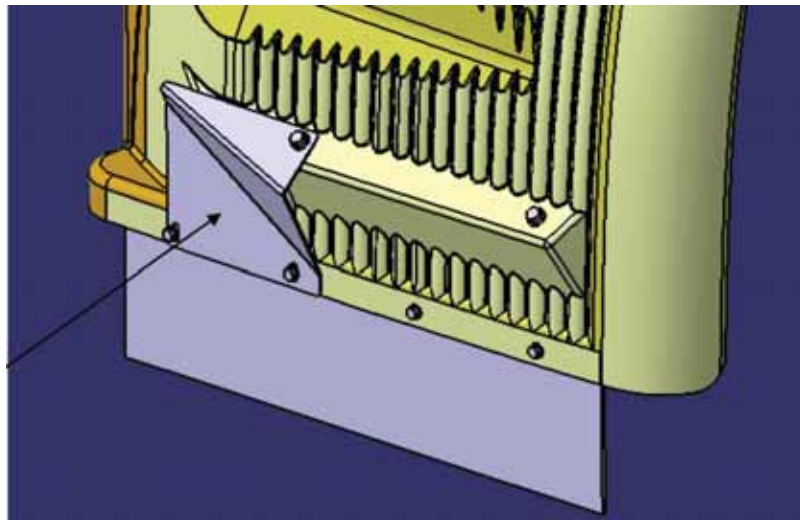
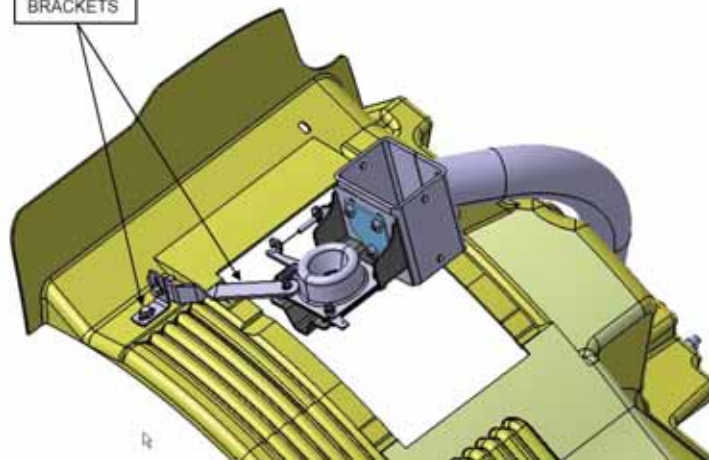
LOOSELY  
ATTACH  
BRACKETS

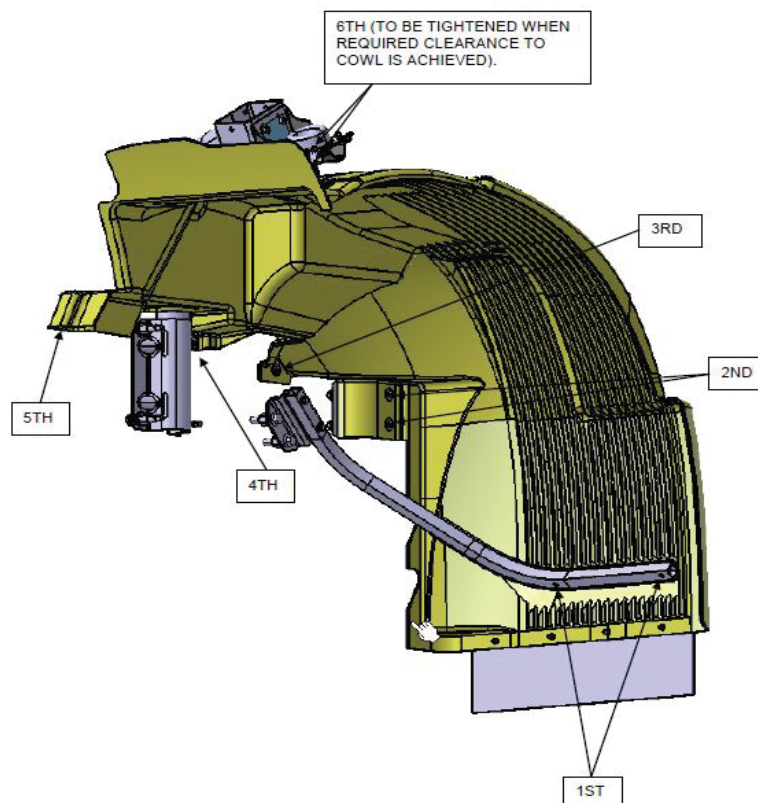
SEQUENCE OF BOLT ATTACHMENT  
LH SHOWN, RH SYM OPPOSITE
