L73X-A.05.18	<b>To:</b> <b>Subject:</b> <b>Date:</b> <b>Pages</b>	<b>Official After Sales Network</b> <b>E-box Covers Substitution</b> <b>26 September 2018</b> <b>14</b>	 
--------------	---	--	---

**Campaign description.**  
E-box Covers Substitution

**Model.**  
Aventador S and SV FL

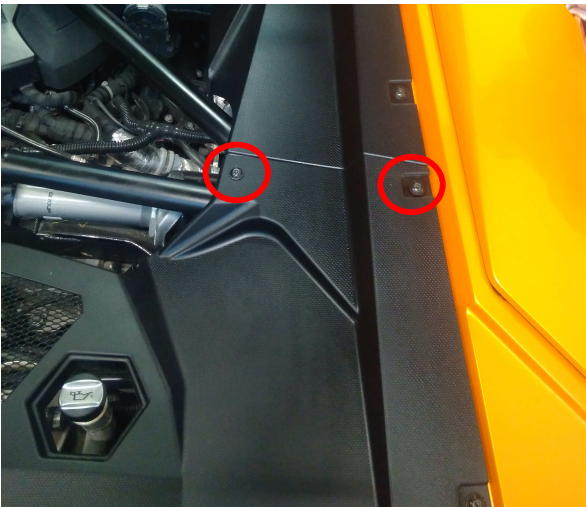
1. Unfasten the 2 side screws of the right cover under the engine bay.

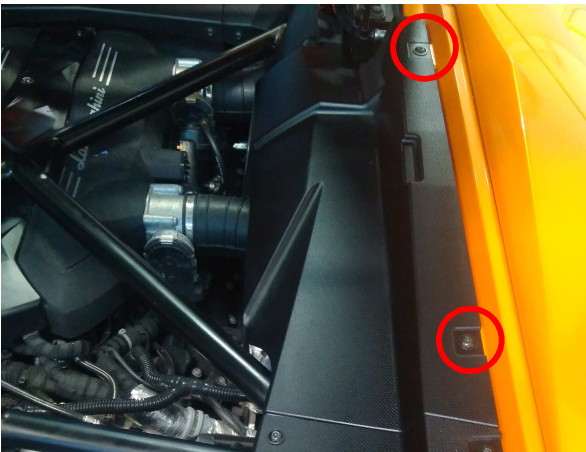
2. Unfasten the 2 screws from the right cover.

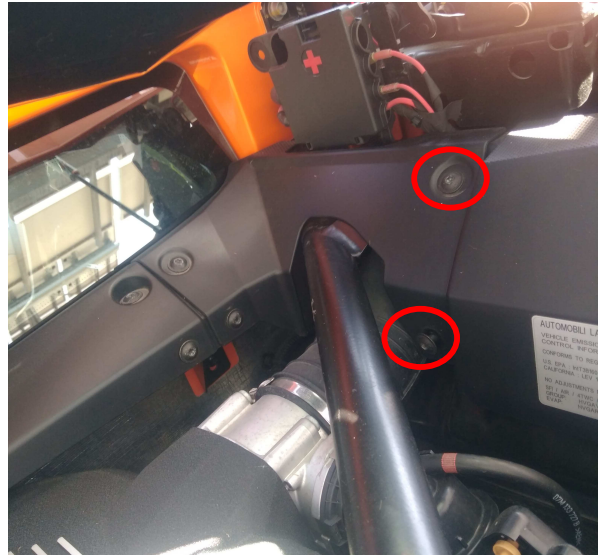
3. Unfasten the 2 screws from the front cover and make free the side cover in order to have access to the e-box.

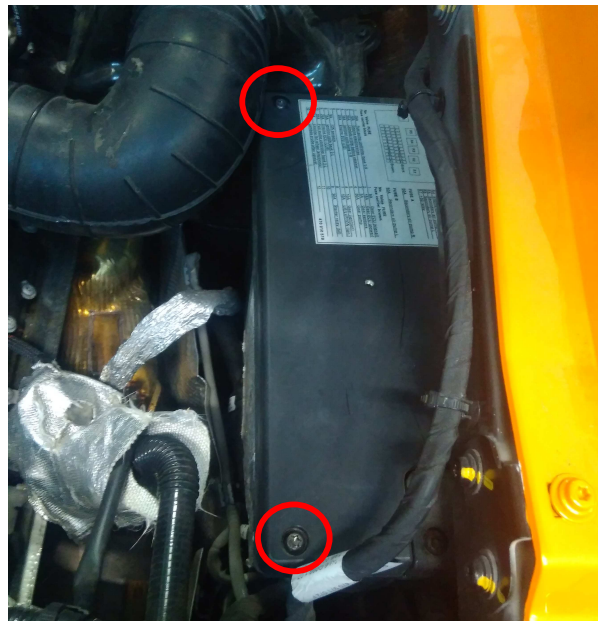
4. unfasten the 2 screws

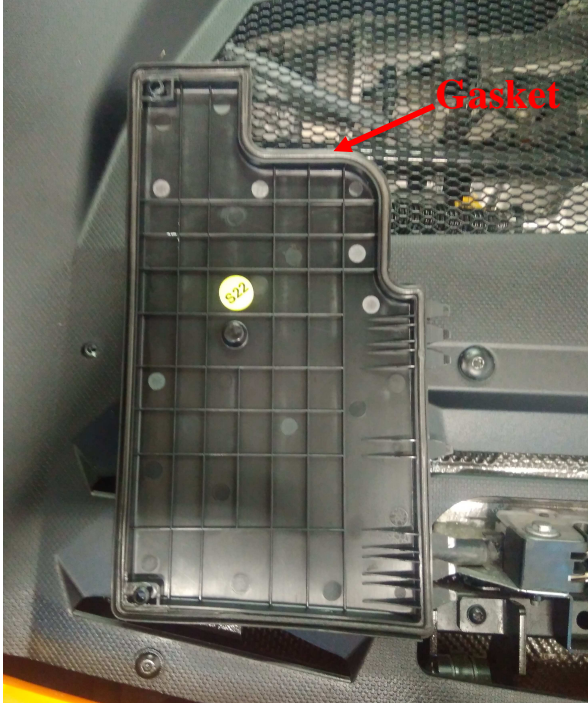
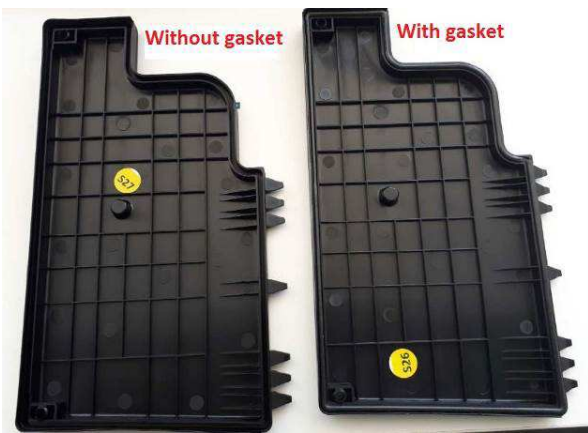
5. Make free the first cover and check the sealing.

In case the sealing are NOT missing, please re-assemble back the covers, and no further operations are required.

Whereas, in case the sealing is not there, it is a requirement to substitute both the covers (even if only one is missing). Hence, order the kit p/n 470.919.167.C and follow through the provided instructions.

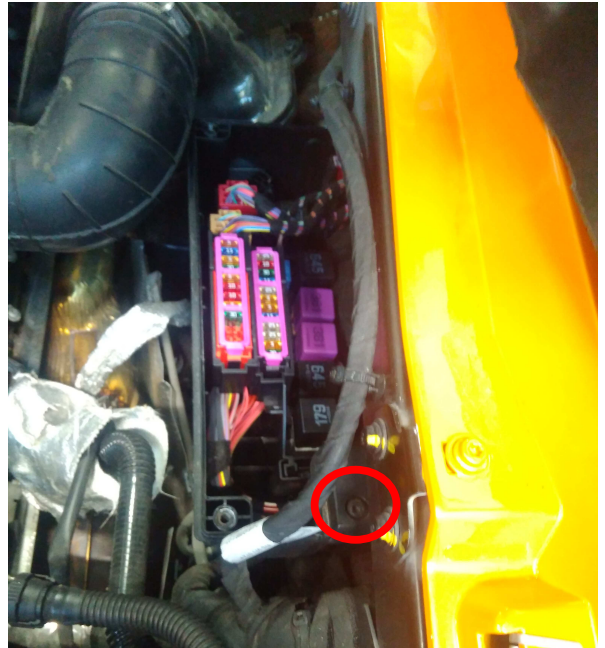
6. Unfasten the screw.

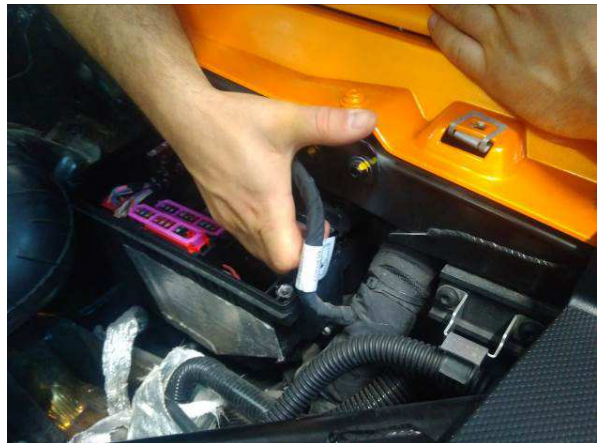
7. Lift the second cover and check the presence of the sealing.

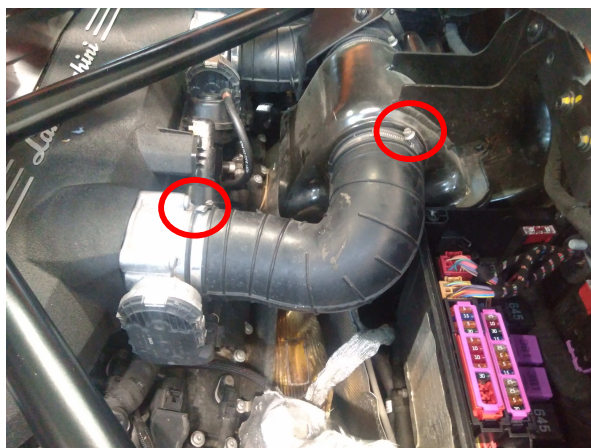
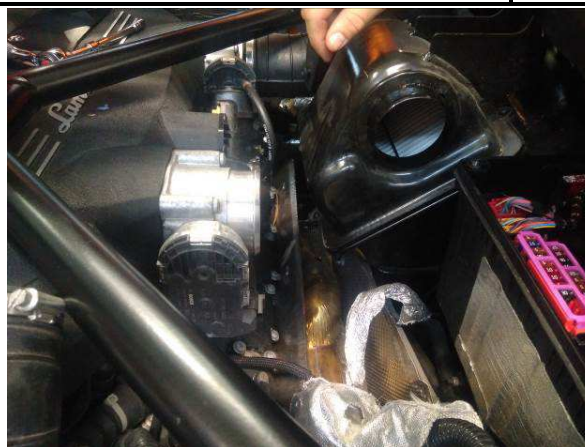
- 9. Unfasten the 2 cable tie and remove the pipe.

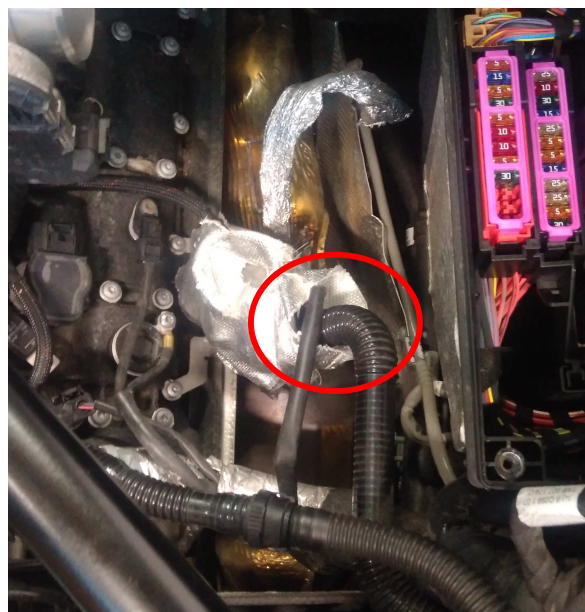
- 10. Make free the pipe and remove it from any conjunction.

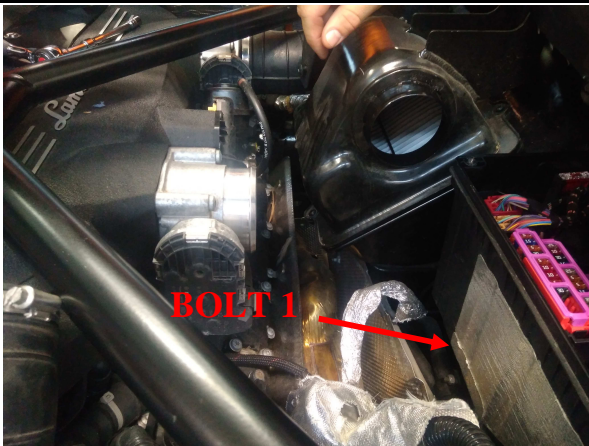
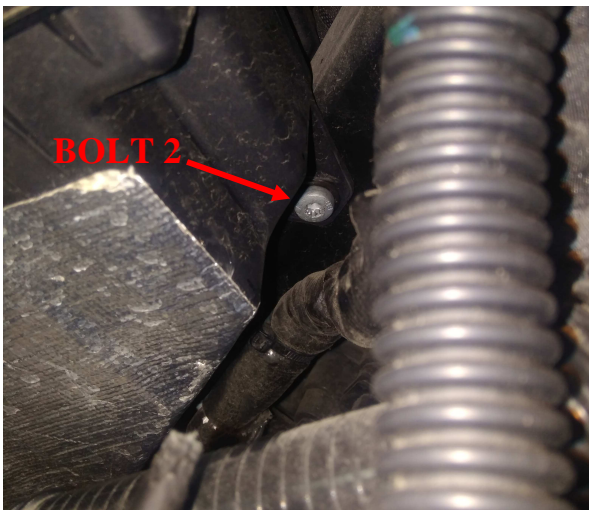
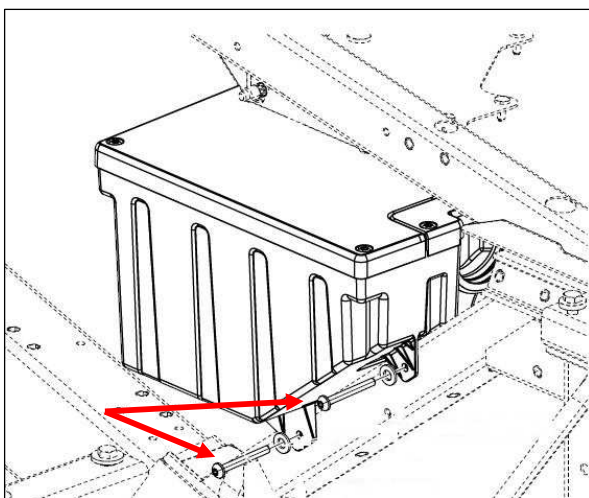
- 11. Unfasten the 2 screws underneath the fuse box.

Tighten the screws.

Tightening torque: **5,00 Nm ( 3,69 lbf ft ) ±20%.**

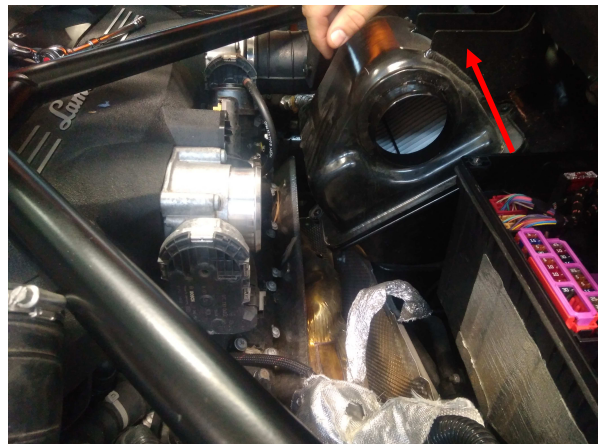
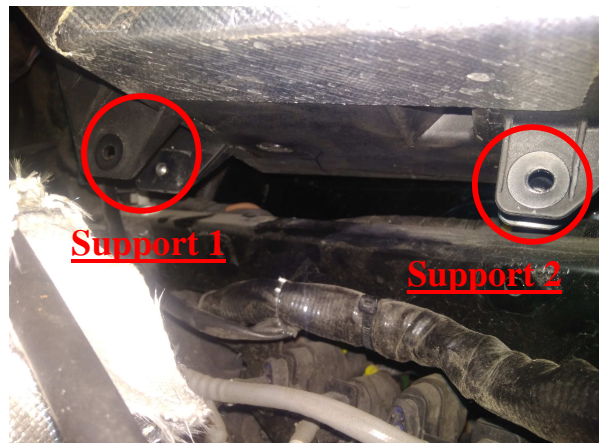
12. Push the fuse box in direction of the air filter and release the brackets from the frame.

At first release the front support (1) and then the rear support (2) to avoid damaging.

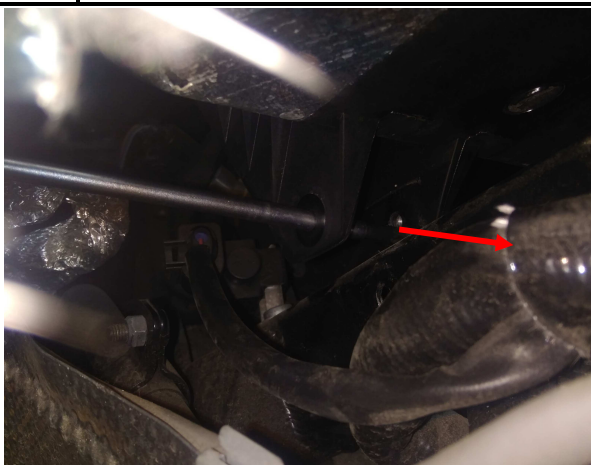
Use a screwdriver as a guide to reassemble. Push the holder 1 into position and remove the screwdriver.

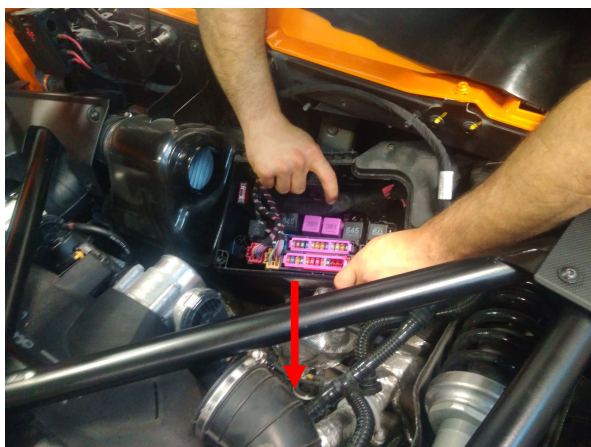
13. Bring the fuse box in direction of the engine so that the remaining two screws of the second cover are visible.

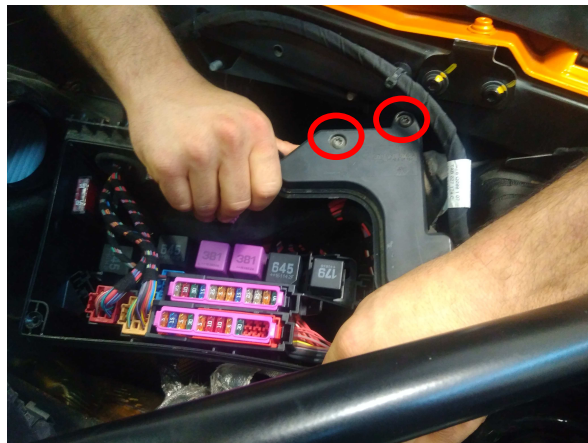
14. Unfasten the 2 screws

15. Replace the cover with the new with gasket p/n: 470937576 A already present in the ordered kit.

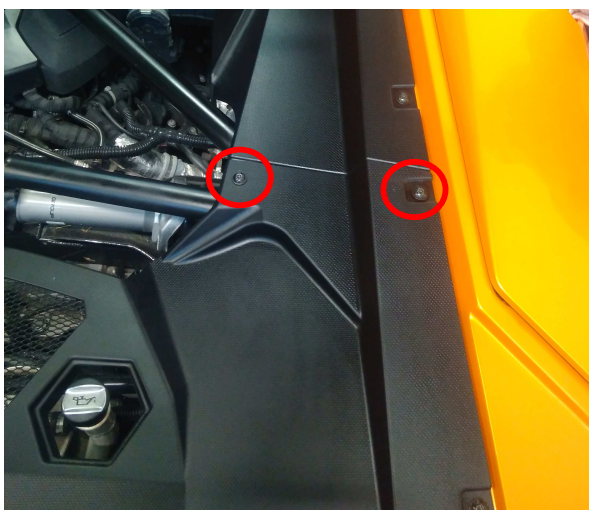
17. Svitare le 2 viti superiori lato destro della copertura motore posteriore.

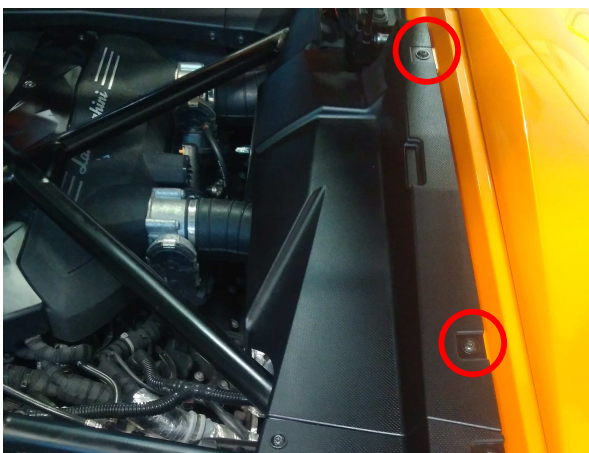
18. Svitare le 2 viti della copertura laterale destra.

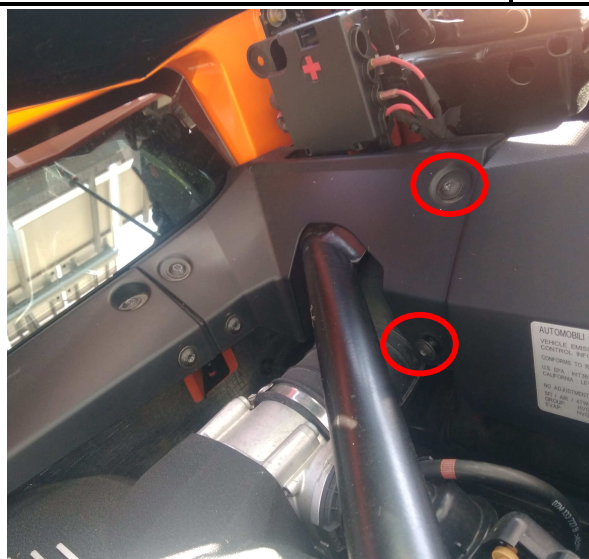
19. Svitare le 2 viti della copertura anteriore e svincolare la copertura laterale in modo da avere accesso all'E-box.

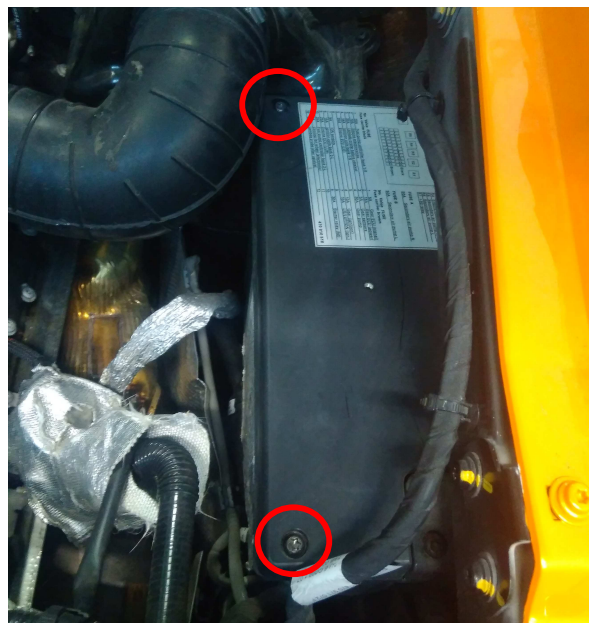
20. Svitare le 2 viti.

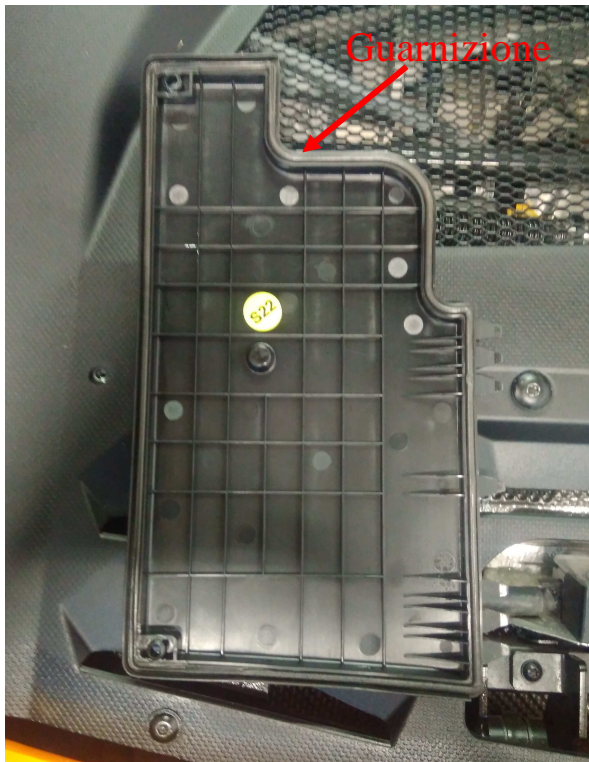
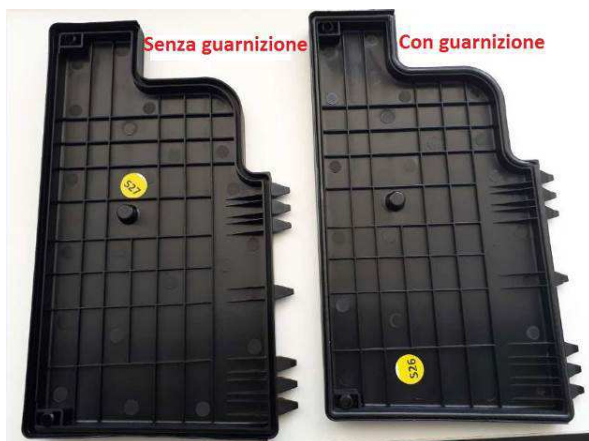
21. Svincolare la cover 1 e controllare la presenza della guarnizione.

Nel caso la guarnizione sia presente è possibile iniziare il rimontaggio.

Nel caso che, anche solo una guarnizione non sia presente, occorre sostituire entrambe le cover. Ordinare il kit p/n 470.919.167.C e continuare la procedura seguente.

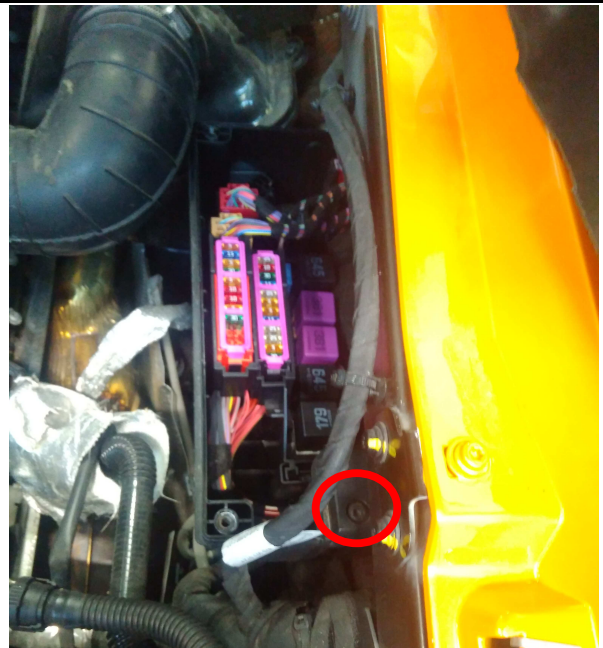
22. Svitare la vite.

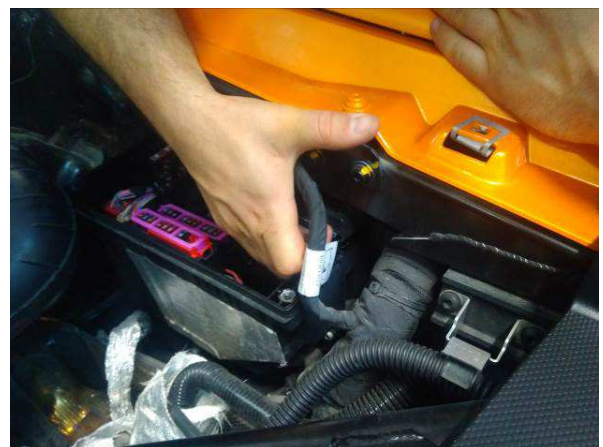
23. Sollevare leggermente la cover 2 e verificare con un dito la presenza della guarnizione.

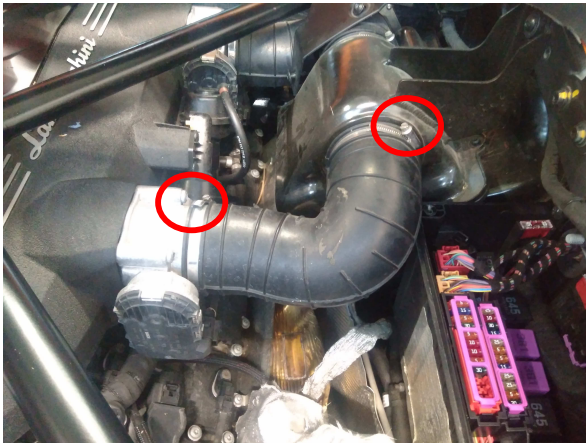
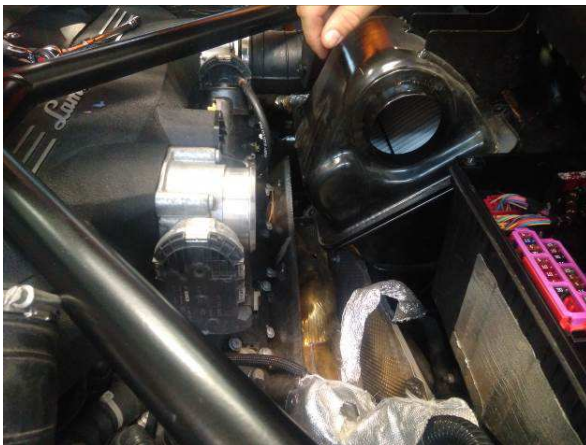
25. Svitare le due fascette e rimuovere il tubo.

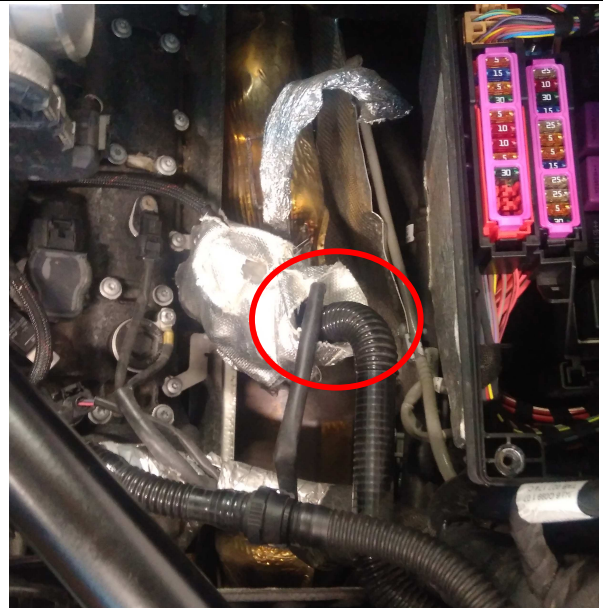
26. Svincolare il tubo corrugato e portarlo fuori ingombro.

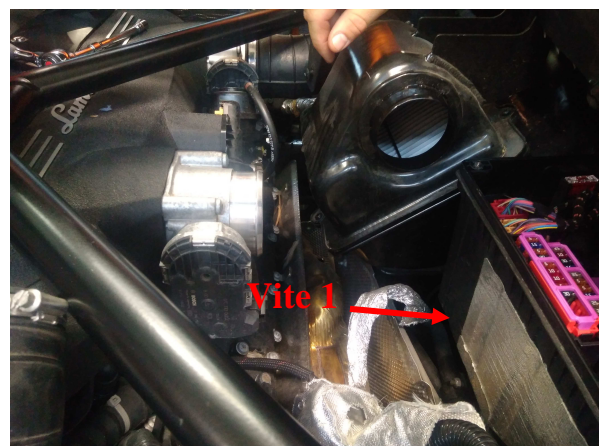
27. Svitare le 2 viti nella parte inferiore della scatola portafusibili.

**Coppia di serraggio: 5,00 Nm ( 3,69 lbf ft )  $\pm$  20%.**

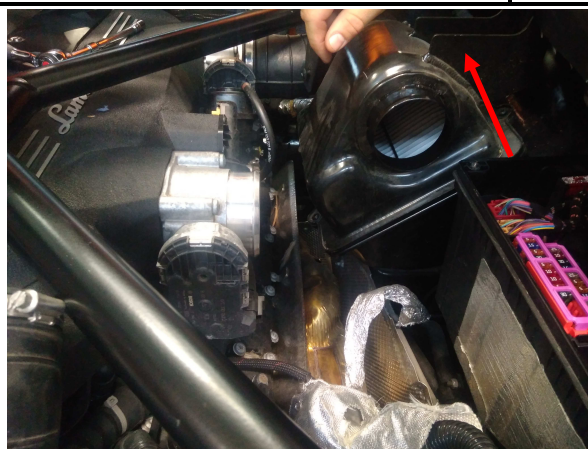
28. Portare la scatola fusibili verso il filtro dell'aria e successivamente svincolare i supporti di fissaggio dal telaio.

Svincolare prima il supporto anteriore (1) e successivamente quello posteriore (2) per evitare di danneggiarli.

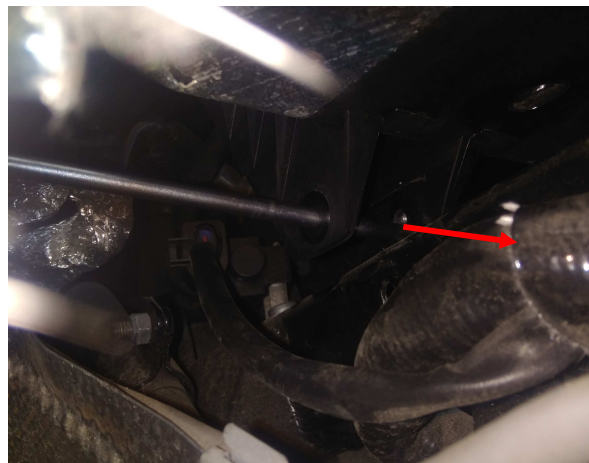
Per il rimontaggio utilizzare un cacciavite come guida. Spingere il supporto 1 in posizione ed estrarre il cacciavite.

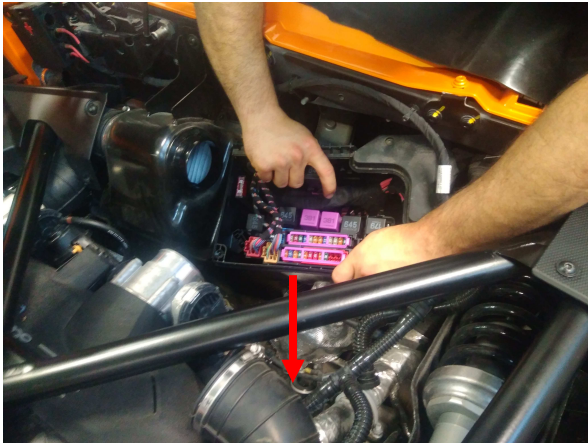
29. Portare la scatola portafusibili verso il motore in modo da rendere visibili le restanti due viti della seconda cover.

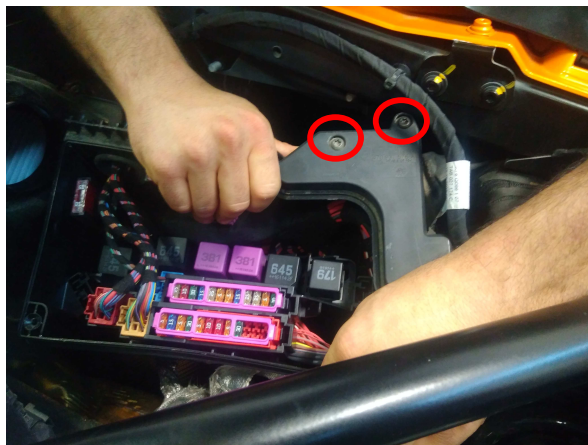
30. Svitare le 2 viti.

31. Sostituire la cover con la nuova completa di guarnizione p/n: 470937576 A presente nel kit ordinato.
