# SERVICE BULLETIN

Technical Service Bulletin: 205-0849

Forest River is alerting you to an issue involving certain 2019 Coachmen - Catalina travel trailer recreational vehicles. Please carefully review the attached document pertaining to your vehicle.

# CATALINA – GREYSTONE RANGE HOOD WIRE RETAINMENT REMEDY INSTRUCTIONS

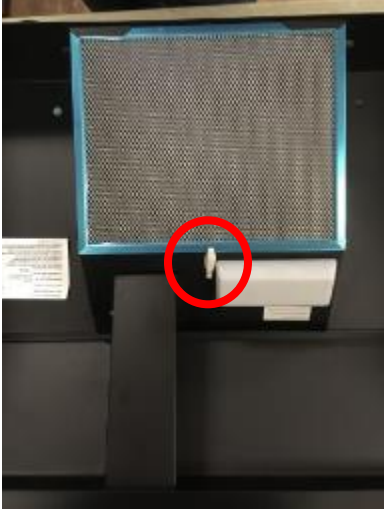
STEP ONE: REMOVE FAN SCREEN BY TURNING WHITE RETAINING TWIST LOCKER;

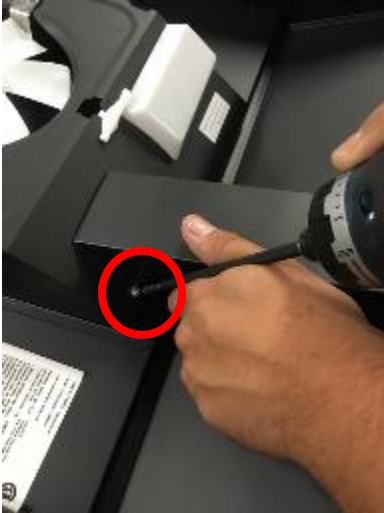
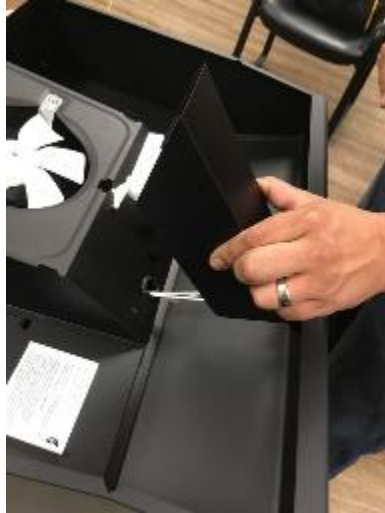
STEP TWO: REMOVE WIRE COVER BY REMOVING ONE RETAINING SCREW ON LEFT SIDE;

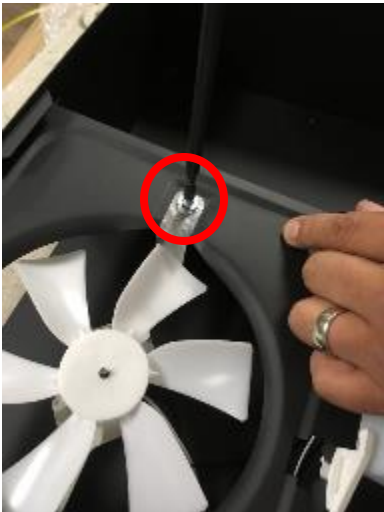
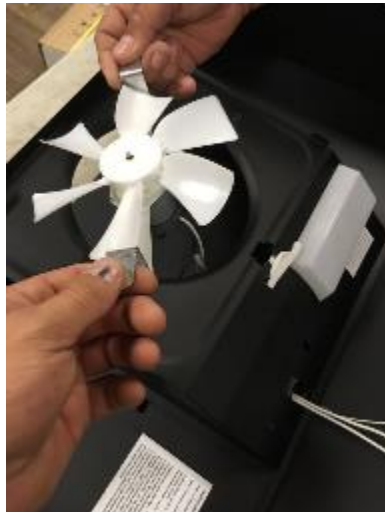
STEP THREE: REMOVE FAN MOUNTING SCREWS - ENSURE THAT THE FAN DOES NOT DROP AFTER REMOVING MOUNTING SCREWS

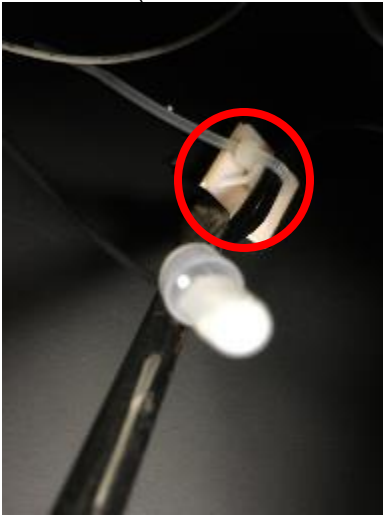
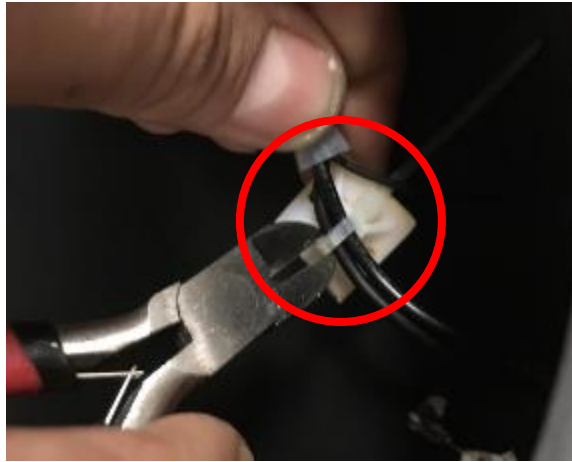
STEP FOUR: REMOVE EXISTING ADHESIVE WIRE RETAINING HANGER FROM THE INSIDE OF THE RANGE HOOD HOUSING WITH A FLAT HEAD SCREW DRIVER OR SIMILAR TOOL AND CLIP SMALL ZIP TIE WITH SIDE CUTTERS.(ENSURE THAT YOU DO NOT CUT ANY OF THE WIRES SECURED BY ZIPTIE)

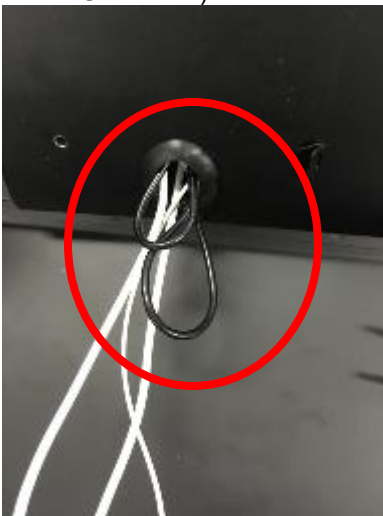
STEP FIVE: PULL THE SLACK FROM THE FAN WIRES THROUGH THE PASS THROUGH HOLE THAT GOES TO THE FAN AND LIGHT SWITCHES THAT WERE EXPOSED BY REMOVING COVER IN STEP TWO; USING NEEDLE NOSE PLIERS (ENSURE THAT YOU DO NOT PULL THE WIRES TO TIGHT OR YOU WILL DISCONNECT OR DAMAGE THEM)

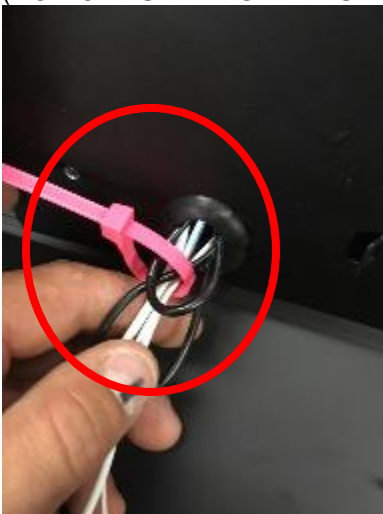
STEP SIX: PUT ZIP TIE OVER SLACK WIRE TO ENSURE IT DOES NOT PULL BACK THROUGH (DO NOT FULLY TIGHTEN UNTIL FAN IS REINSTALLED)

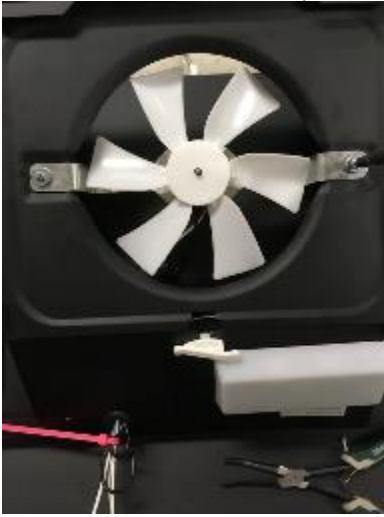
STEP SEVEN: REMOUNT THE FAN (ENSURE THAT IT IS CENTERED SO THE BLADES DO NOT CONTACT OR RUB AGAINST THE SHROUD)

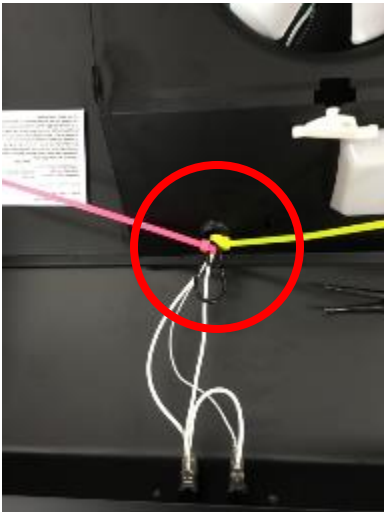
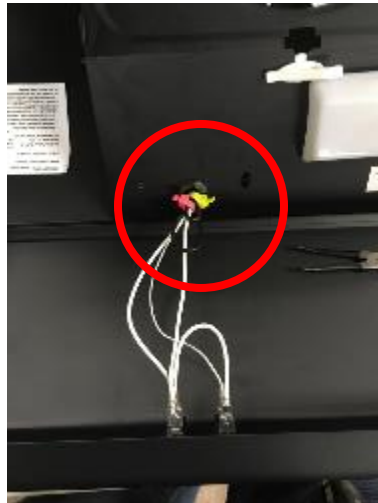
STEP EIGHT: TIGHTEN ZIP TIE HOLDING WIRES, ADD SECOND ZIP TIE AROUND WIRE BUNDLE AND SNIP OFF ENDS.

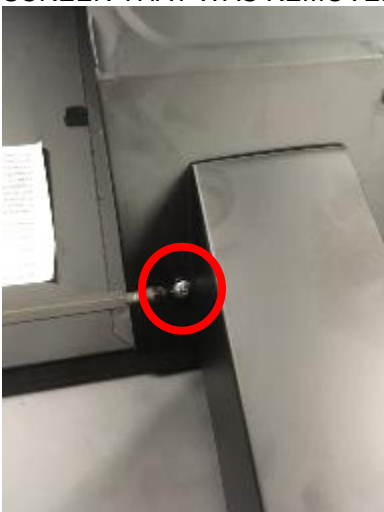
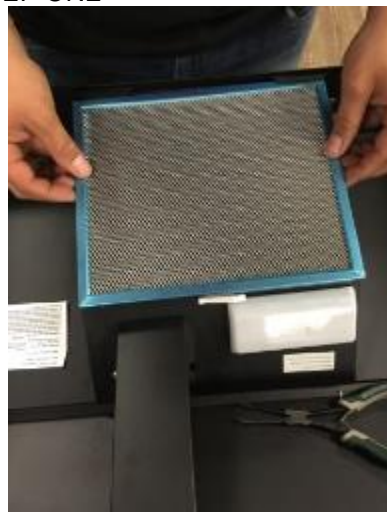
STEP NINE: REMOUNT WIRE COVER USING THE ONE SCREW REMOVED IN STEP 2, REINSTALL THE FAN SCREEN THAT WAS REMOVED IN STEP ONE
