CAMPAIGN BULLETIN

Third Row Seat Belt Buckle Dealer Inventory

Reference: PC660
Date: October 5, 2018

PC660 – PATHFINDER SEAT BELT BUCKLE (3RD ROW) INSPECTION

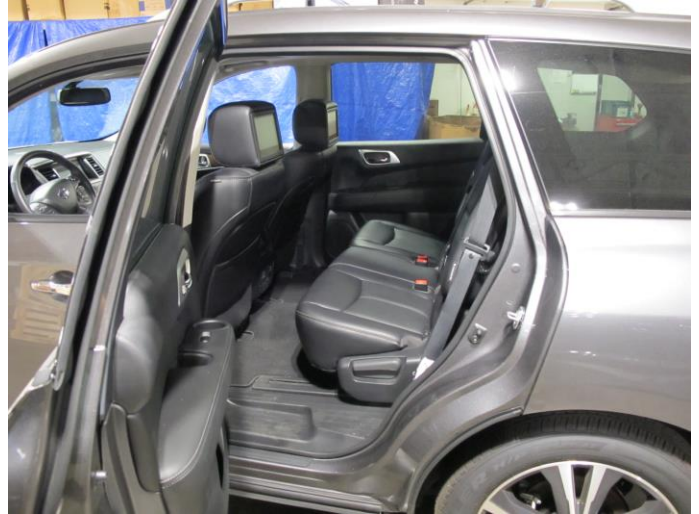
Figure 1

1. Open the Driver side rear door.

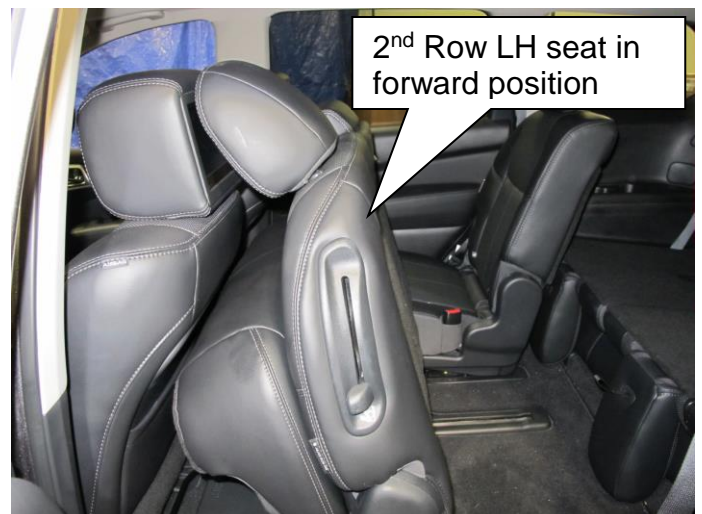
Figure 2

2. Slide and fold the 2nd Row LH seat all the way forward to the Driver seat allowing access to the 3rd row seat (Figures 2 and 3).

- Push handle (1) up.
- Push seat back (2) forward.
- Lift seat bottom (3) up.
- Slide folded seat assembly fully forward (4).

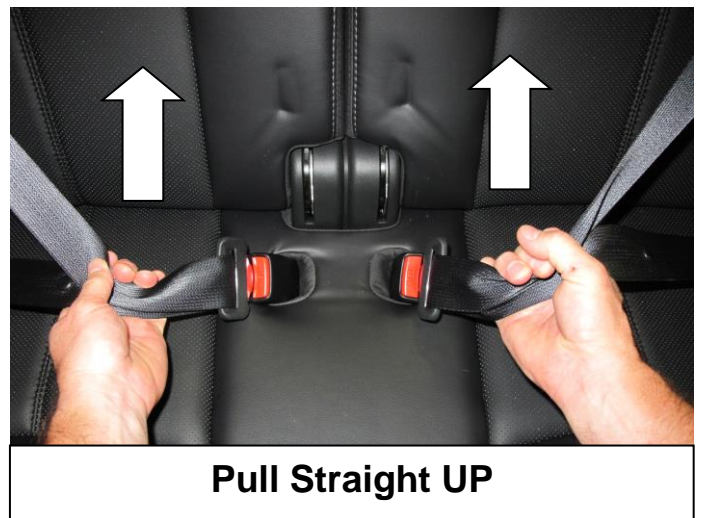
Figure 5

4. Using your hands, grasp both shoulder harnesses and pull straight up toward the roof of the vehicle (Figure 5).

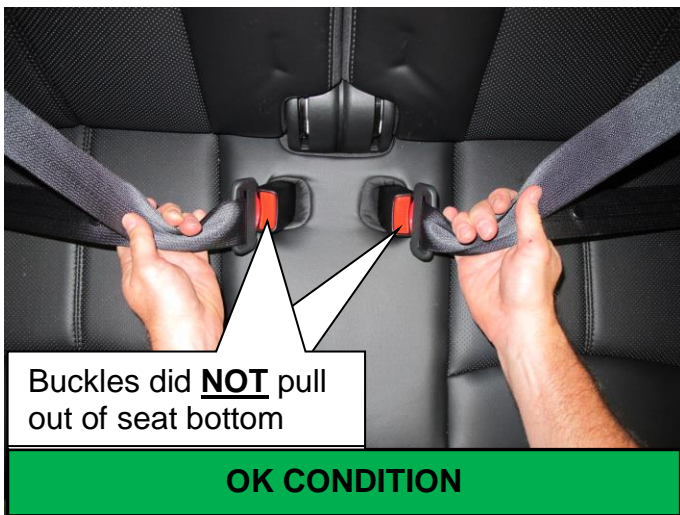
Figure 6

- If **NO**, then unbuckle the 3rd Row shoulder harnesses and return the 2nd Row seat to the latched position, submit a warranty claim using Op Code PC6600 (see Claims Information), release the vehicle. **(OK CONDITION)**
- If **YES**, then continue to HOLD the vehicle. **(CONTACT FQA)** Do not submit warranty claim. Proceed to Step 6

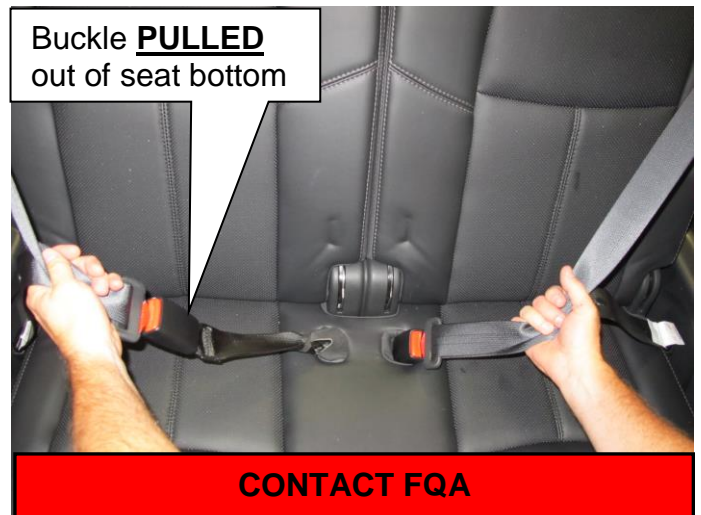
Figure 7

5. Did one or both of the 3rd Row seat belt buckles pull out of the 3rd Row seat bottom as shown in Figure 7?
