WJ38 - Checking Presence of Front Covers (Fins) and Removing if Necessary (Workshop Campaign)

Vehicle Type: **911 GT3 (991)**

Model Year: **2018**

Subject: **Front covers (fins)**

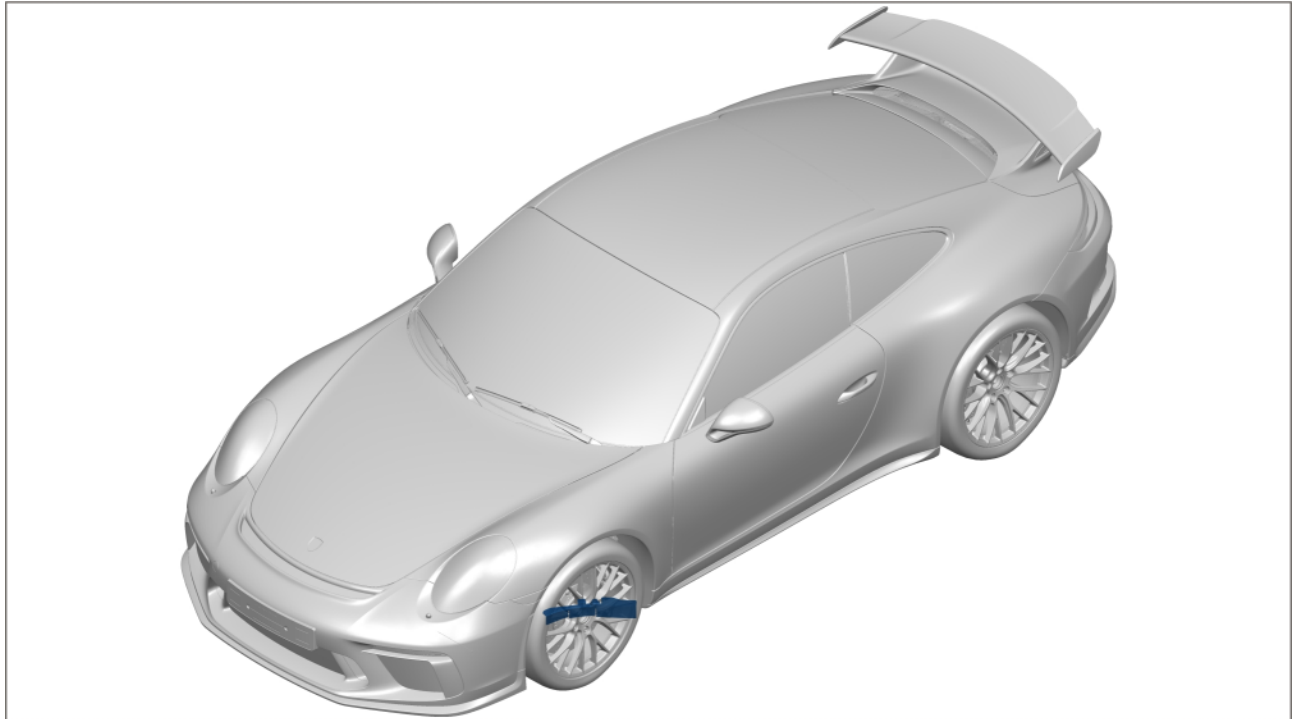
Installation position of front cover (fins)

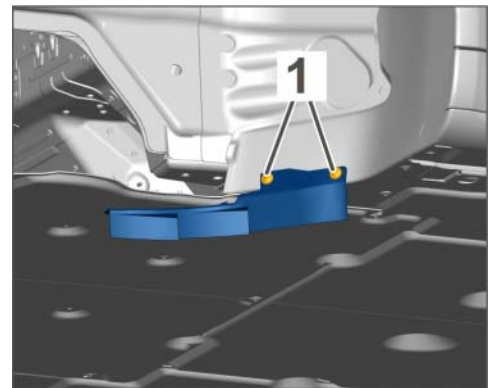
Checking fins

- Work Procedure:
- 1 Turn the steering fully to the right.
 - 2 Check whether the fins are attached in the underbody area in the left and right wheel housing.
 - **Fin is not fitted:** The vehicle **complies with specifications**. End of action required. Continue with Step 3.
 - **Fin is fitted:** The vehicle **does not comply with specifications**. The fins must be removed. To do this, continue with ⇒ *Technical Information 'Removing front covers (fin)'*
 - 3 Enter the campaign in the Warranty and Maintenance booklet.

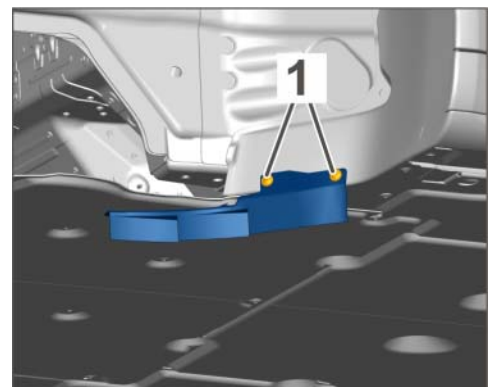
Removing fin

- Work Procedure:
- 1 Raise the vehicle on a lifting platform ⇒ *Workshop Manual '4X00IN01 Lifting the vehicle'*.
 - 2 Turn the steering fully to the right.
 - 3 On the left-hand side of the vehicle in direction of travel, unscrew the side fastening screws ⇒ *Removing fin -1-* for the fin.

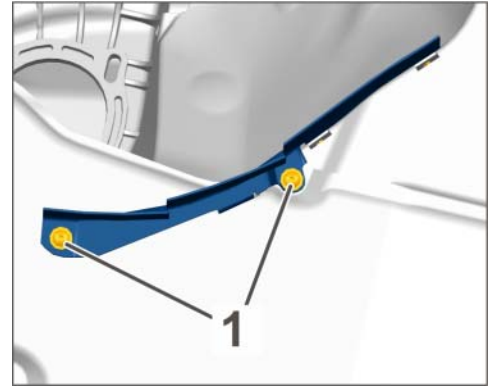
Removing fin

- 4 Unscrew lower fastening screws ⇒ *Removing fin -1-* for the fin.
- 5 Remove the fin and dispose of it.
- 6 Turn the steering fully to the left and repeat steps 3 to 5 on the right-hand side of the vehicle.
- 7 Remove front wheel housing liner (rear part) at the left and right and replace them with new wheel housing liners (without holes) ⇒ *Workshop Manual '50561925 Removing and installing front wheel housing liner (rear part)'*.
