Inspect For Missing High Voltage (HV) Battery Breather Valves

Classification	Campaign Bulletin	Section/Group	16 - Battery System	Country/Region	United States, Canada
Year	2017, 2018	Model	Model 3	Version	All

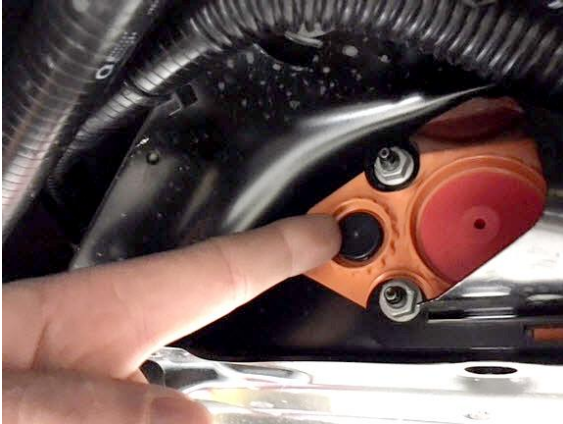
1. Raise and support the vehicle (refer to Service Manual procedure 10000205).
2. Insert a video scope through the mid aero shield to inspect the LH and RH HV battery vent assemblies (Figures 1 and 2):

✓ **Figure 1 (LH vent shroud with breather)**

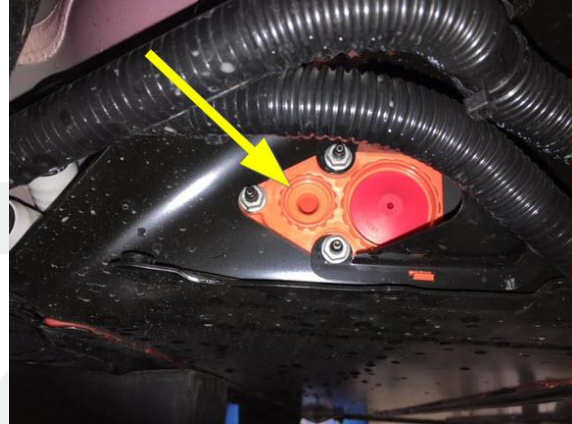
On some Model 3 vehicles, one or two HV battery breather valves might be missing or improperly installed.

✗ **Figure 2 (LH vent shroud without breather)**

- If both HV battery breather valves are present and properly installed (the HV battery breather valve should be flush with the HV battery vent assembly), discontinue this procedure.
 - If any HV battery breather valves are missing or improperly installed (i.e., not flush or parallel with the HV battery vent assembly), continue to the next step.
3. Inspect the vent hole for evidence of water or debris ingress (Figure 2).
 - If evidence is found, create a Toolbox session, add photos of evidence, and escalate the session.
 - If no evidence is found, continue to the next step.
 4. Enter these key phrases, as appropriate, into the Cause Narrative field of the Repair Order:
 - LH breather valve absent.
 - LH breather water/debris entry.
 - RH breather valve absent.
 - RH breather water/debris entry.
 5. Replace any HV battery vent assemblies that are missing HV battery breathers.

NOTE: Only install 1098630-00-G or newer.

NOTE: New HV battery vent assemblies do not come with HV battery breather valves preinstalled. For every HV battery vent assembly ordered, also order 1 HV battery breather valve.

- LH HV battery vent assembly (Service Manual procedure 16102102).
 - RH HV battery vent assembly (Service Manual procedure 16102112).
