SERVICE CAMPAIGN BULLETIN

VOLUNTARY SERVICE CAMPAIGN 2018 ALTIMA; FRONT PASSENGER SEATBACK

CAMPAIGN ID #: PC657
APPLIED VEHICLES: 2018 Altima (L33)

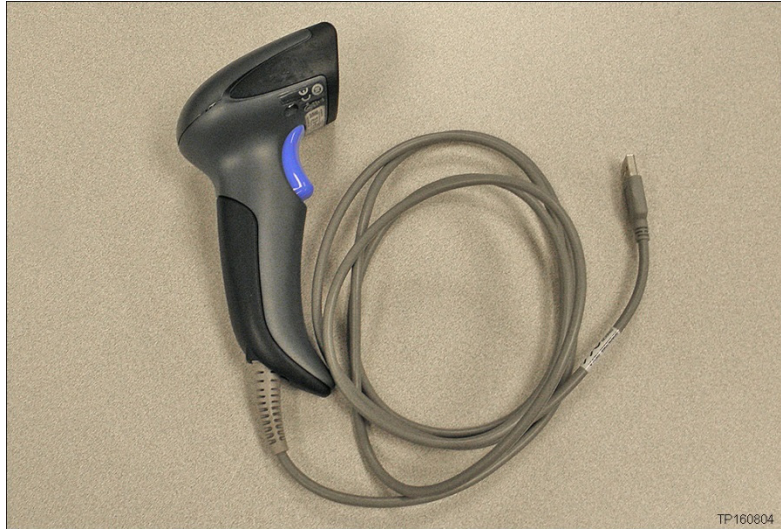
Figure 1

Quick Scan Tool (J-52352)

- Each dealer has been shipped one Quick Scan Tool (J-52352).
- Additional tools can be obtained from Tech•Mate at 1-800-662-2001.

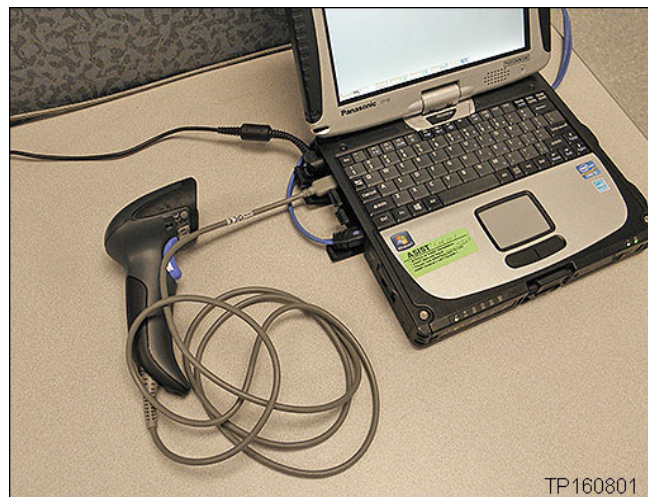
Figure 2

2. Attach the quick scan tool (J-52352) to your CONSULT PC USB port.

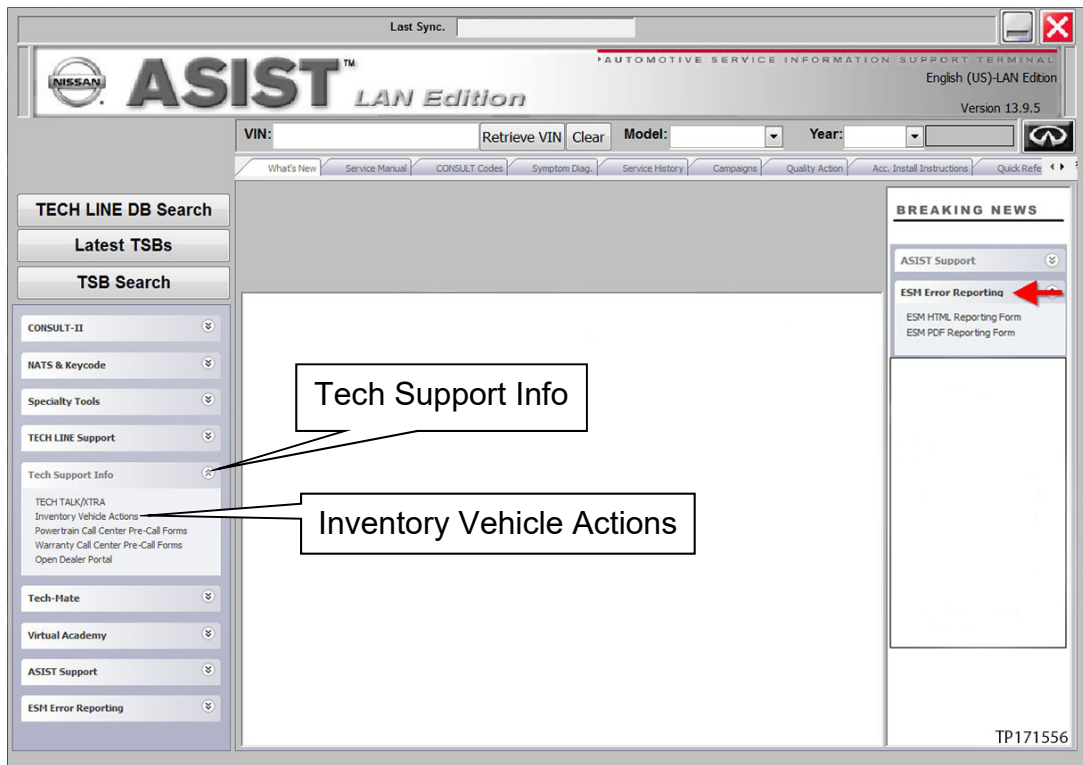
Figure 3

3. On the left side of the ASIST main menu, select **Tech Support Info**, and then **Inventory Vehicle Actions**.

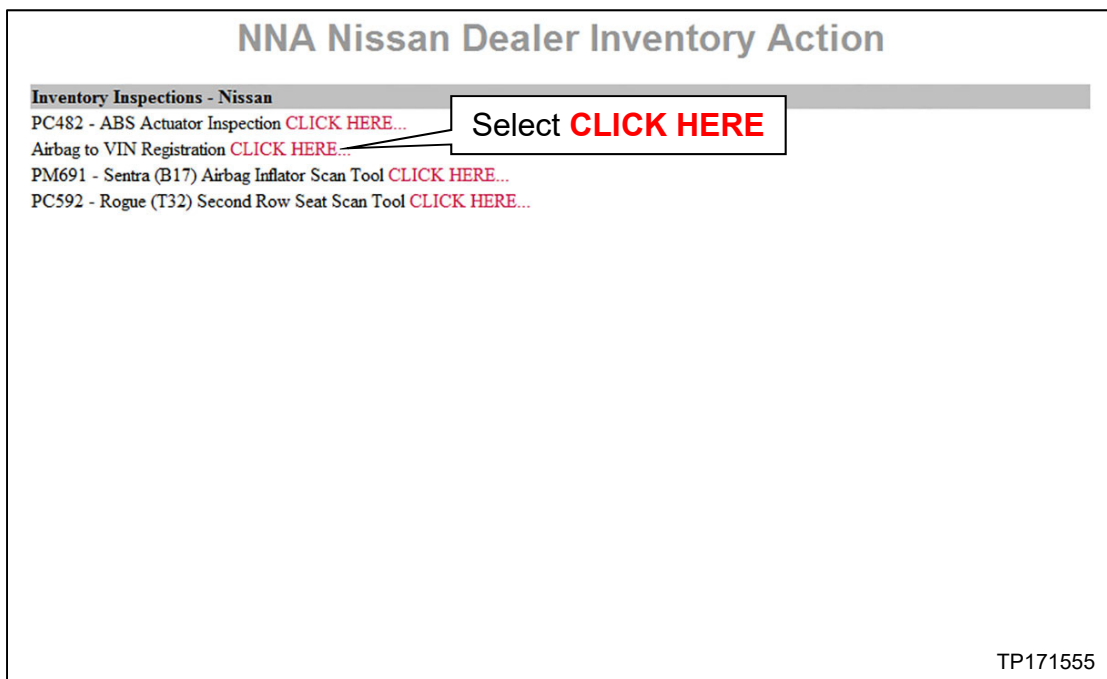
Figure 4

4. Select **CLICK HERE** ("Airbag to VIN Registration").

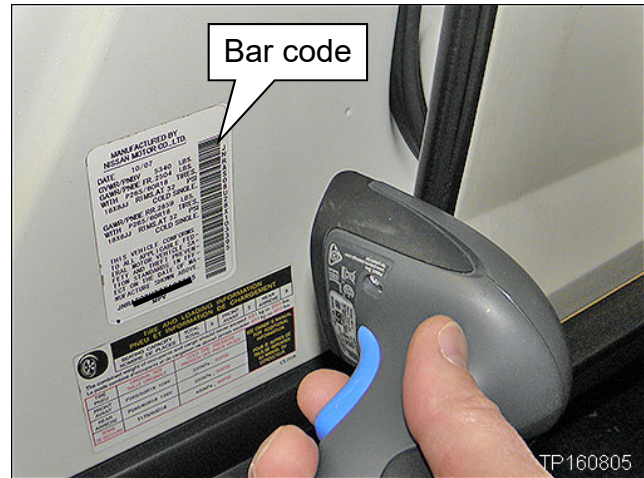
Figure 5

5. Use the quick scan tool to scan the VIN bar code on the B-pillar label.

- Wipe off any dirt/debris on the bar code before scanning.

- Some labels may not scan quickly.
- Hold the scan tool approximately 6 inches away from the label.
- Hold the trigger down until the label is read (this may take several seconds).

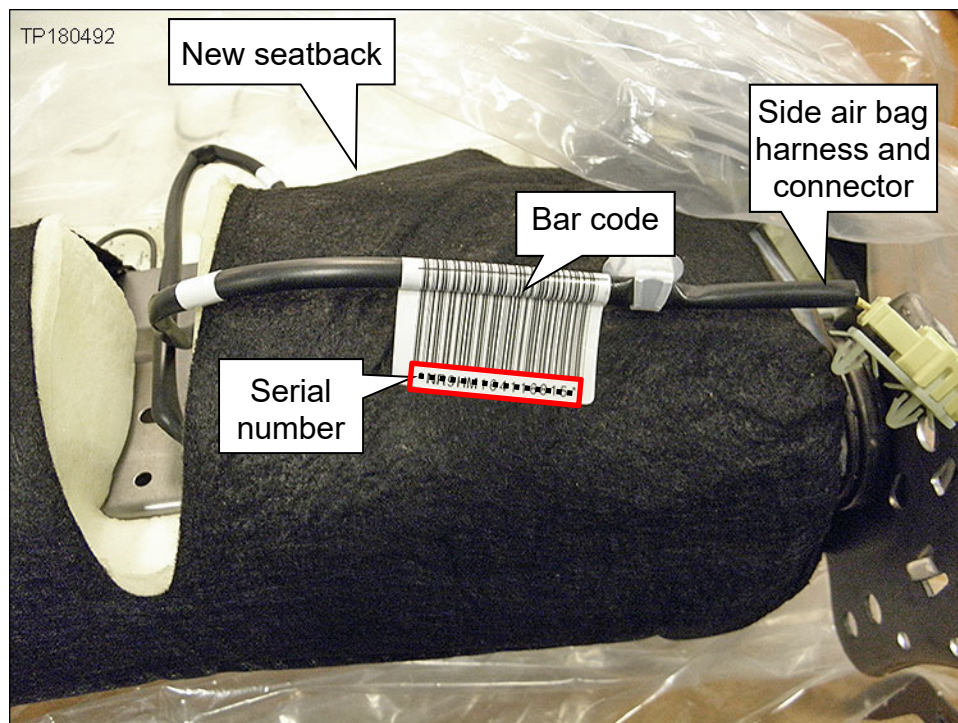
Figure 7

6. Use the quick scan tool to scan the bar code (serial number) of the new module.
 - Access the bar code label on the module harness (see Figure 7).
 - Hold the scan tool approximately 6 inches away from the bar code label.
 - The serial number will automatically populate (see Figure 6 on the previous page).

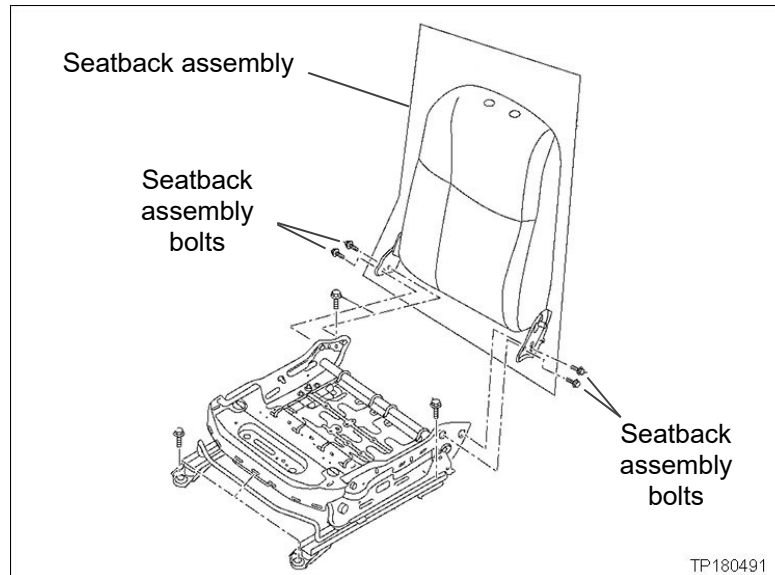
Figure 8

- Seatback assembly bolts torque: 55 N•m (5.6 kg-m, **41 ft lbs**)

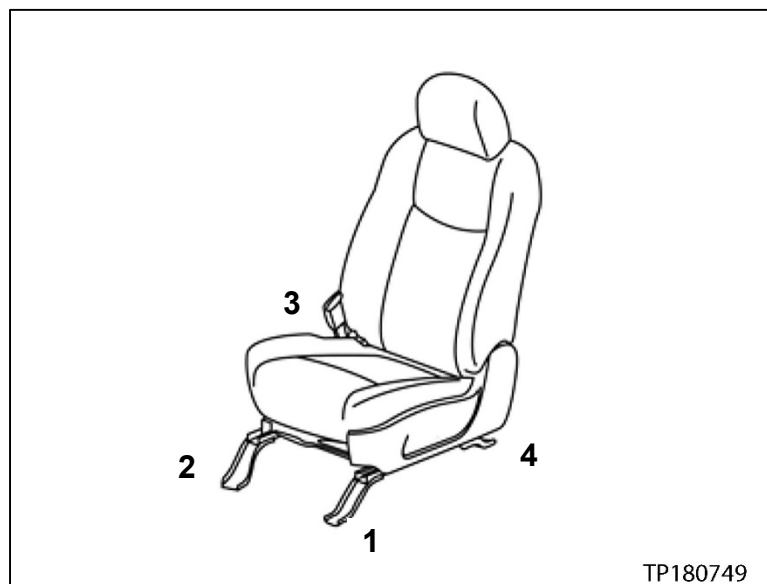
Figure 9

- Front passenger seat bolts torque: 49 N•m (5.0 kg-m, **36 ft lbs**)
 - Torque the bolts in the sequence shown in Figure 9.
