# SERVICE BULLETIN

EL18-032

## 2018 TITAN; IPDM E/R SERVICE INFORMATION

**APPLIED VEHICLES:** 2018 Titan (A61)

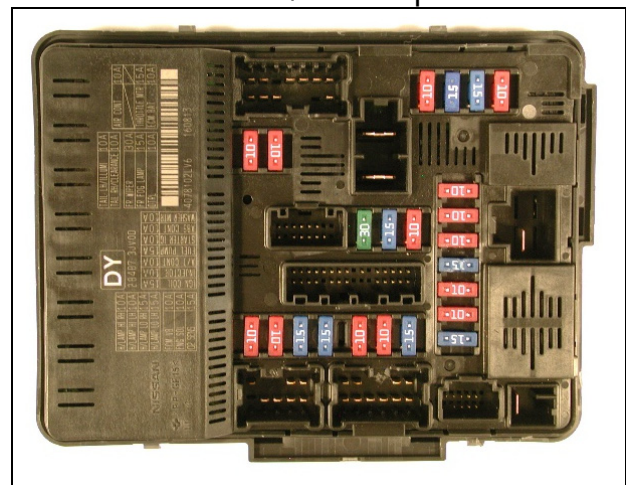
Figure 1

IPDM E/R Example

When diagnosing an electrical issue that involves the IPDM E/R, make sure to:

- Check for blown fuses in the IPDM E/R.
- Replace any blown fuses and recheck the issue.

- Do not replace an IPDM E/R if replacement of a fuse will resolve the issue.
- Part numbers for IPDM E/R fuses are listed in the Parts Information on the next page.
