Preliminary Information

PIP5395E Ticking Rattle Or Buzz Noise Heard The Best In The Passenger Compartment

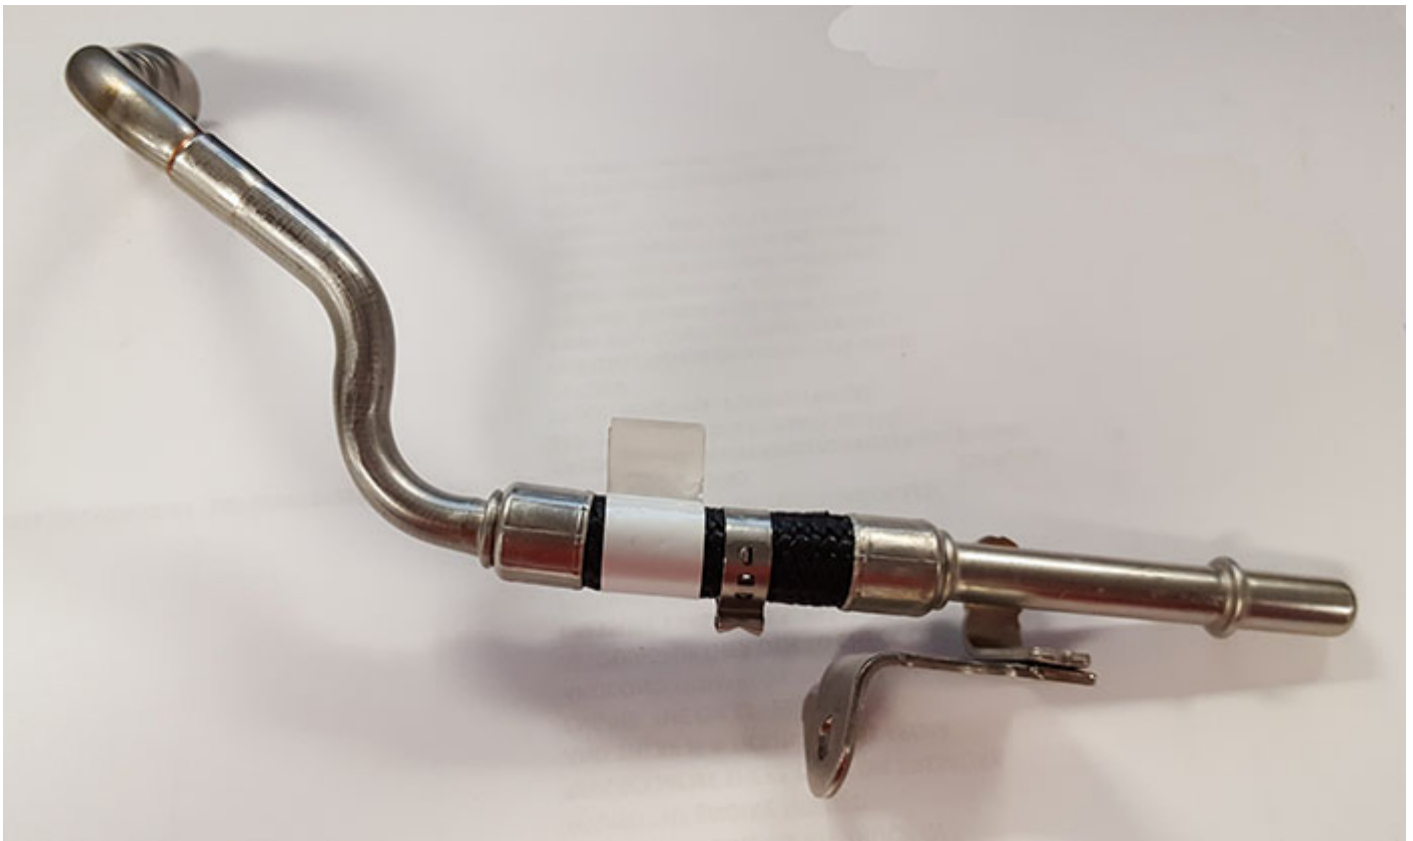
**The line above is the fuel feed pipe for Corvette, truck and SUV.
This line connects the chassis fuel line to the high pressure fuel pump.**

**Listen to the fuel line connection at the left side of the engine.
If the noise is heard best at the fuel line (this sound will be real loud with a stethoscope).
The fuel feed line between the high pressure fuel pump and chassis fuel line could be the cause allowing high pressure pulsation back to the low side of the fuel system. There is not a good way to test the check valve, the line will need to be replaced.**

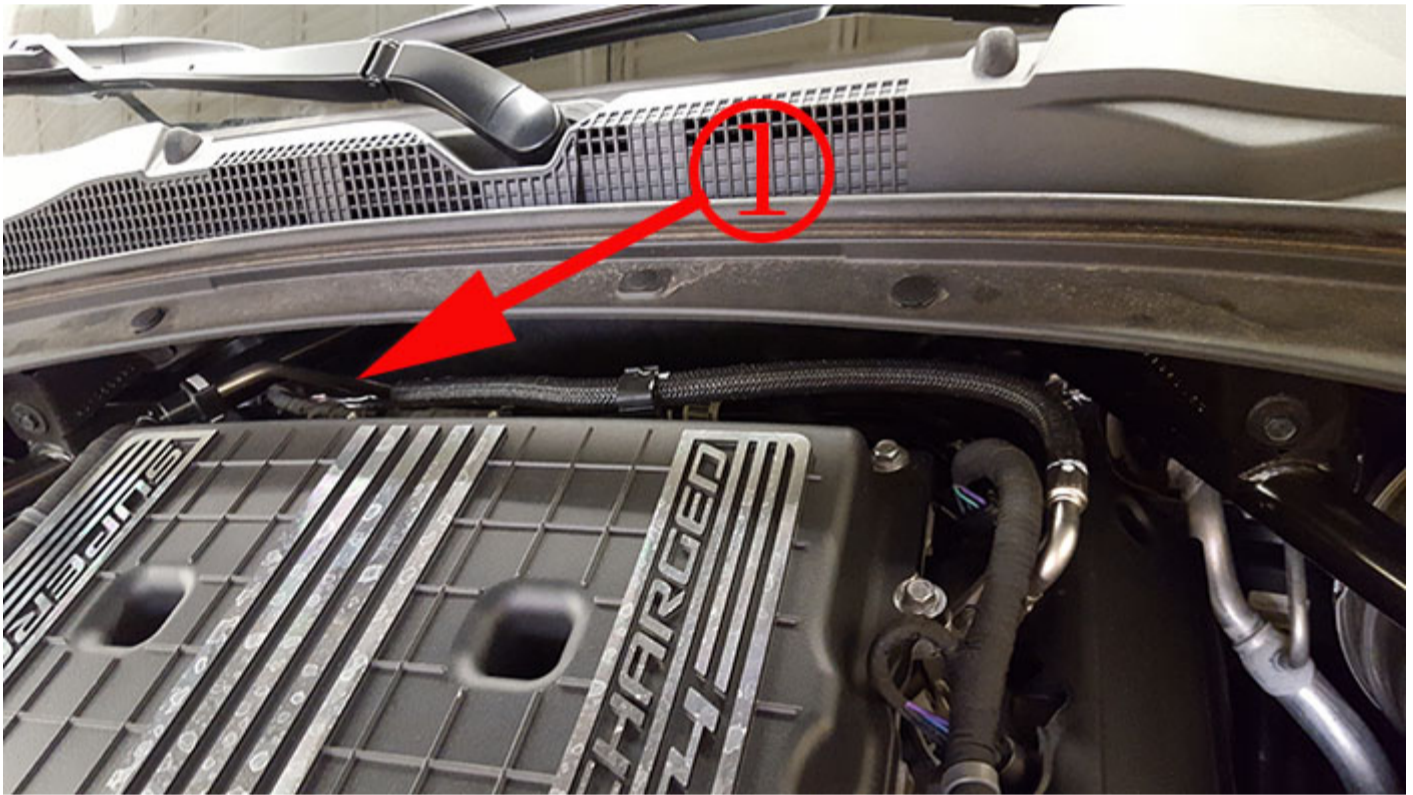
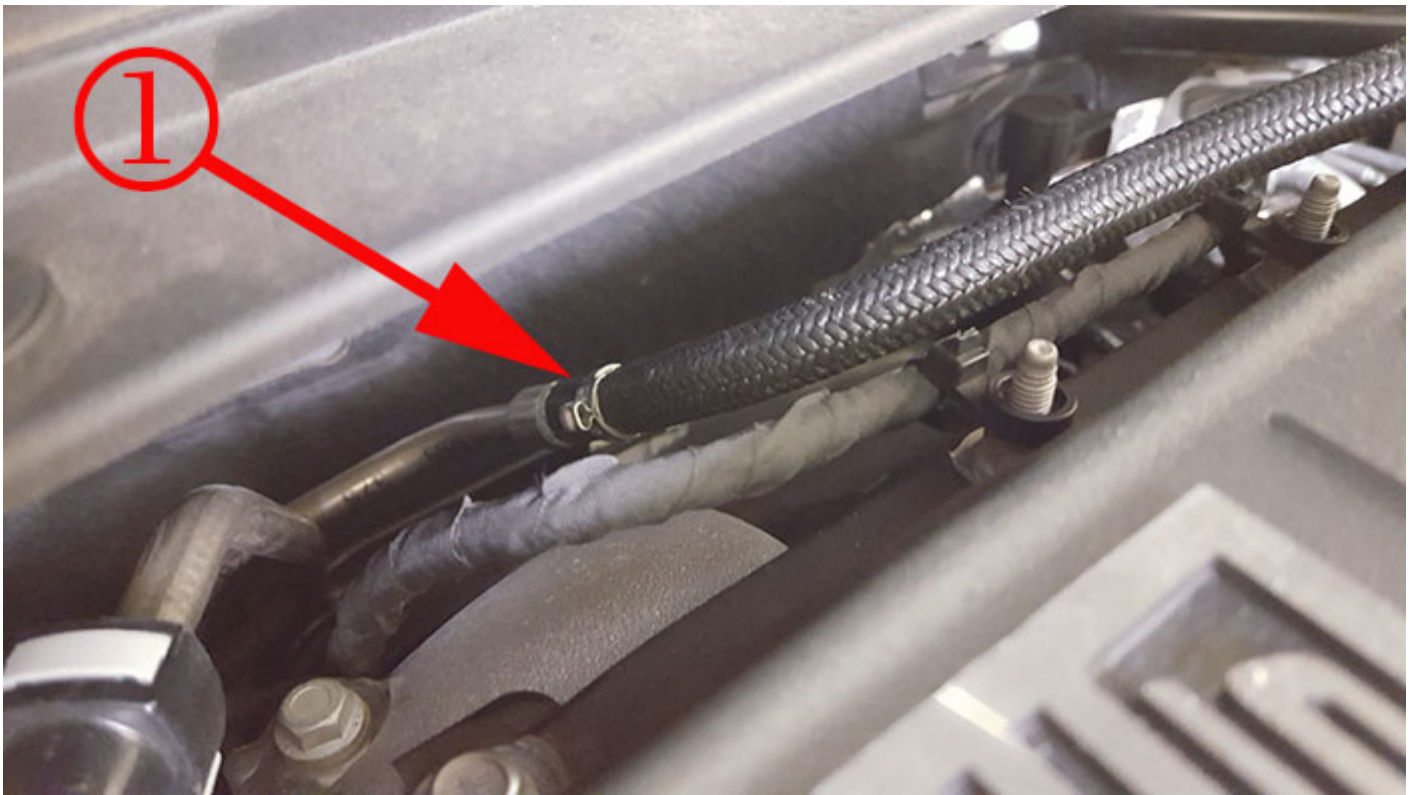
These pictures above shows the chassis fuel feed pipe for the LT4 supercharged ZL1 Camaro.

On LT1 Camaro and LT4 CTS-V this line would have a jumper line with quick disconnects at both ends.

One end will connect to the chassis line and the other to the high pressure pump feed line.
