Technical Tip

Topic	17-18-01TT - DTC P168C Oil Pressure Switch 3 Implausible Signal during Engine Operation Stored in the Engine/Motor Control Module -J623- After Oil Filter Housing Replacement
Market area	United States 444 Volkswagen of America, Inc. (6444)
Brand	Volkswagen
Date	October 12, 2018

DTC P168C Oil Pressure Switch 3 Implausible Signal during Engine Operation Stored in the Engine/Motor Control Module -J623- After Oil Filter Housing Replacement

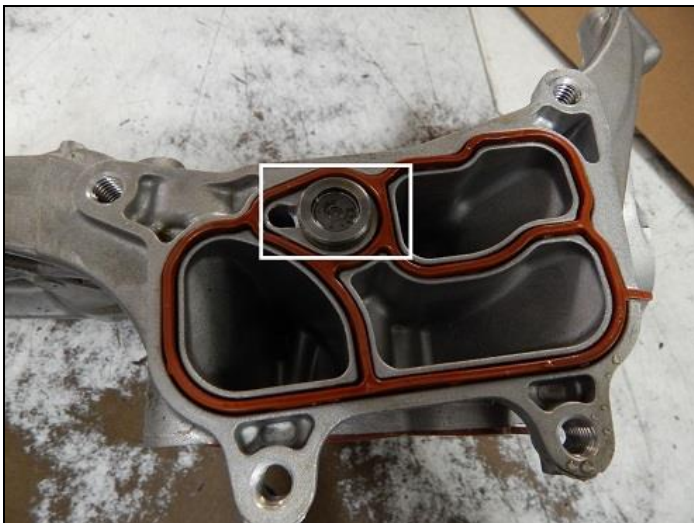
Figure 1

A new oil filter housing does not come with the oil control mechanical valve. Replacement of the housing without this valve will generate fault P168C.

Inspect the old filter housing and if present, install the mechanical valve into the new housing.
