Technical Tip

Topic	66-18-02TT – Passenger Outside Rear View Mirror Does Not Auto Down with Transmission Gear Selector in Reverse		
Market area	United States 444 Volkswagen of America, Inc. (6444)		
Brand	Volkswagen		
Date	October 12, 2018

Passenger Outside Rear View Mirror Does Not Auto Down with Transmission Gear Selector in Reverse

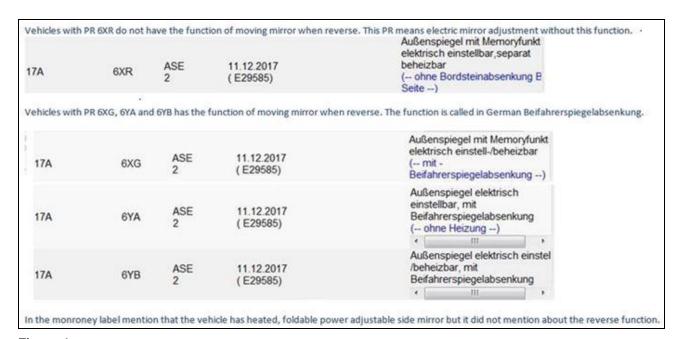
Figure 1

Refer to PR codes to check if PR code **6XG** is present. If 6XG is not present, the vehicle does not have the auto down feature and is operating normally.

Even with memory function, the vehicle may not have the auto down function. If 6XG is present and the feature does not work, refer to the owner's manual for procedure to set the positions.
