# Technical Bulletin

**92 18 01** October 8, 2018 **2026253** Supersedes Technical Bulletin 91-17-01 (V921701) dated March 13, 2017 to include additional model and model year applicability.

### Windshield Wipers Do Not Clean Properly or Noisy During Operation (U.S. Only)

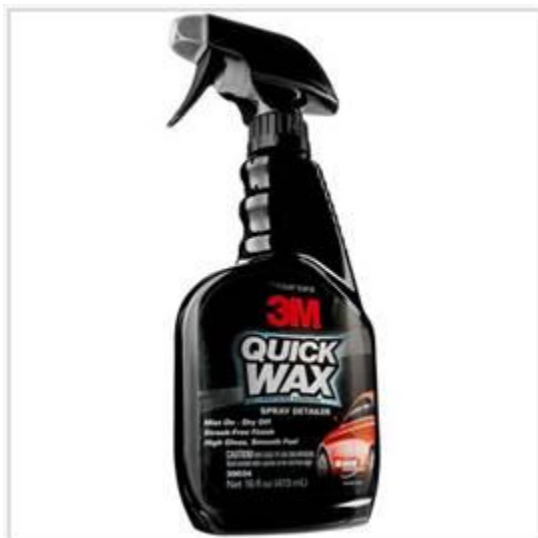
With vehicle exterior (including all glass surfaces) washed and dried and the wiper arms placed in the service position, perform the following:

- Apply 3M™ Quick Wax Part No. 39034 to the windshield or rear glass.

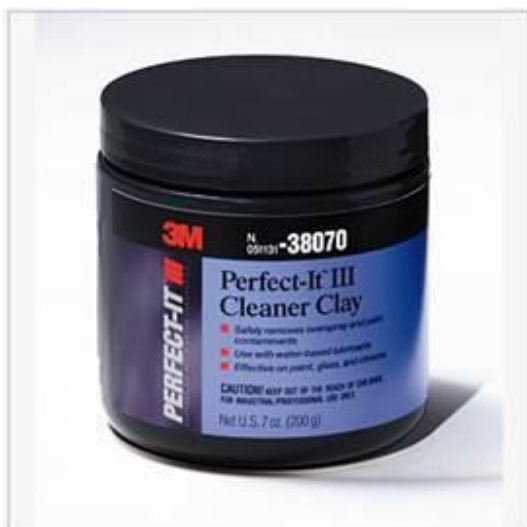
Using 1/3 of a bar 3M™ Perfect-It™ III Cleaner Clay Part No. 38070:

- Flatten clay into a small palm size pancake.
- With clay flat between windshield and your hand, rub windshield (with light friction) using a vertical motion (up/down) across windshield.

Ensure glass stays moist with Quick Wax. The 3M™ Perfect-It™ III Cleaner Clay can be flipped over when dirty and can be reused several times by kneading the clay.
