Whine Noise From Rear of Vehicle

Service Category Drivetrain

Section Axle/Differential

YEAR(S)	MODEL(S)	ADDITIONAL INFORMATION
2016 - 2018	Tacoma	Body Type(s): D CAB

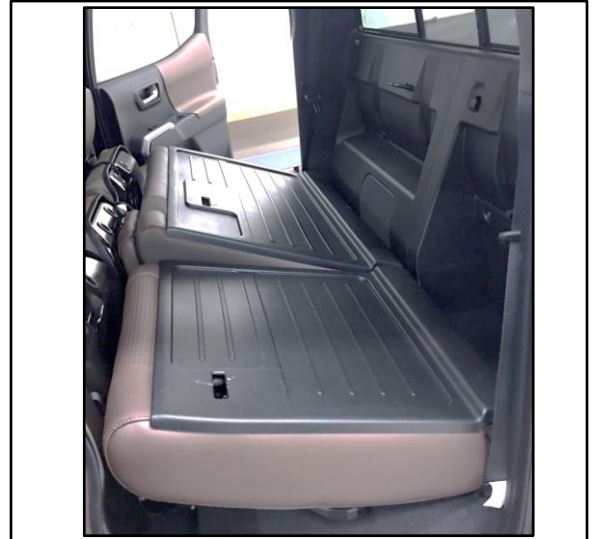
Figure 1.

2. Install the No. 5 pillar pad to the C pillar.
 - A. Fold down the seat and seat back for adequate space during the repair.

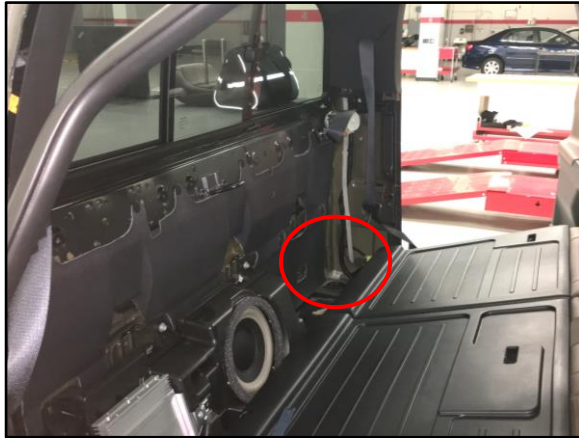
Figure 2. Installation Area

- D. Install the No. 5 pillar pad on the bottom of the C pillar to the RH and LH sides.

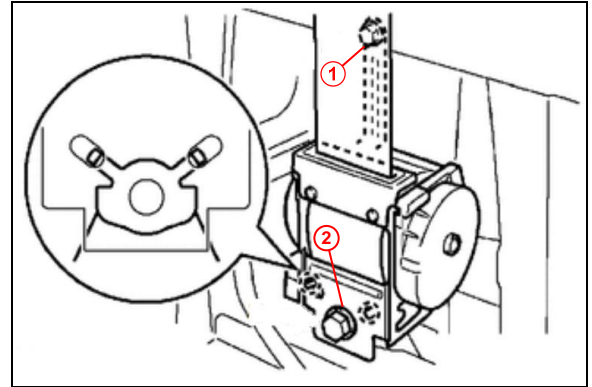
Figure 4.

F. Torque the seat belt bolts.

Bolt A

Torque: 12.5 N*m (127 kgf*cm, 9 ft*lbf)

Bolt B

Torque: 42 N*m (428 kgf*cm, 31 ft*lbf)

1	Bolt A
2	Bolt B

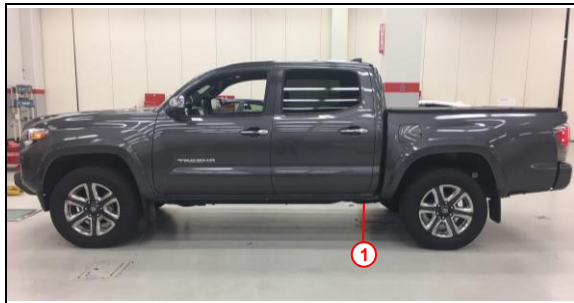
Figure 5.

A. Remove the No. 3 nut cab mount (17 mm) and LH and RH cab mounting cushion stopper.

1	No. 3 Cab Mount
----------	------------------------

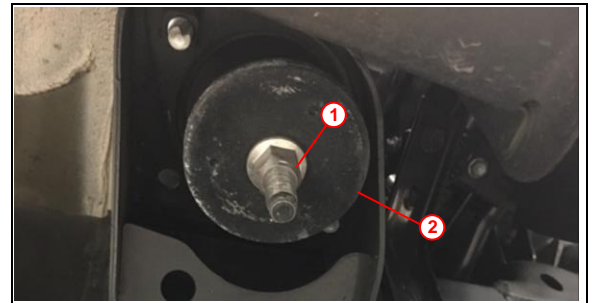
Figure 6.

1	No. 3 Nut Cab Mount
2	Cab Mounting Cushion Stopper

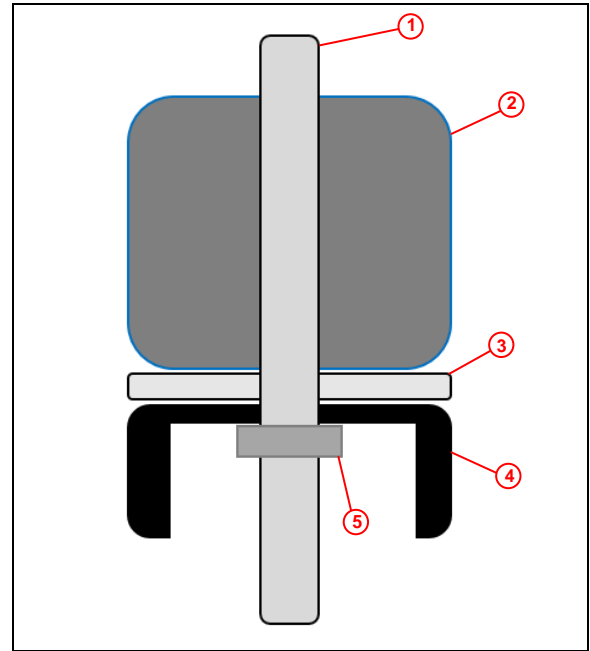
Figure 7.

- B. Install the NEW cab mounting cushion stopper and the NEW frame dynamic damper to the RH and LH cab mount.
- C. Retighten the cab mount nut.
Torque: 45 N*m (459 kgf*cm, 33 ft*lbf)

1	Body Mounting Bolt
2	No. 3 Cushion Sub-assy Cab Mounting
3	Cab Mounting Cushion Stopper
4	Frame Dynamic Damper
5	Lock Nut
