DISPLAY KEY IS NON-FUNCTIONAL

This Service Information bulletin replaces SI B66 20 17 **dated November 2017**

DISPLAYKEY BATTERY RESET/EXCHANGE

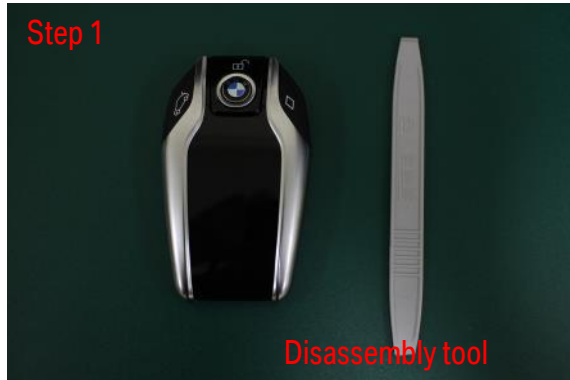
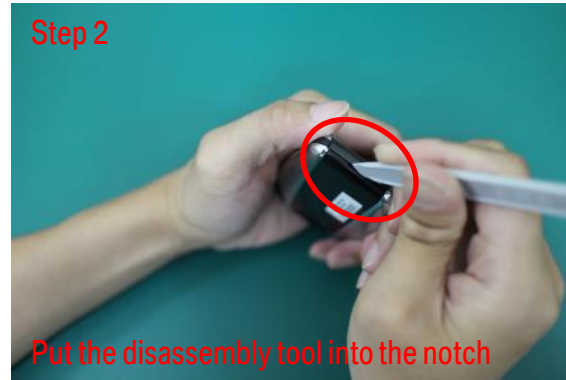
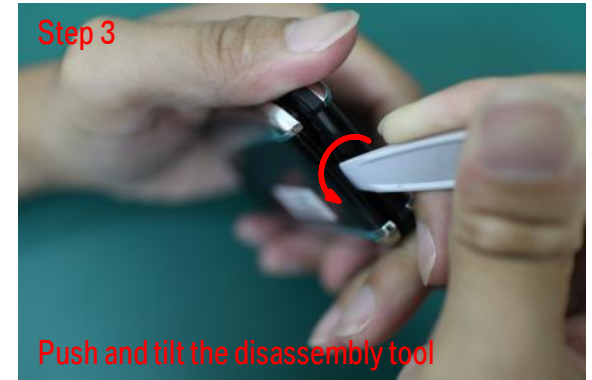
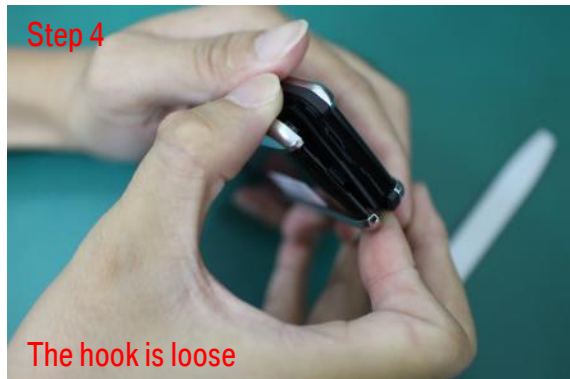
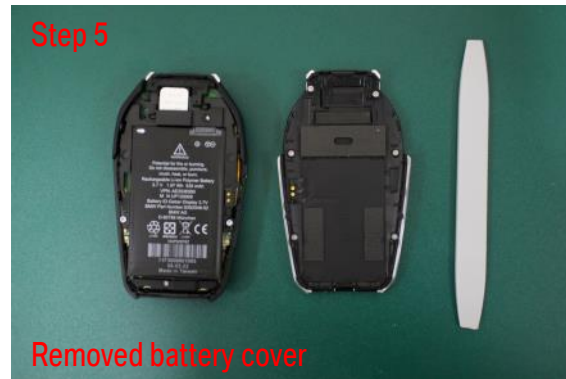
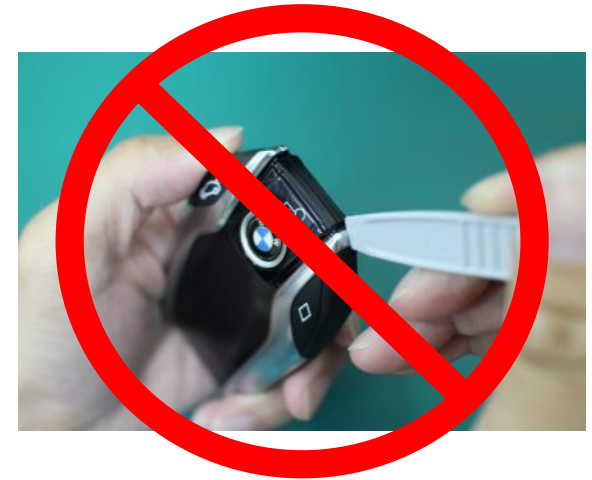
How to remove the battery cover?

DO NOT disassemble battery cover from top side.

3. Remove the battery from the display key (as per instructions in attachment) and then reinsert the battery.

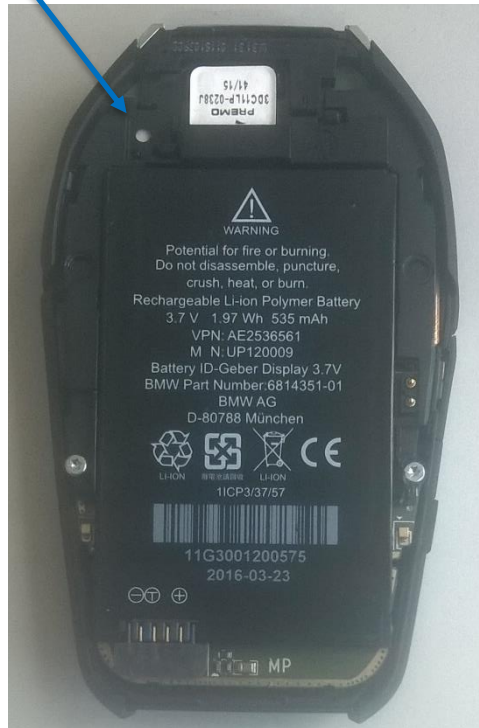
white color: no water ingress

4. Examine the moisture indicator above the battery (as per instructions in attachment).

NO – if the indicator is still white, the display key warranty has not been voided by excess moisture exposure. Go to next step.

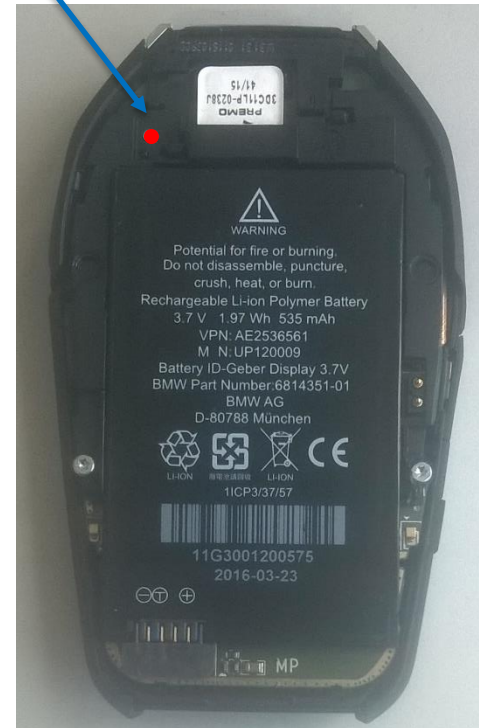
red color: water was in the key!

YES- - the display key has been subjected to excess moisture and is NOT replaceable under warranty.

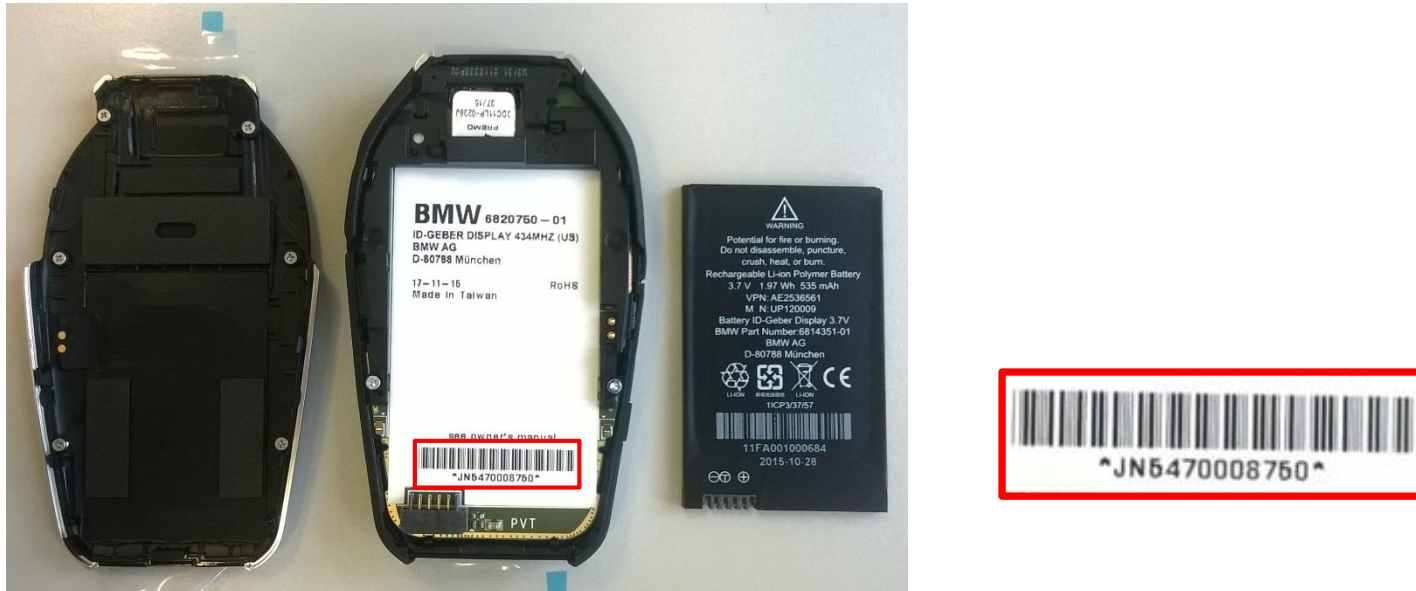
Serial-No on inside label below the battery:
