Service Update

18319 Front Brake Caliper Cotter Pin Missing

Reference Number: N182185420

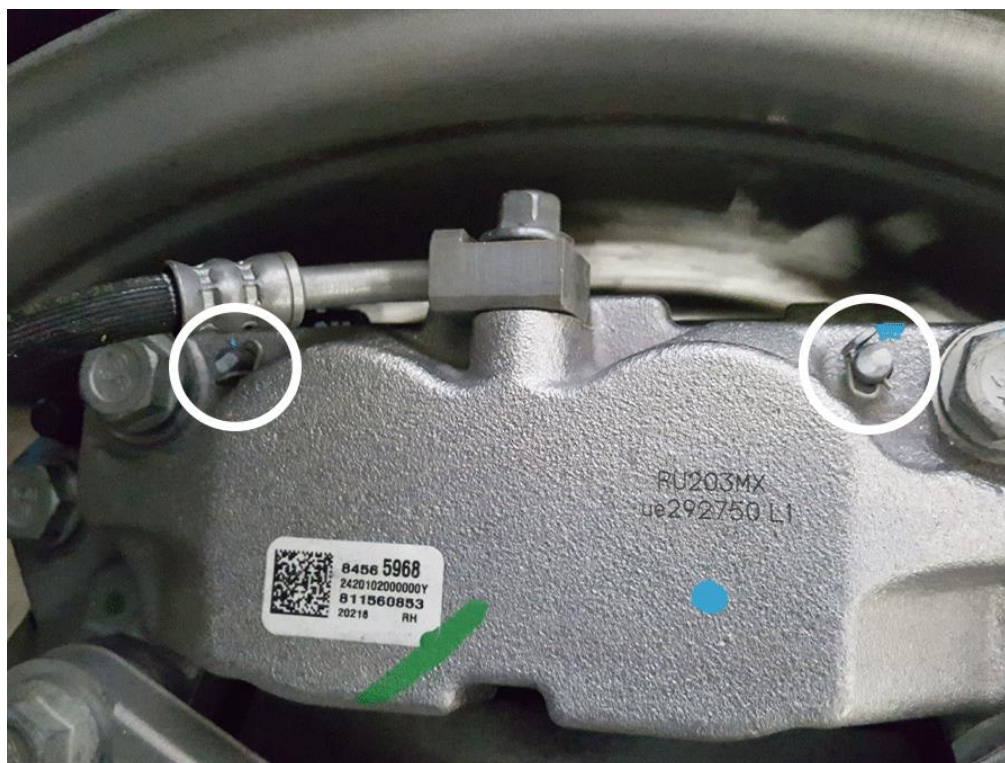
5150845

Condition	Certain 2019 model year Chevrolet Silverado and GMC Sierra vehicles may have the cotter key clip retainer missing from the front brake pad guide pin.
Correction	Inspect front calipers and install the cotter pin if necessary.

2. Inspect both front brake calipers to be sure there are cotter pins securing the brake caliper guide pins as shown.
 - If the cotter pins are installed (one on each guide pin, two per caliper), no further action is required.

Note: If replacing a missing cotter pin, it is not necessary to replace the entire brake caliper guide pin, only the cotter pin. The part number listed is for the entire guide pin and cotter pin because they are serviced as an assembly – we are only using the cotter pin from that assembly.

- If any of the cotter pins are missing, install a new cotter pin.
3. Lower the vehicle. Refer to *Lifting and Jacking the Vehicle* in SI.
