ATU (Audi Technical Update)

Summer 2018

Audi Premium Air Quality in the Audi A8

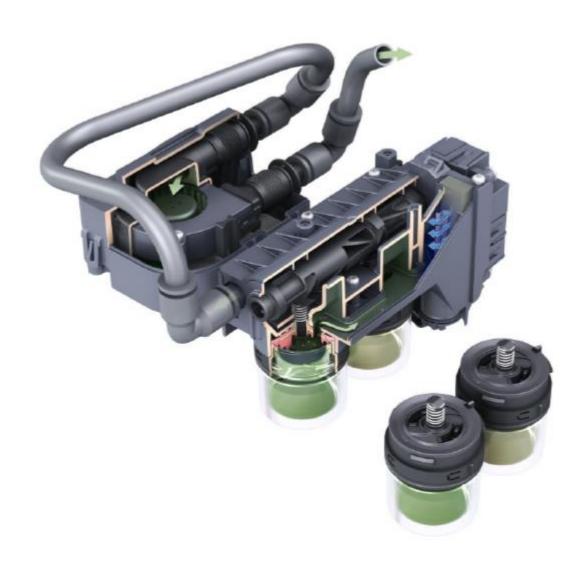
4.1 Component overview

- > Blower and vial unit (supplier: Mahle); hose (Schlemmer).
- > LIN component; terminal 30 participant (2 minute run-on).
- One vial of each scent: winter (Cool Blue) and summer (Acqua Summer) –
 Robertet, Grasse.
- > Operation via HMI; four intensity levels (subtle, low, medium, and strong).
- > Active substances were checked for safety and approved.
- Consumption: stage 4; operation: approximately 50 h; display is reduced by 1% (series).
- > Difficult to characterize the fragrances, as they are a matter of subjective perception.
- > Recommendation: "subtle" or "low" setting for a feeling of freshness (owner's manual).

- > Both vials should be replaced every two years as part of vehicle inspection service.
- > Storage compartment on driver side must be removed/fitted.
- > Replace regardless of consumption.

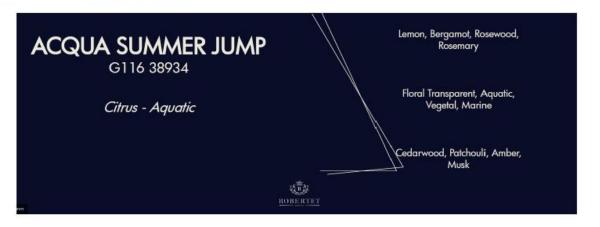
Components of the summer fragrance

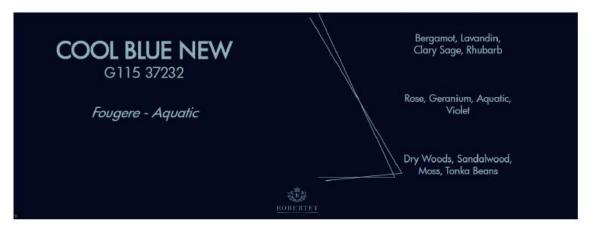
Components of the winter fragrance

Technical features of aroma unit – AAU (Audi aroma unit):
