# Emissions Service Action

## Code: 26K2

<b>Subject</b>	<b>Reductive Agent Heating Element (AdBlue Heater)</b>
<b>Please Note:</b>	<b>This action is fully independent of the approved emissions modification recall on TDI vehicles. For owner convenience, this action can be performed at the same time as other service work, but can also be done independent of the diesel modification. Owners do not need to receive the diesel modification in order to receive this repair.</b>
<b>Release Date</b>	July 27, 2018
<b>Affected Vehicles</b>	<b>U.S.A. &amp; CANADA: 2009-2016 MY Volkswagen Touareg with TDI (diesel) engine</b> <i>Check Campaigns/Actions screen in Elsa on the day of repair to verify that a VIN qualifies for repair under this action. Elsa is the <u>only</u> valid campaign inquiry &amp; verification source.</i> <ul style="list-style-type: none"><li>✓ Campaign status must show "open."</li><li>✓ If Elsa shows other open action(s), inform your customer so that the work can also be completed at the same time the vehicle is in the workshop for this campaign.</li></ul>

**Subject: Emissions Service Action 26K2 - Reductive Agent Heating Element (AdBlue Heater)  
2009-2016 Model Year Volksw

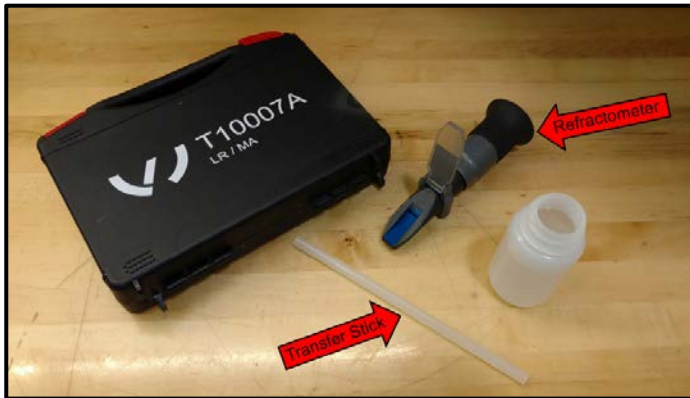
- Using the Transfer Stick -T10007A/1- from the -T10007A- Refractometer Kit, remove a sample of 1 or 2 drops of fluid from the Adblue tank and place the sample onto the reading glass of the -T10007A- Refractometer.
- Close the reading glass flap and view the sample reading through the ocular reticle.

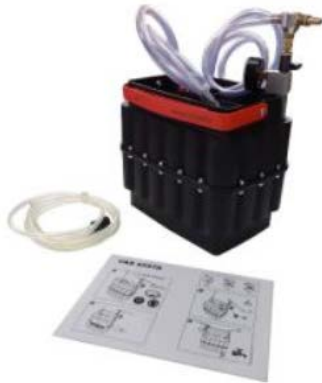
- If the refractometer test shows the AdBlue out of acceptable range, extract the AdBlue from the tank through the filler cap opening <1>.
- Follow the directions included with the -VAS6557A- (or equivalent) and drain the AdBlue fluid from the reducing agent tank.

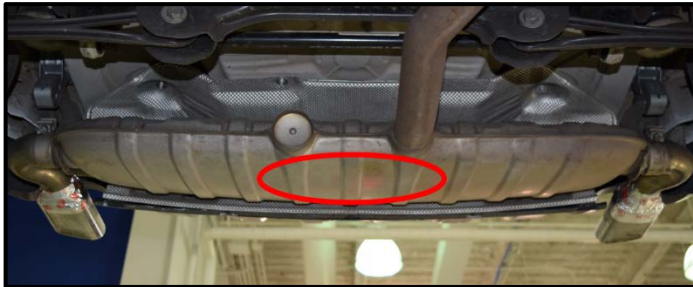
- Position the Engine and Gearbox Jack -VAS6931- (or equivalent) under the rear muffler at the <circle> location to support the rear muffler during removal.

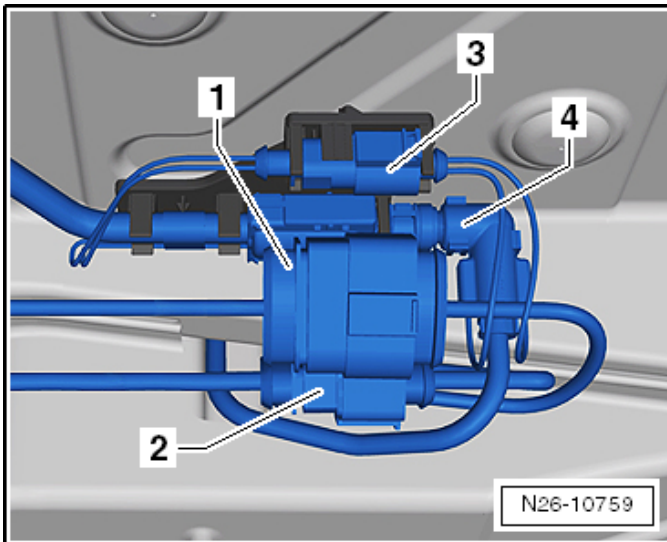
- Towards the left side of the AdBlue tank, remove the connectors <1 through 3> from the support bracket and disconnect the bulkhead connectors.
- Disconnect the AdBlue feed line <4>, noting the specifics in the next step.

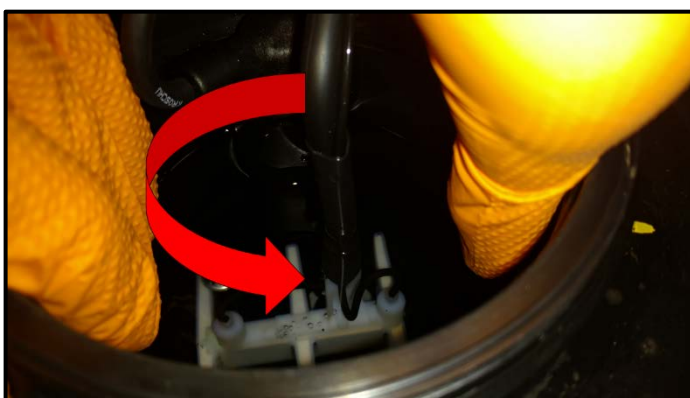
- Carefully reach into the delivery module chamber, grasp the delivery module and turn it counterclockwise <arrow> about 10 degrees to loosen it from its retainer. The delivery module will snap free from its mounting points.

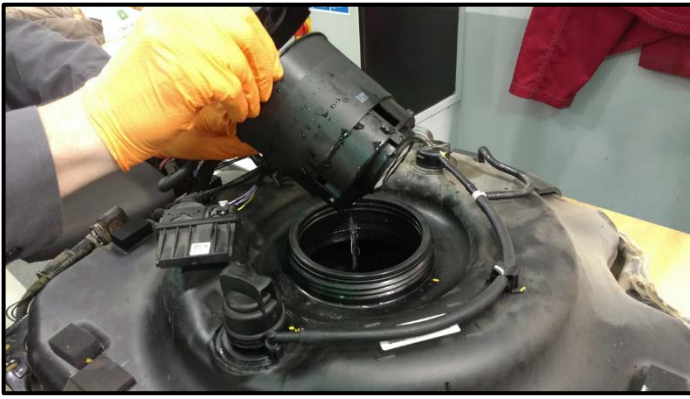
- Remove the delivery module upward from the reducing agent tank.
- Tip the delivery module and allow it to drain fully into the reducing agent tank opening before removing.
- Use a cloth to wipe up any spilled AdBlue from the top of the tank.

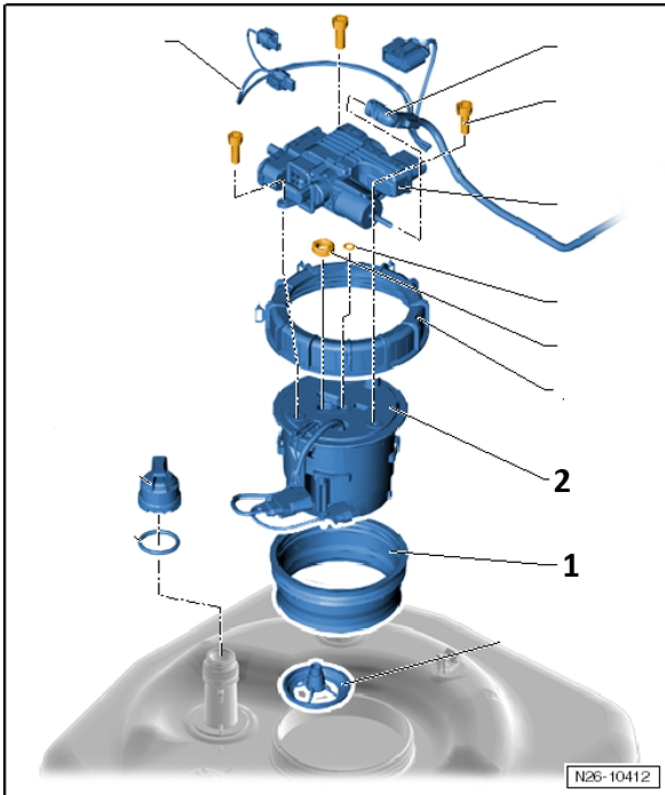
- Insert new delivery module/heating element into the reducing agent tank.
- Install new seal <1> into the reducing agent tank opening over the delivery module <2>.

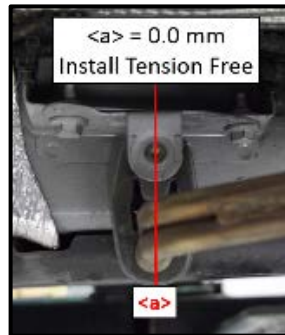
Figures <B and C>

Left and Right SCR hanging straps:  $\langle a \rangle = 0.00 \text{ mm}$ , install without tension.

If necessary, loosen the bolts at the left and right SCR Cat hanging straps <B and C> and adjust the brackets until  $\langle a \rangle = 0.00 \text{ mm}$ . The SCR Catalyst hanging straps are installed tension free.

- Tighten the two hanging strap bracket bolts <B> to 60 Nm.
- Tighten the two hanging strap bracket bolts <C> to 23 Nm.
