**SERVICE BULLETIN**

**APPLICABILITY:** 2017-2019MY Impreza  
 2018-2019MY Crosstrek

**NUMBER:** 10-89-18

**SUBJECT:** Center Vent Grille Assembly- Improper Fit / Gap

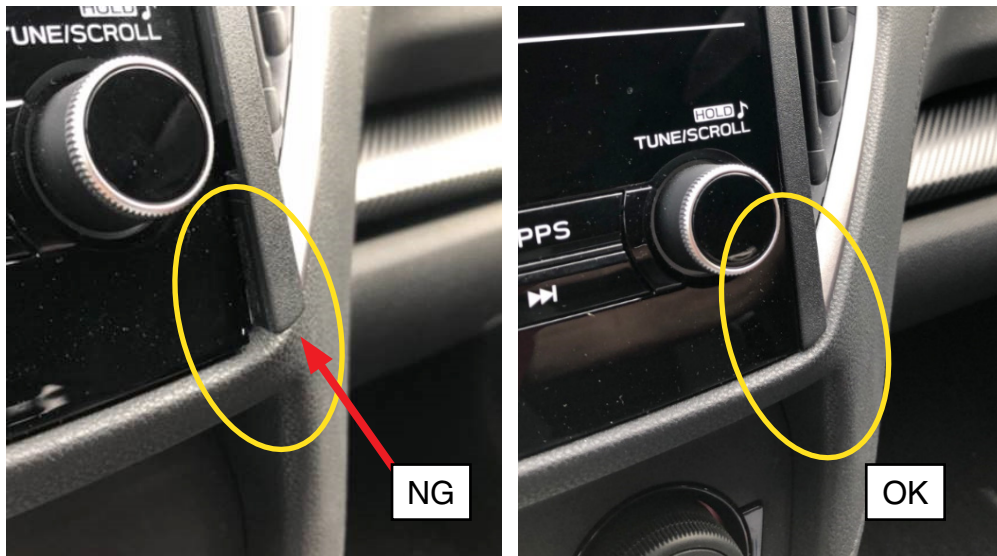
This bulletin provides a procedure and precautions to use when addressing a customer concern of an improper fit or gap condition of the center vent grille assembly as shown in the comparison photos below.

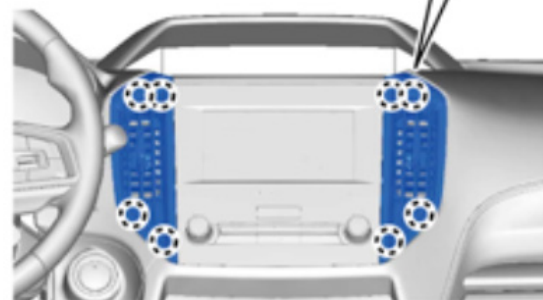
After removing the vent grille assembly, inspect the mounting tabs the claws clip onto closely for any damage. This photo shows a bent (and possibly cracked) tab. If any tabs are damaged and / or claws broken, the assembly must be replaced.
