**North America LLC      Customer Advisory Letter**

**Subject :** A/C hose routing clamping

**Models Affected:** P3 Cascadia

**8-6-2018**

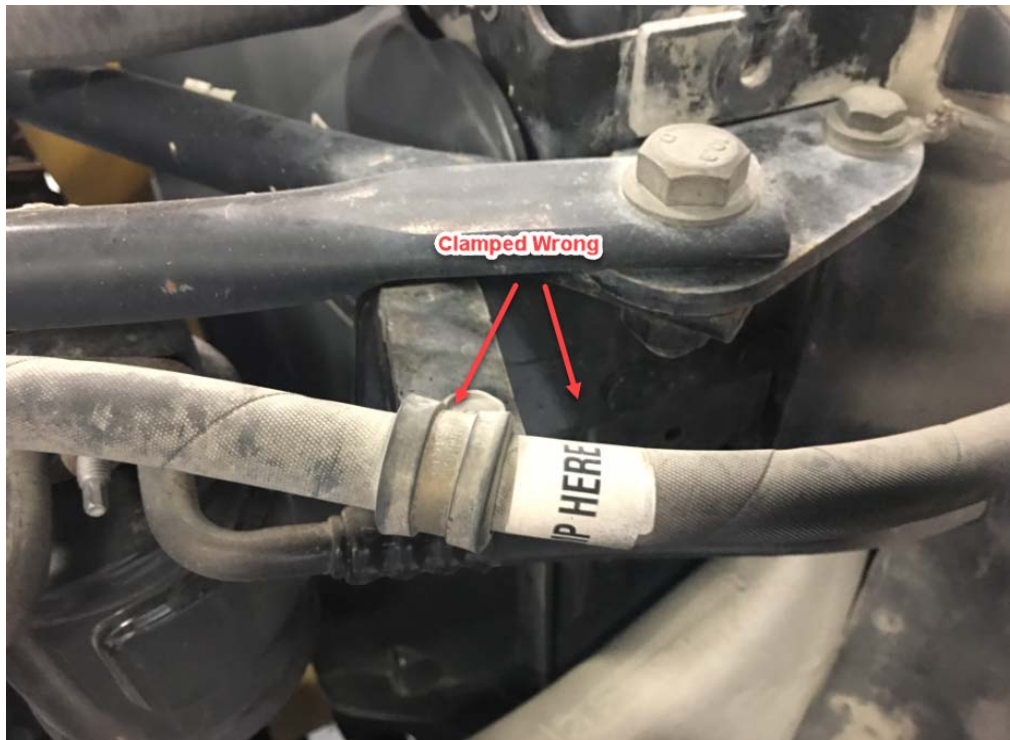
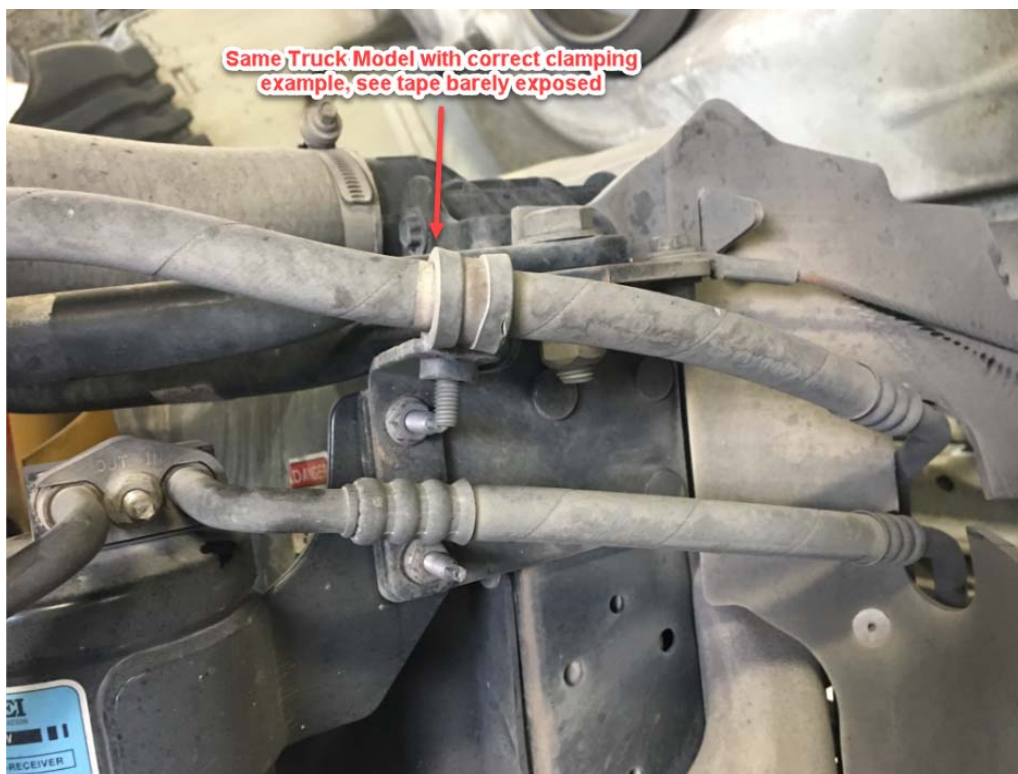
Discharge A/C hoses from the compressor to the condenser were not installed correctly. Hoses are tagged with tape with writing (Clamp Here) on the tape indicating where to position the P Clamp. With the P Clamp too far back, the hose is rotated forward causing the grille to contact and wear. These instructions are to move the hose and rotate the line at the condenser for proper installation.

Check the A/C line for proper installation, if the clamps are positioned over the tape marking the proper clamp location, no repair is required. If the clamp is not properly installed, loosen the P Clamp where the line will slide in the clamp, loosen the clamp securing the line at the condenser and rotate while moving the line in the P Clamp. Once the line is positioned in the P Clamp, re-secure the clamp at the condenser and then the P Clamp., Inspect to insure there are no leaks.
