FIELD SERVICE CAMPAIGN BULLETIN

Subject: **Field Service Campaign D18M4**
Remanufactured Detroit™ DT12™ Transmission

Detroit Diesel Corporation (DDC) has determined that some remanufactured Detroit™ DT12™ transmissions will need to be inspected, and have the rear range housing or transmission replaced.

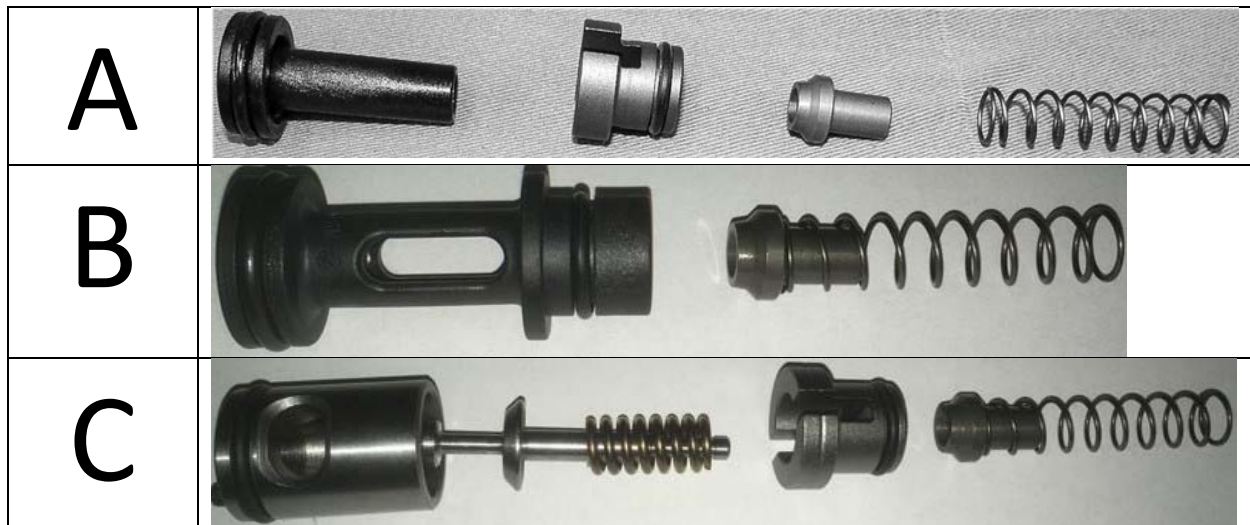
Figure 13 – Oil Pump Relief Valve

On oil-cooler-equipped transmissions, align the pressure relief valve locating dowel, with the hole on the cover. The correct pin location is approximately the 9 o'clock position

- 29. Apply Loctite 518 sealant to the oil pump cover mating surface.
- 30. Install the oil pump relief valve. See Figure 13 and Table 2.

A	Transmission Without An Oil Cooler (Previous Design)
B	Transmission Without An Oil Cooler (Current Design)
C	Transmission With An Oil Cooler
