North America LLC **Customer Advisory Letter**

**Subject :** Telematics Connections

**Models Affected:** All Cascadia and M2 Models built after 2016

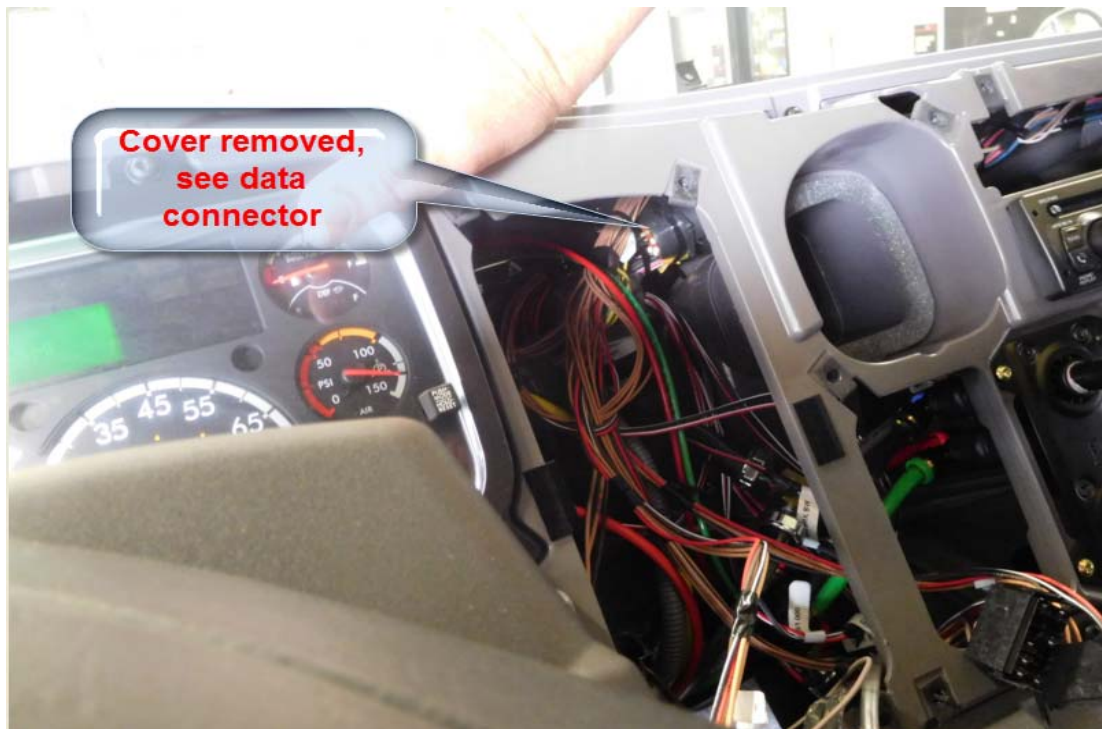
M2 9 Pin 250k connection can be seen above.

It has been found some telematics or devices are being connected into the Green or OBD (Onboard Diagnostics 500k baud) connector. The connector used by the telematics device manufacture maybe the green connectors but should not be connected here. All Ryder trucks have a black 250k baud connector inside the center of the dash that should be used.

**Follow these steps to check and correct;**

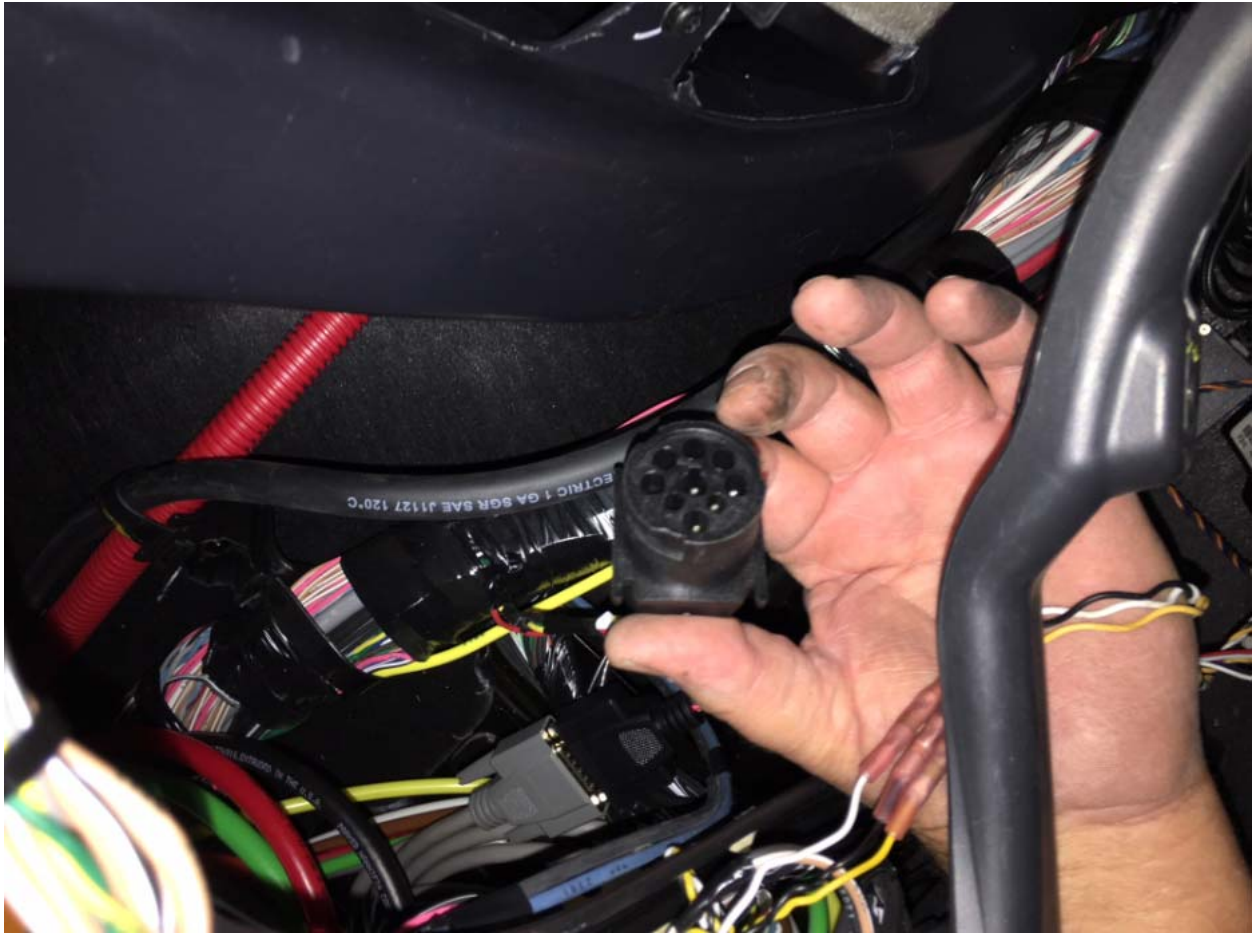
Both Cascadia models can be found in the center of the dash, New Cascadia is above.
