Field Service Campaign

October 2018
SF563A

Subject: TBB Minotour Driver Seats with Fireblock

Models Affected: Specific Thomas Built Buses Minotour vehicles manufactured June 21, 2010, through October 1, 2018.

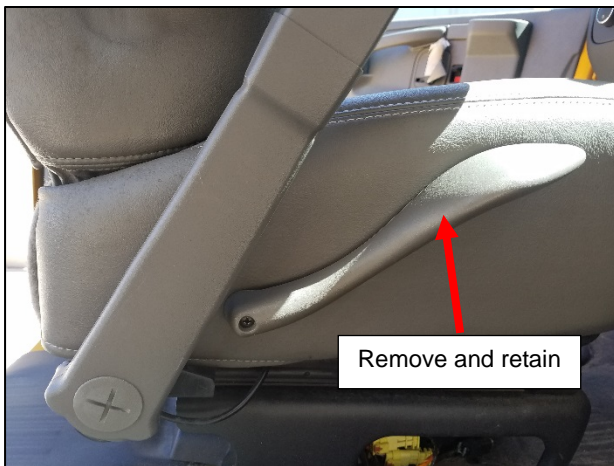
Figure 1: Recliner Lever

3. Using a Philips head screwdriver, remove the recliner lever shown in **Figure 1**. Retain the lever and screw.
4. Remove the OEM J-hook underneath the rear of the seat cushion and discard, see **Figure 2**.

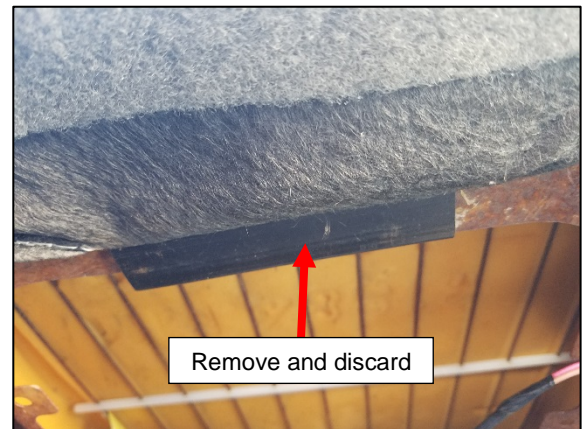
Figure 2: OEM J-hook Underneath the Rear Seat Cushion Cover

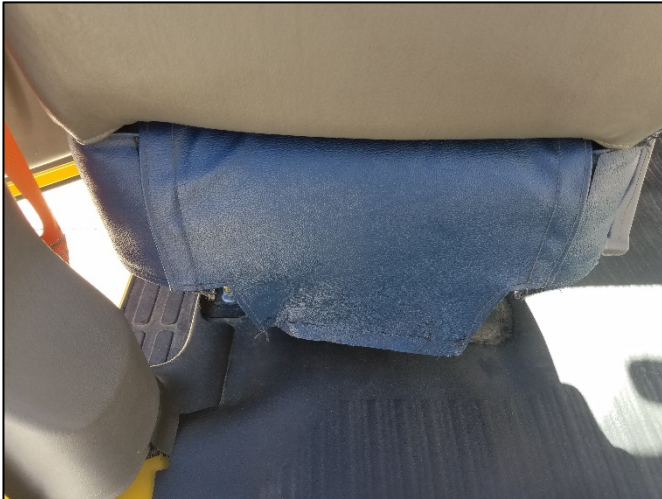
Figure 3: Flap Pulled Through Seat Cover and Seat Back then Attached with Velcro

5. Put the new seat cushion cover over the existing OEM cover and pull the back flap between the seat back and cushion. See **Figure 3**.
6. Velcro the sides of the cover and the flap tightly. See **Figure 3**.
7. Hook the rear J-hook in the original location (when removed in step 4).
8. Hook the front J-hook underneath the front seat frame, making sure it is as far as possible toward the rear between the seat adjustment bar and the seat cushion. See **Figure 4**.
9. Reinstall the recliner lever using the retained parts

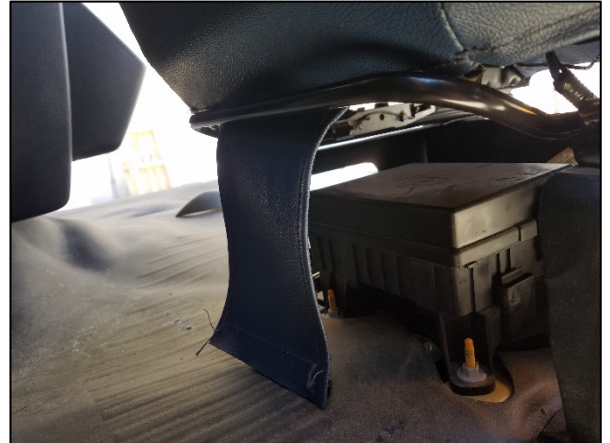
Figure 4: Flap Between Seat Adjustment Bar and Cushion

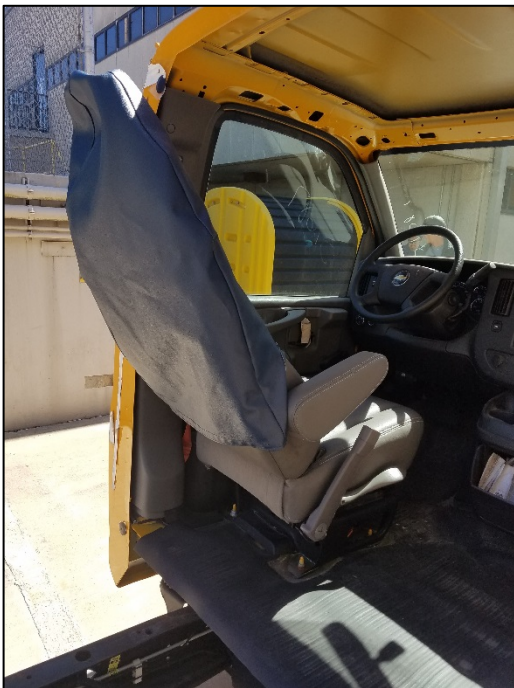
Figure 5: Seat Back Cover

10. Slip the cover over the seat back and pull down tightly. See **Figure 5**.
11. Slide the front flap under the seat back. See **Figure 6**.

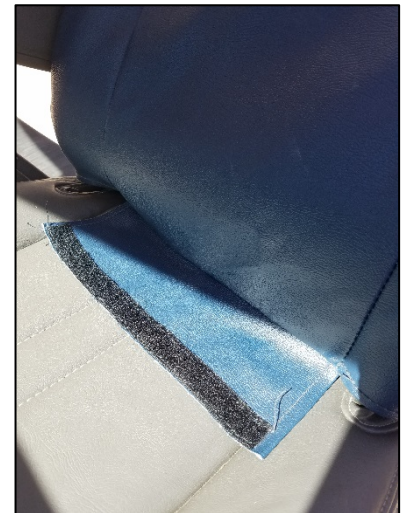
Figure 6: Seat Back Cover Flap Pulled Between the Seat and Cushion

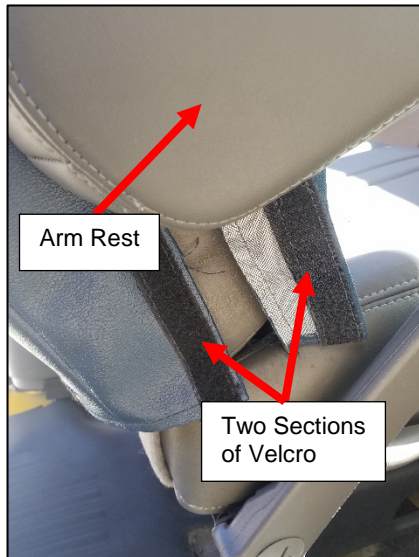
Figure 7: Connecting Two Pieces of the Cover Under the Armrest

12. Under the armrest, line up both parts of the seat cover and Velcro tightly. See **Figure 7**.
13. Velcro the part of the seat cover that was pushed between the back of the seat and the cushion to the back of seat. See **Figure 8**.

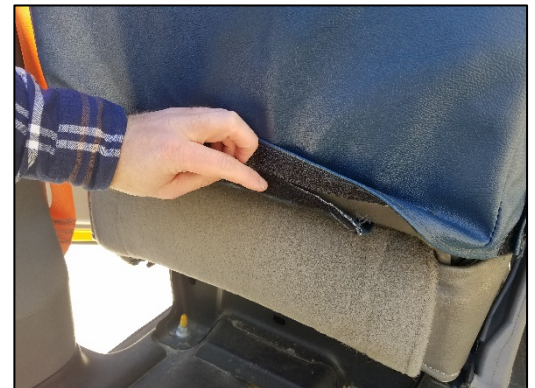
Figure 8: Velcro at the Back of the Seat

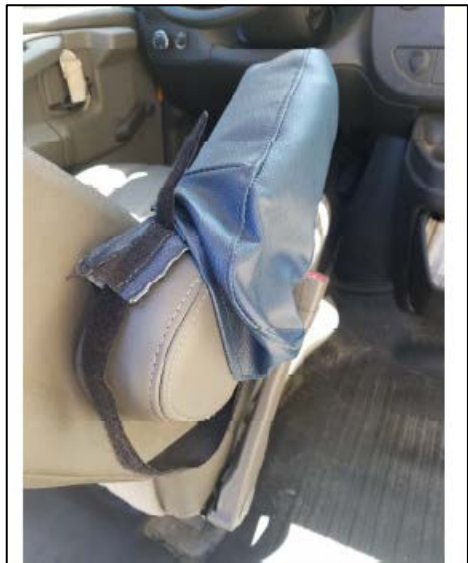
Figure 9: Armrest Cover

14. Place the armrest cover over the armrest. See **Figure 9**.
15. Wrap the Velcro around the back side of the armrest as shown in **Figure 10**.
16. Pull the Velcro tight as shown in **Figure 11**.
17. Tuck the Velcro between the seat back and rest. See **Figure 12**.

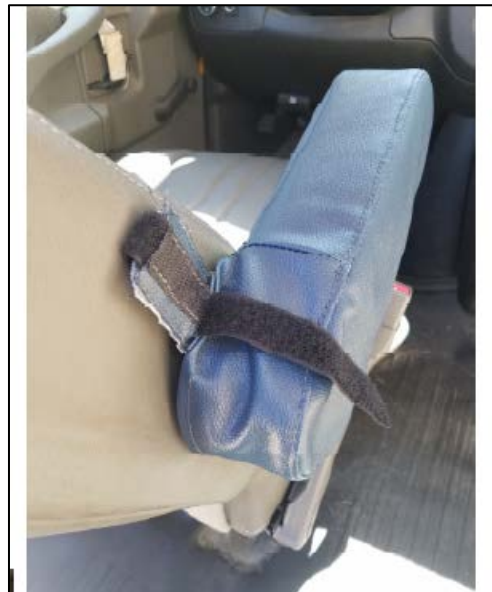
Figure 10: Wrap Velcro from Armrest Cover

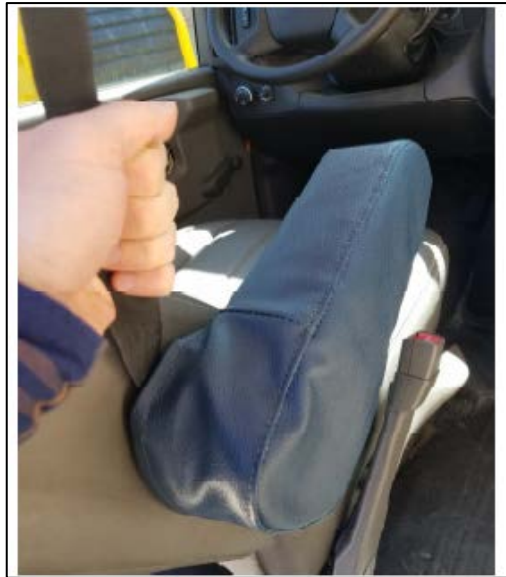
Figure 11: Pulling Velcro to Secure Cover

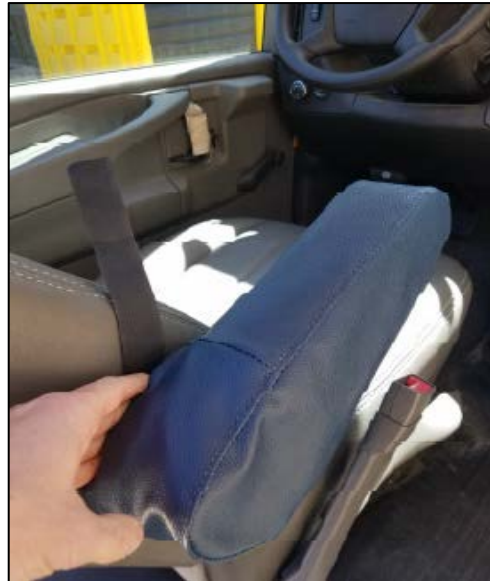
Figure 12: Tuck In the Velcro Strap
