Front seat belt does not roll up completely

| Topic number | LI91.40-P-068490 |
| Function group | 91.40 Seat belts, emergency tensioning retractors |
| Validity | C205 |

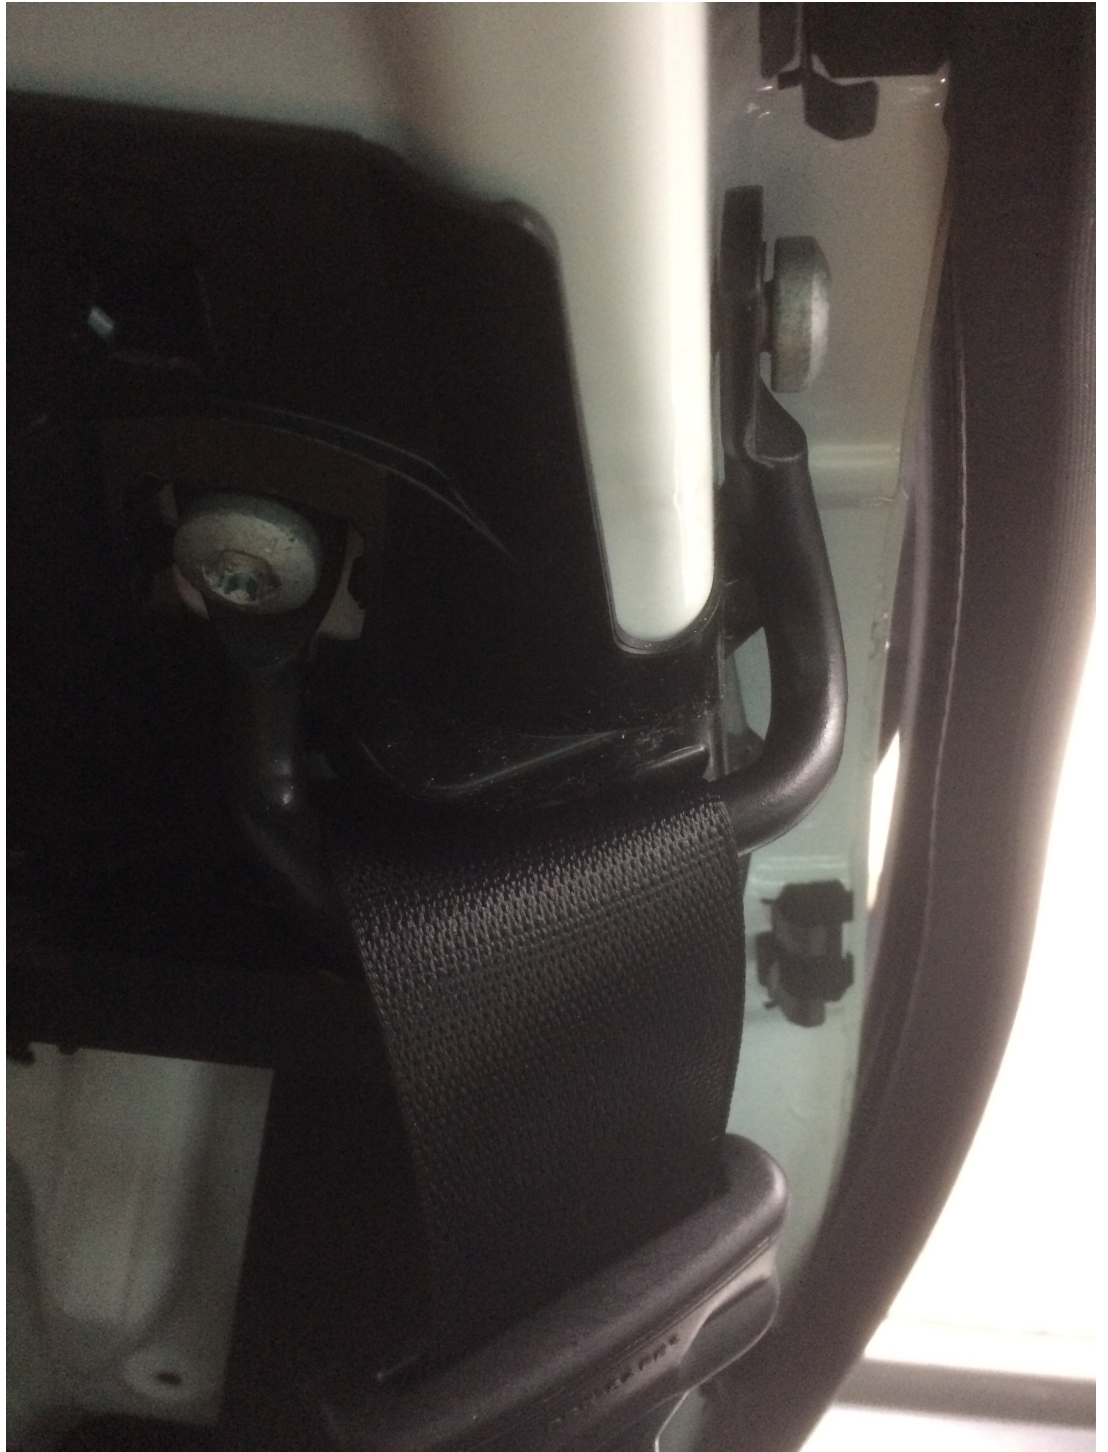
Picture 2.JPG:

Due to insufficient tolerances between the B-pillar and the belt sash guide, the seat belt strap may be impeded when rolling up (Picture 2).

| Attachments | |
|---|---|
| Picture 2.JPG | Belt strap inhibited when rolling up |

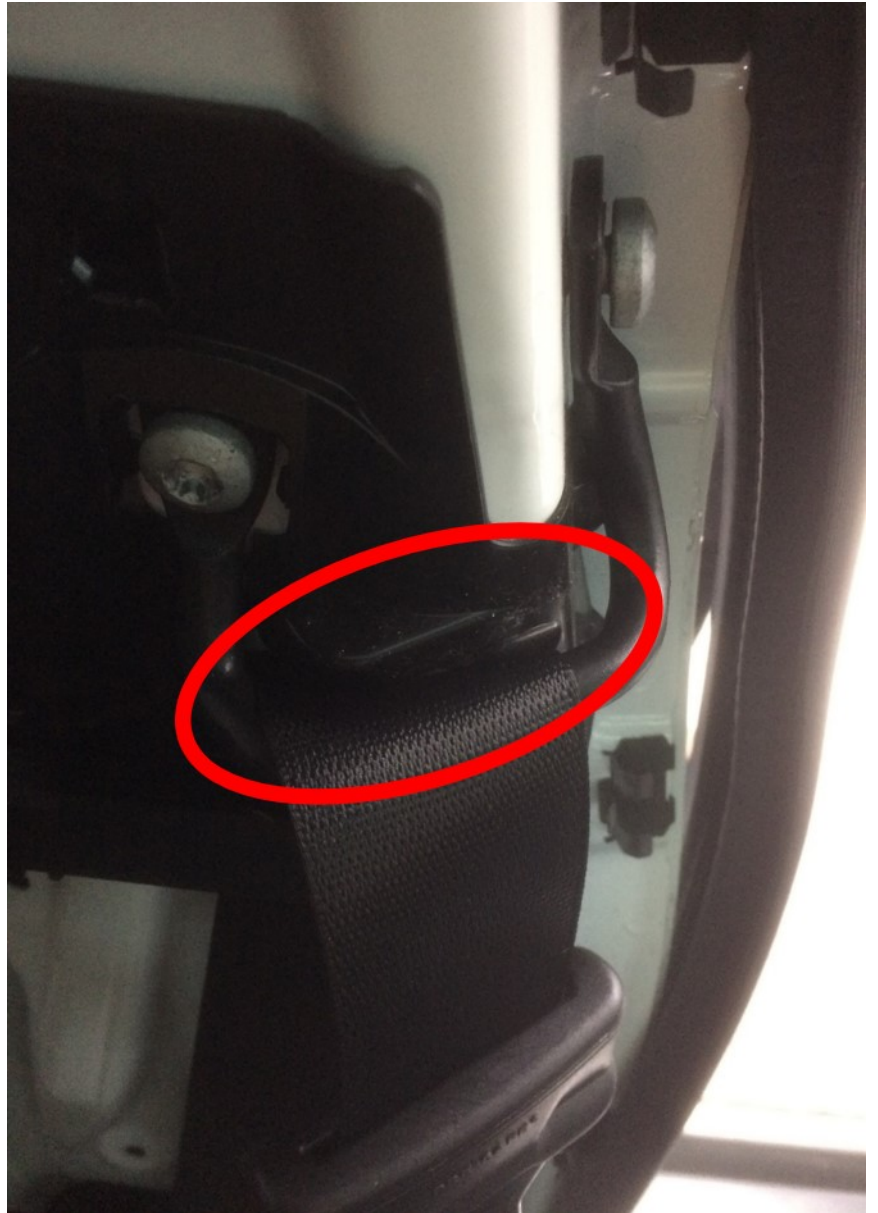
Picture 3.jpg:

| Attachments | |
|---|---|
| Picture 3.jpg | Belt sash guide |

Adjust tolerance between B-pillar and belt sash guide (Picture 3).

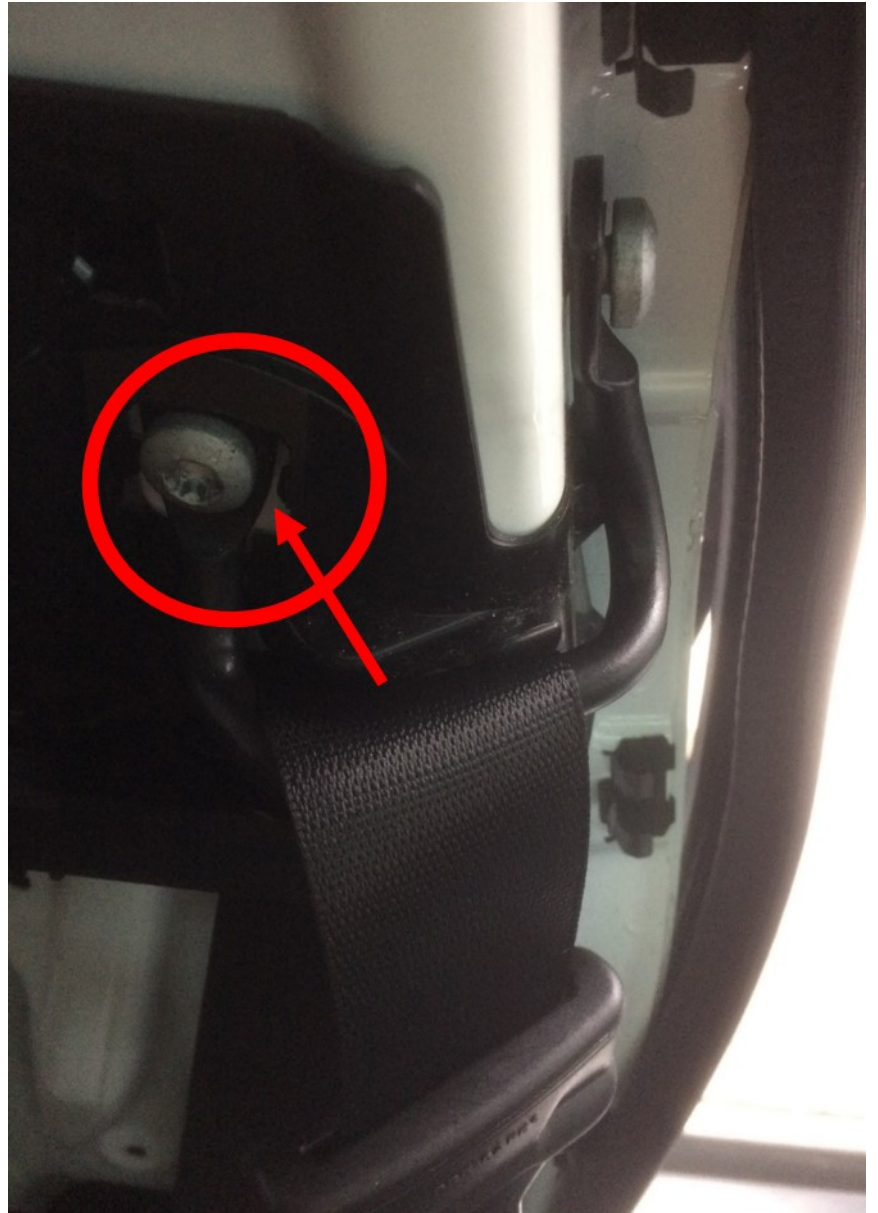
Picture 8.jpg:

| Attachments | |
|---|---|
| Picture 8.jpg | Installation of washer |

If the seat belt strap still does not roll up completely, install a washer between the bolted belt sash guide and the B-pillar (Picture 8).

Recommended washer (see N-item number)

Tighten screws of belt sash guide to 30 Nm

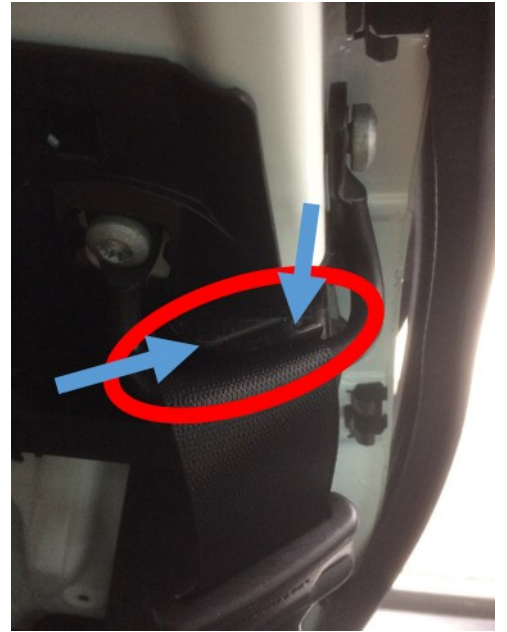
Picture 9.jpg:

| Attachments | |
|---|---|
| Picture 9.jpg | Test |

When the belt sash guide has been reworked, the seat belt strap should run easily between the seat belt guide and the belt sash guide (Picture 9).

It is not necessary to replace the seat belts
