## Center Caps on the Wheels May Have Surface Damage, Corrosion, or Fading

| Topic number | LI40.10-P-068659 |
| Function group | 40.10 Wheels, tires |

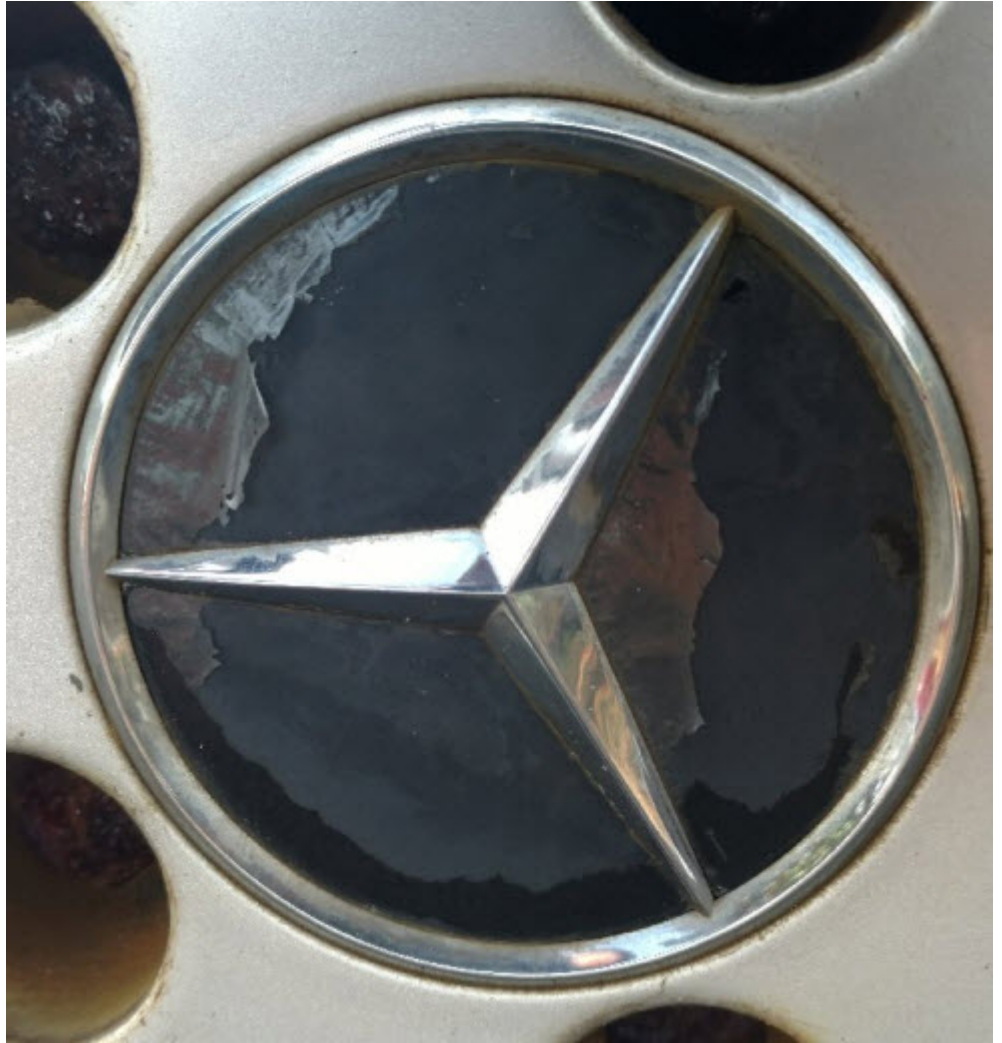
A.jpg:

See pictures (A) and (B) for examples of damages you may see. The pictures are of the black center caps, but all types of center caps may be susceptible to this if the right conditions are met.

| File | Description |
|---|---|
| A.jpg | Center Cap Peeling and Corroded |

Accelerated aging of the center caps may be caused by long-term or continuous exposure to one or more of the following conditions;

If you would like to replace the center caps, this can not be claimed under warranty as the damage is due to natural causes and not manufacturer's defect.

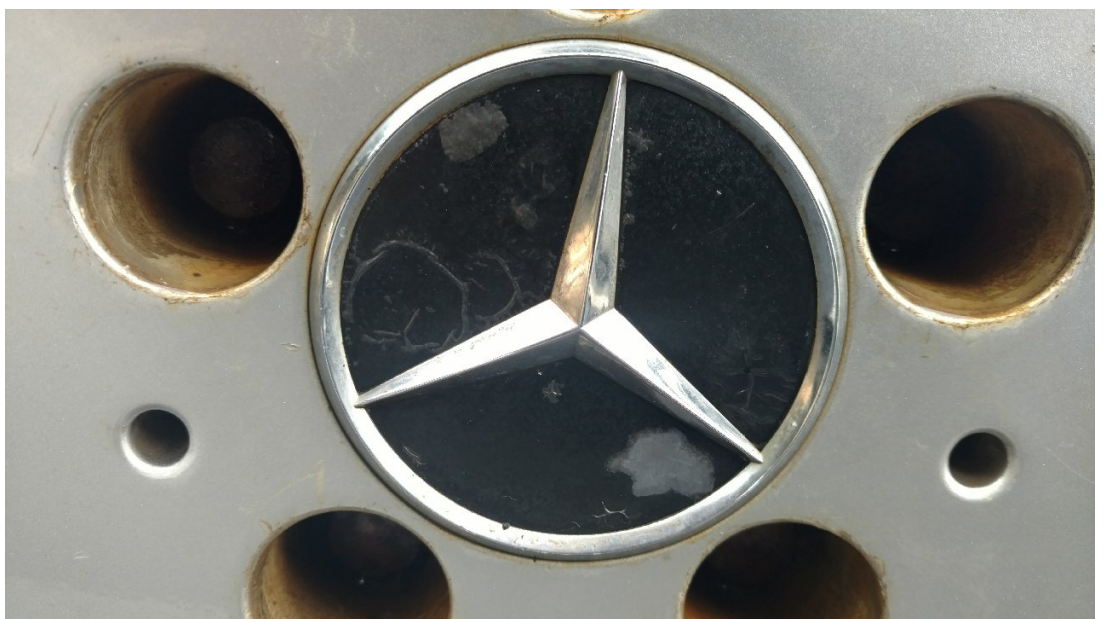
B.jpg:

| File | Description |
|---|---|
| B.jpg | Center Cap Fading and Peeling |
