Noises from seat climate control/ seat ventilation

Topic number	LI91.30-P-068713
Version	1
Function group	91.30 Seat heater, seat ventilation
Date	08-24-2018
Validity	BR166 and BR292 with 401 and without 555 (code: 401/-555)
Reason for change	
Reason for block

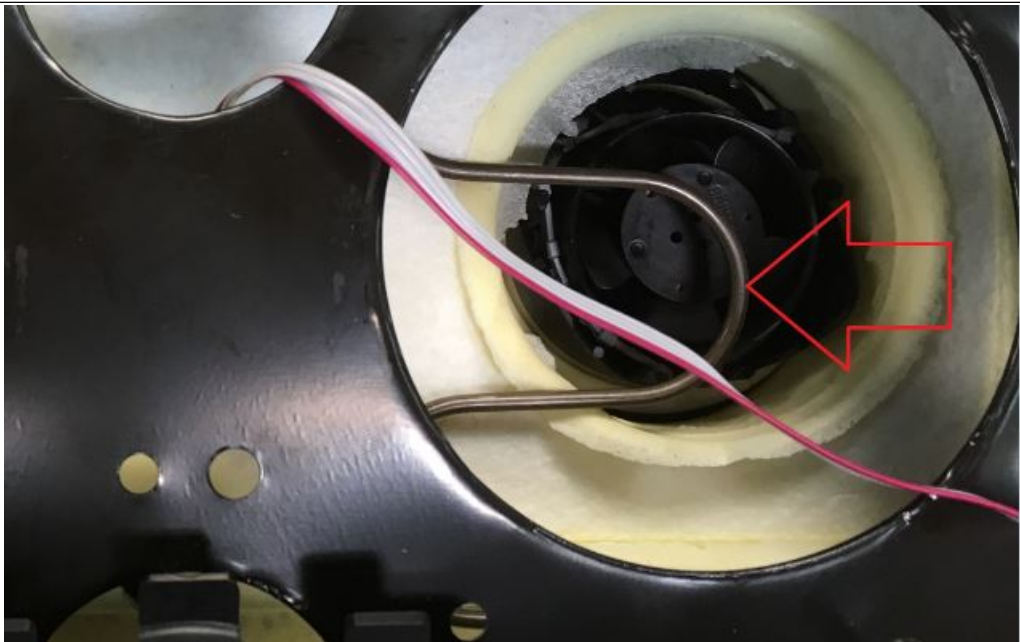
Draht_an_Belüftung.JPG:

Fan rubbing on feed line under load (see picture 1)

Attachments	
File	Description
Draht_an_Belüftung.JPG	Picture 1

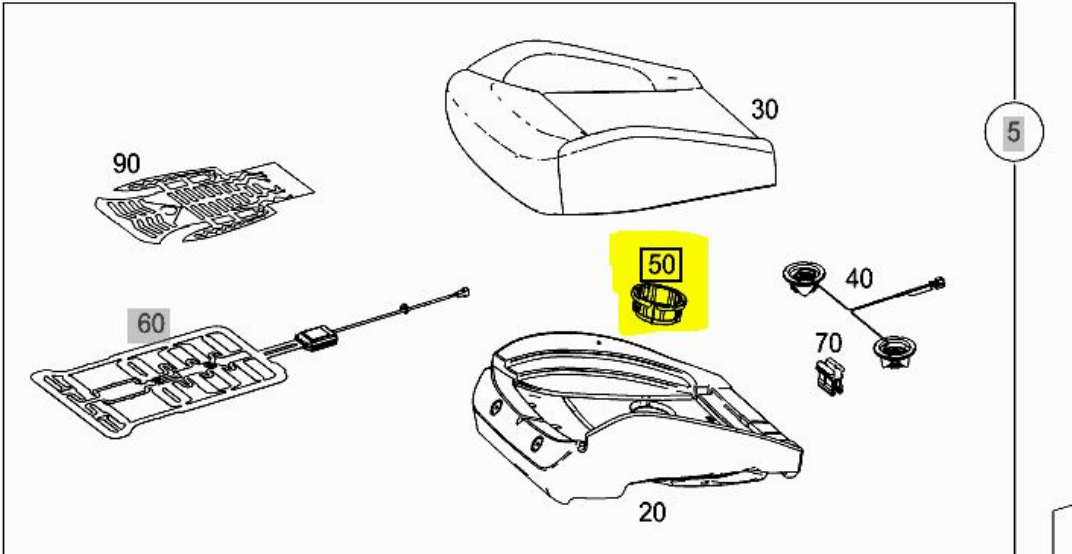
Aufnahme_Lüfter_EPC.
JPG:

File	Description
Aufnahme_Lüfter_EPC.JPG	Picture 2

-> Install mounts (A 166 919 48 00) on fan in cushion padding to prevent contact with the electrical feed line (see picture 2).

-> Without code U10: Install mounts (A 166 919 48 00) on fan in cushion padding to prevent contact with the electrical feed line (see picture 2).
