## AXLES AND SUSPENSION

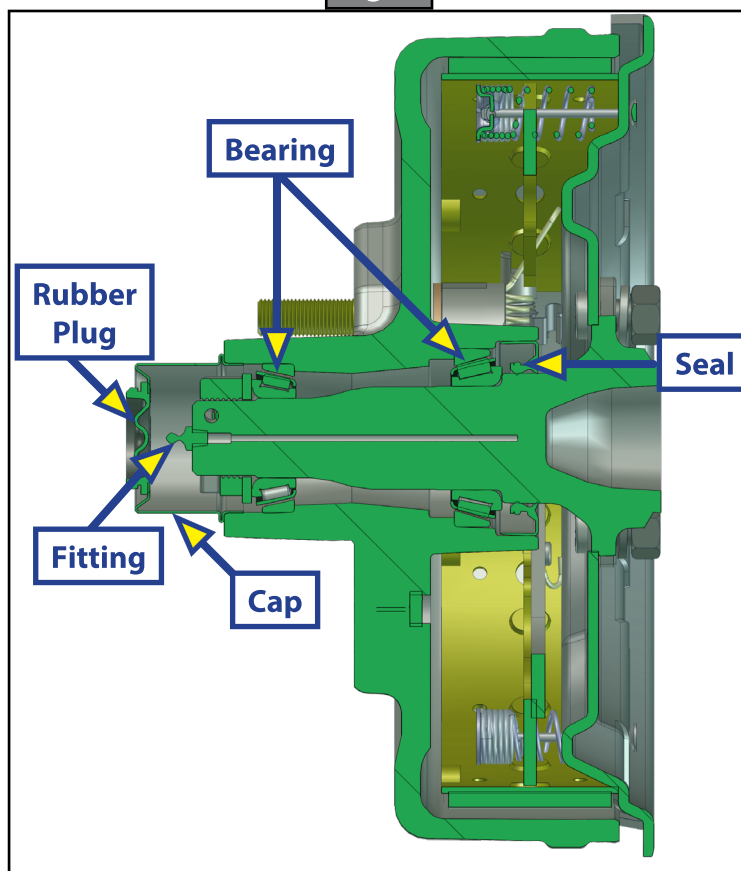
Fig. 1

1. Remove rubber plug from grease cap.
2. Place nozzle of standard grease gun onto the grease fitting found behind plug.

3. Begin pumping new grease into fitting. The previously used grease will begin to exit the bearing cavity through the outer bearing.
4. To evenly coat the bearings, spin the hub during grease application.
5. As the new grease begins to exit out the grease cap, the grease gun can be removed. Excess grease can then be cleaned up and the rubber plug replaced in the grease cap.
