TECHNICAL SERVICE BULLETIN

Technical Service Bulletin: 10-0916

ROCKWOOD/FLAGSTAFF – G16TH/E16TH SOFA REMEDY

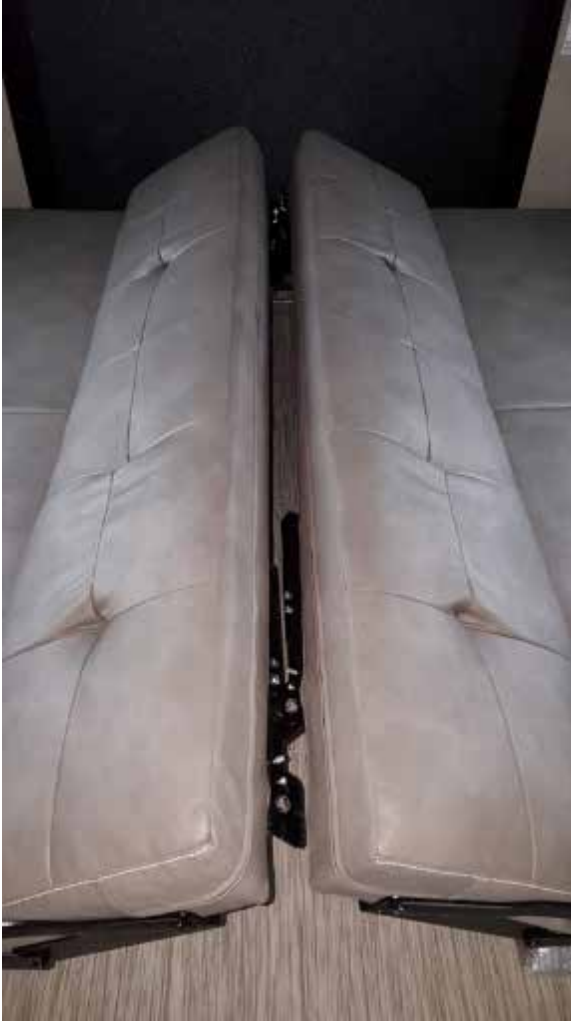
CURRENT

In certain vehicles the sofa/dinette installed may need to be adjusted in order to fold-out as intended into a bed.

- Ø You will need a 3/8" drill bit and a 1/2" wrench or socket;
- Ø Remove the back portion of the sofa from the hardware;
- Ø Drill new holes in the hardware 1/2" towards the seat portion of the sofa from the existing holes;
- Ø Remount back onto hardware and after both sofas are done it will work like originally designed;
- Ø Touch up original holes with a black paint marker where paint is worn off.
