Subject <b>Squeak Noise From Front of Vehicle On Uneven Surfaces - NO.1 Body Mount</b>		Market <b>USA</b>
Service Category <b>Suspension</b>	Section <b>Front Suspension</b>	
Applicability <b>16-18MY Tacoma16-18 MY Tacoma</b>

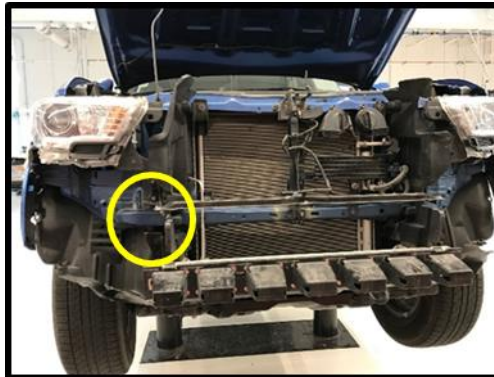
Some vehicles may exhibit a squeak or rattle noise from the FR RH Body Mount Bushing when driving over uneven roads or bumps. Make sure to confirm that noise is coming from RH FR (No.1) Body Mount Bushing before proceeding.

Location of RH No.1 Body Mount

After confirming the noise from front RH No.1 Body Mount, submit the following information in a DPR:

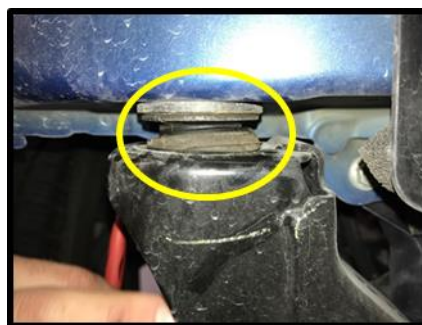
Example of bushing condition photo

1. BEFORE uninstalling the bolt from No.1 Body Mount, take a photo of the bushing condition and position in relation to the frame.

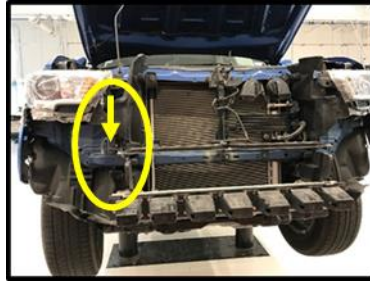
**Location of Bolt top mounting surface and witness mark example**

2. After the bolt is removed, take a photo of the bolt witness mark to the body and note the direction of the offset. (see below for detail)
