Subject <b>Exhaust Manifold Stud and Nut Not Missing, DO NOT attempt to add one.</b>		Market USA
Service Category Engine/Hybrid System	Section Intake/Exhaust	
Applicability Camry, Avalon (2GR-FKS)

2018-2019	Camry	2019	Avalon
-----------	-------	------	--------

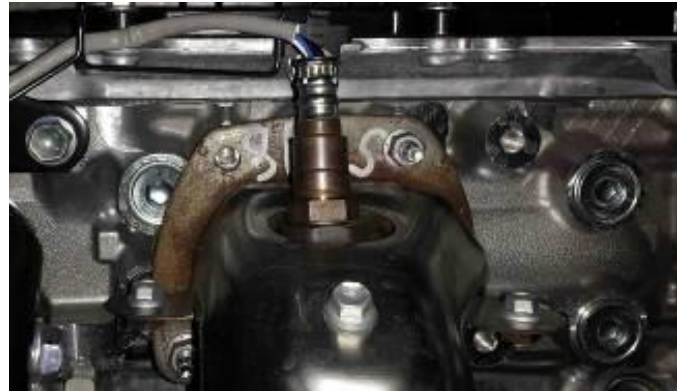
On 2018-2019 model year Camry and 2019 model year Avalon, equipped with the 2GR-FKS engine, technicians may observe that the bank 1 (rear) exhaust manifold may be “missing” a stud and nut. The repair manual shows that, as per design intent, the exhaust manifold is NOT missing a stud and nut.

Figure 2. Vehicle view – Bolt from factory not included, as per intent.

**DO NOT ADD** a stud and nut to the location shown above, as this is per design intent.
