## **SERVICE BULLETIN**

**SB-18-030 AIR SPRING SHIELD**

**SUBJECT VEHICLES:** Certain 06MY-19MY Conventional Trucks equipped with a J08 engine

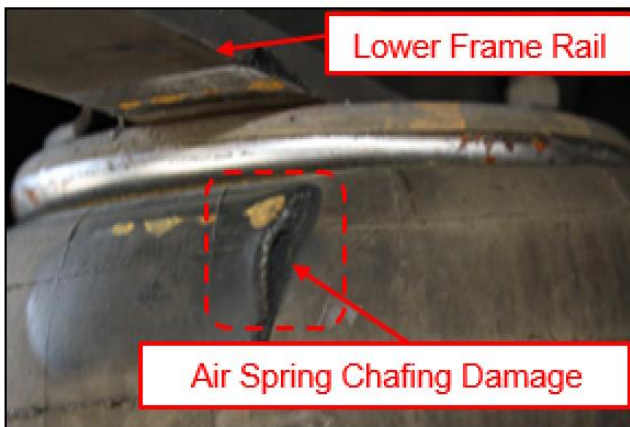
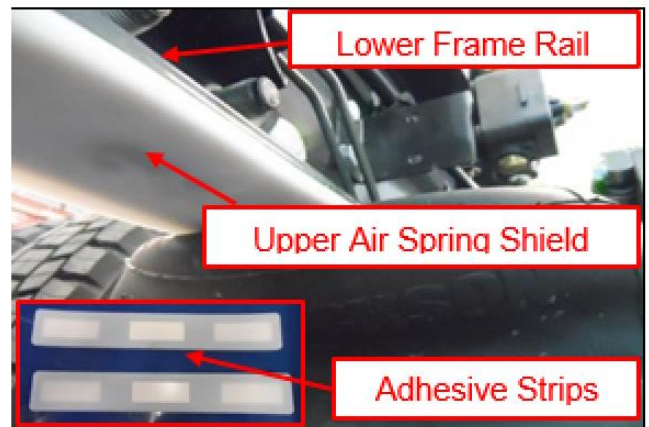
The subject vehicle may experience air spring chafing damage due to contact with the frame rail. An air spring shield has been made available to prevent air spring failure due to frame rail chafing.

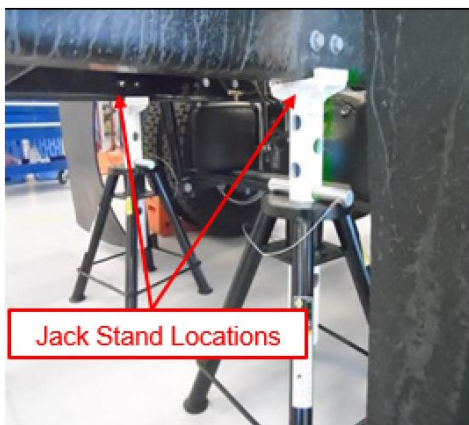
1. Raise the rear of the vehicle and place a jack stand under each frame rail. Lower the frame onto the jack stands, ensuring no weight is carried by the rear suspension.

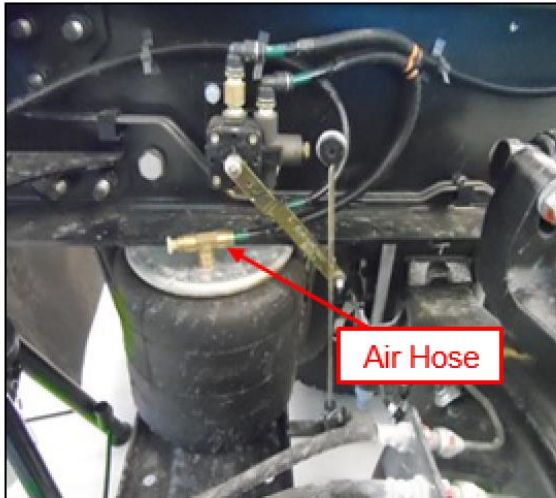
2. Disconnect the air hoses on both sides of the vehicle.  
(Use the same procedure for both sides).

**NOTICE:** Only one side is shown in the photo below.

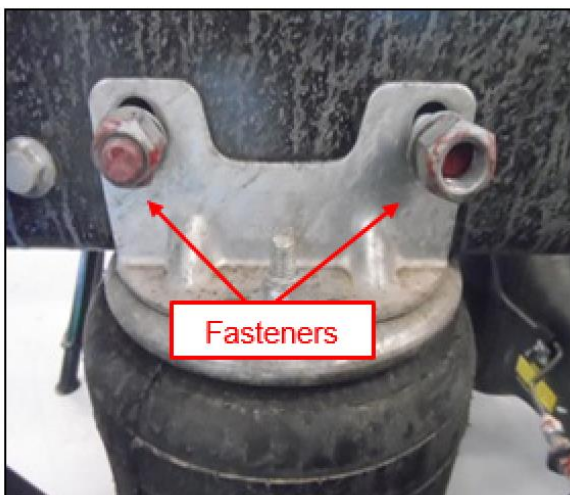
3. Remove the nuts, washers, and bolts from the air springs on both sides of the vehicle. Retain the nuts, washers and bolts for reassembly.  
(Use the same procedure for both sides).

**NOTICE:** Only one side is shown in the photo below.

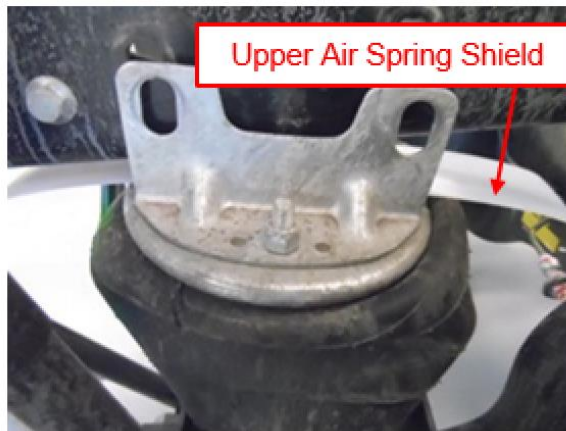
4. Place the first upper air spring shield on top of the air spring as shown in the photo below, with the adhesive strips facing up. Center the upper air spring shield above the air spring with the inner edge 1/8 to 1/4 inch inward of the inside edge of the frame rail. Remove the paper backing from the adhesive strips and push the upper air spring shield onto the frame rail. Repeat the procedure with the second shield.  
(Same procedure for both sides).

**NOTICE:** Double check the air spring shields are fully adhered to the frame rail before moving onto step 5.

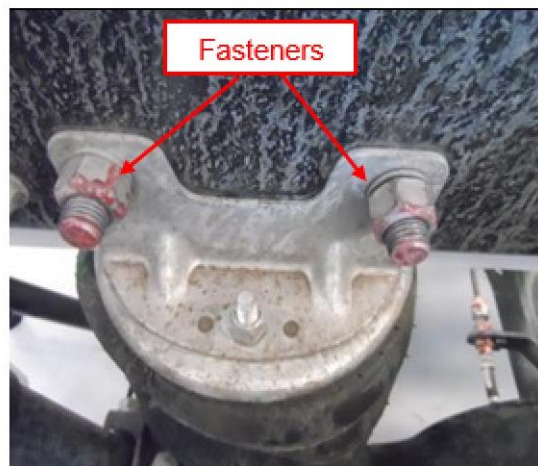
5. Reinstall the fasteners removed in step 3 on both sides of the vehicle. Raise the axle as needed to fully seat the air springs up against the frame rail. Tighten the fasteners to the specified torque.

**Specified Torque:** 249 lb-ft (337Nm)

**NOTICE:** Only one side is shown in the photo below.

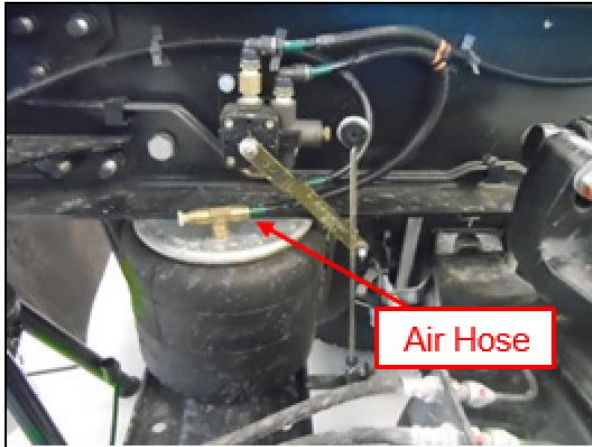
6. Connect the air hose.  
(Use the same procedure for both sides).

**NOTICE:** Only one side is shown in the photo below.
